HAL
open science

Fire behaviour of hybrid filament-wound single and adhesively bonded composites tubes under static pressure

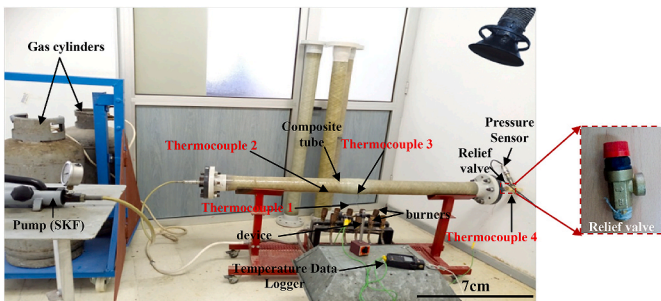
Fig. 2. The experimental device of the fire endurance test.

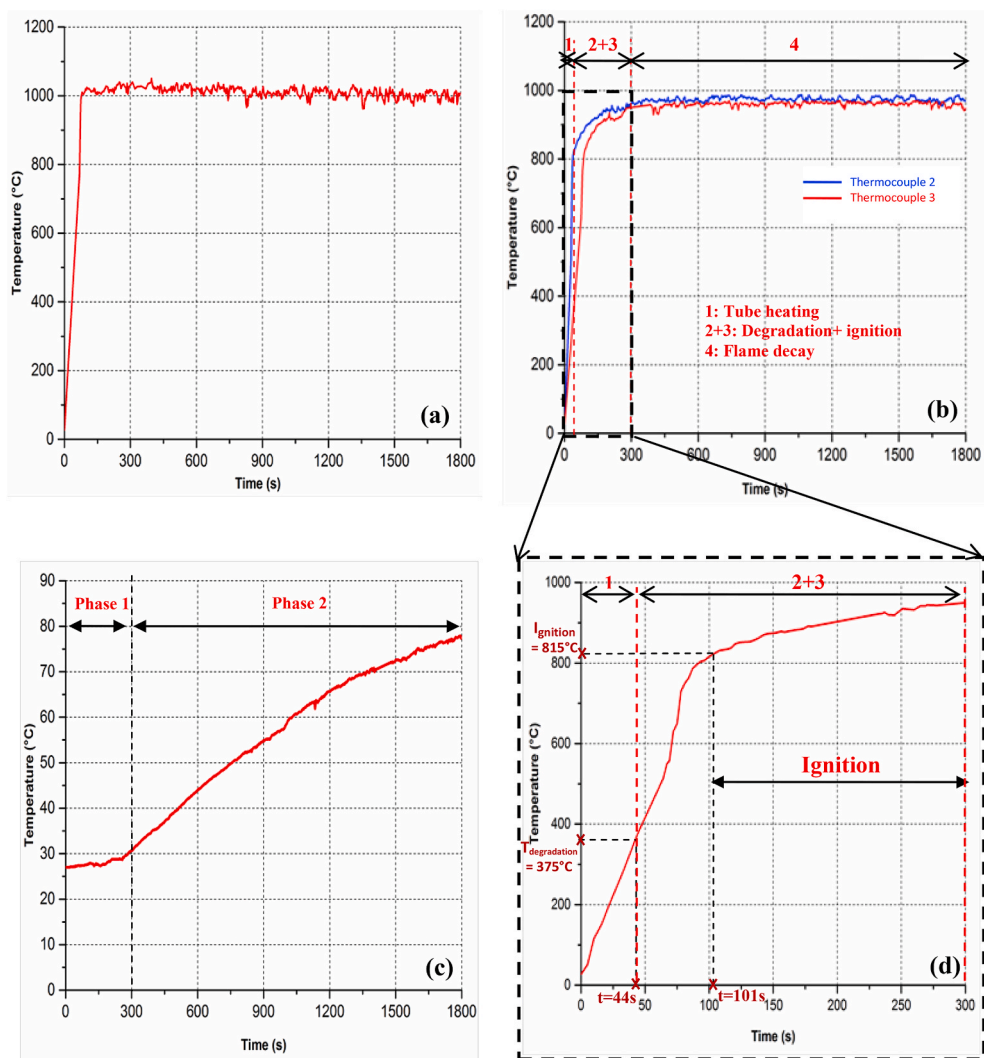
Fig. 4. The temperature-time profiles along the fire endurance test. With (a) The flame, (b) The tube outer surface, (c) The water inside the tube and (d) Zoom of the highlighted zone on figure (b).

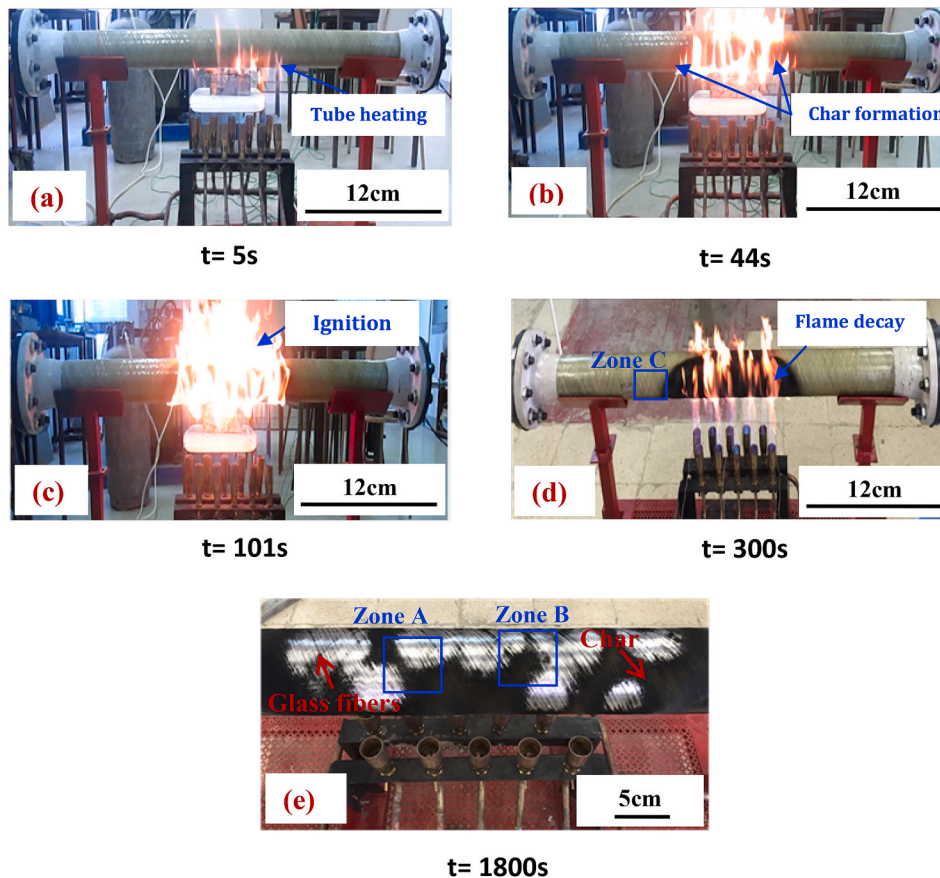
Fig. 5. The combustion process of E glass/Vinylester 411 composite tube exposed to fire during 30 min. With (a) Tube heating, (b) Degradation, (c) Ignition, (d) Flame decay, (e) The tube surface exposed directly to fire.

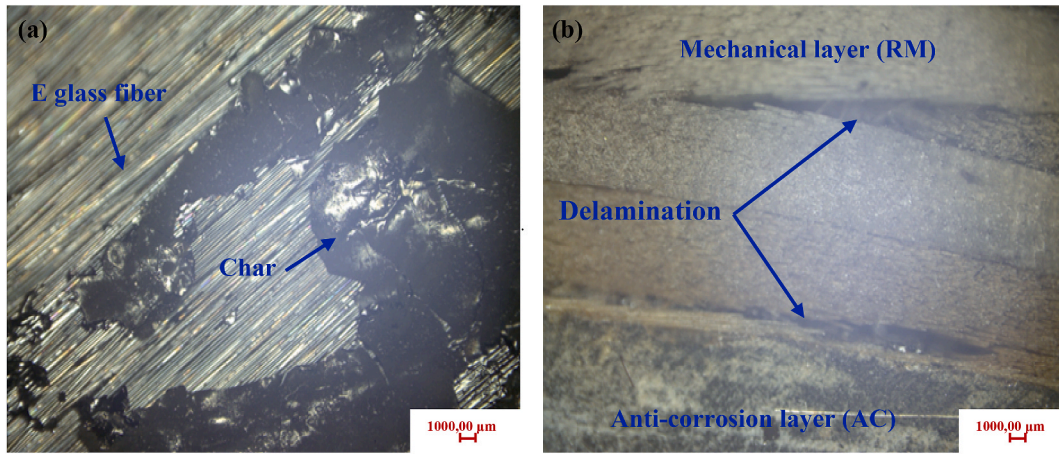
Fig. 6. Optical observations of burnt E glass/Vinylester 411 composite tube (zone B highlighted in Fig. 5-d). With (a) Char formation in the tube surface exposed directly to fire, and (b) Delamination (cross section).

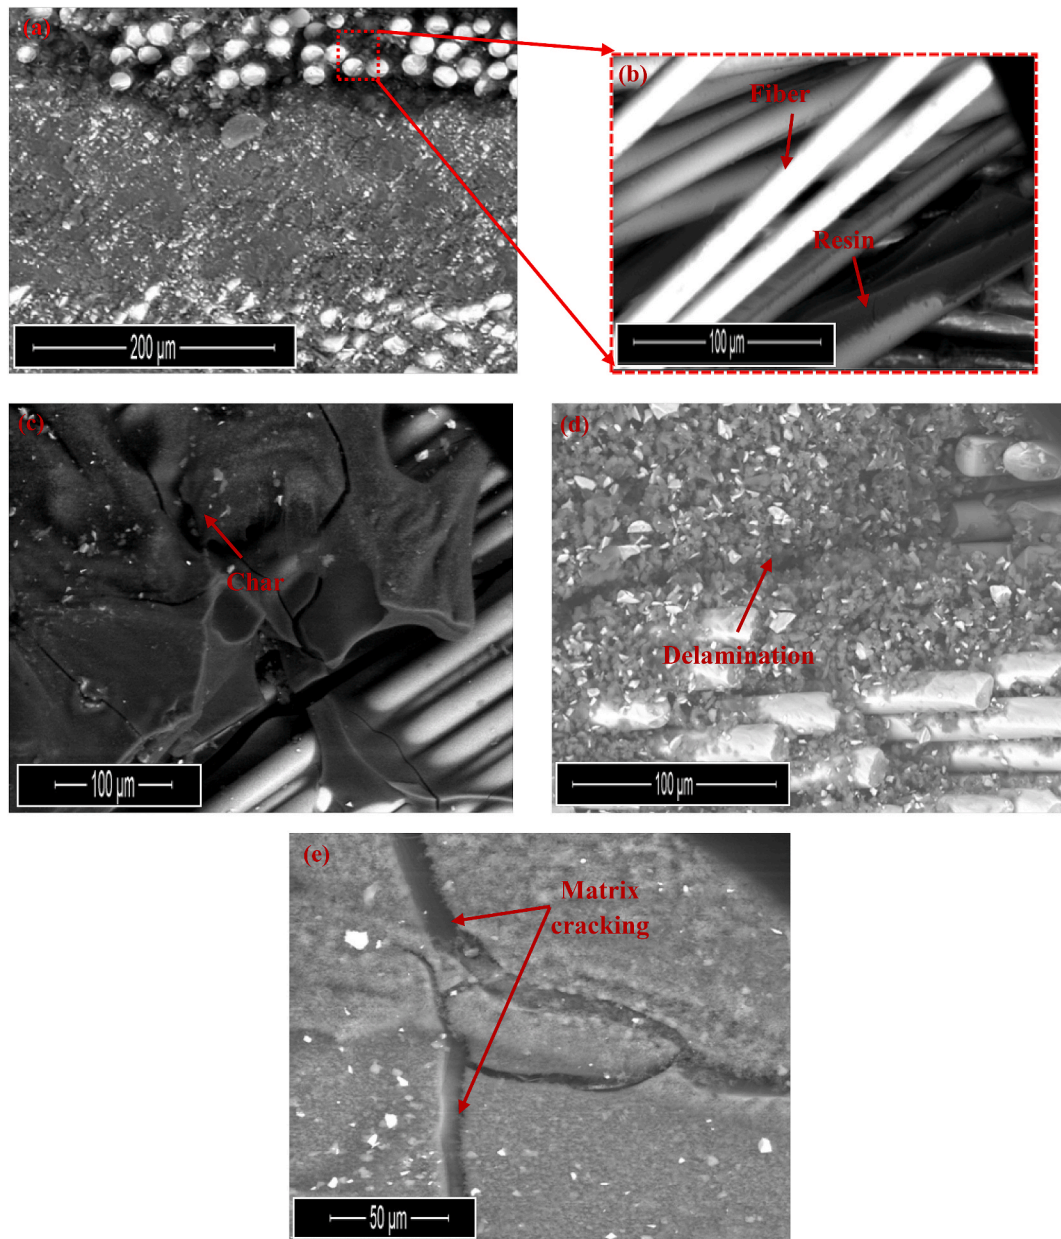
Fig. 7. SEM observations of E glass/VE 411 resin tube after being exposed to fire. With (a) Resin decomposition (b) Zoom of the highlighted zone (c) Char formation (d) Delamination, and (e) Matrix cracking (zone c highlighted in Fig. 5-c).

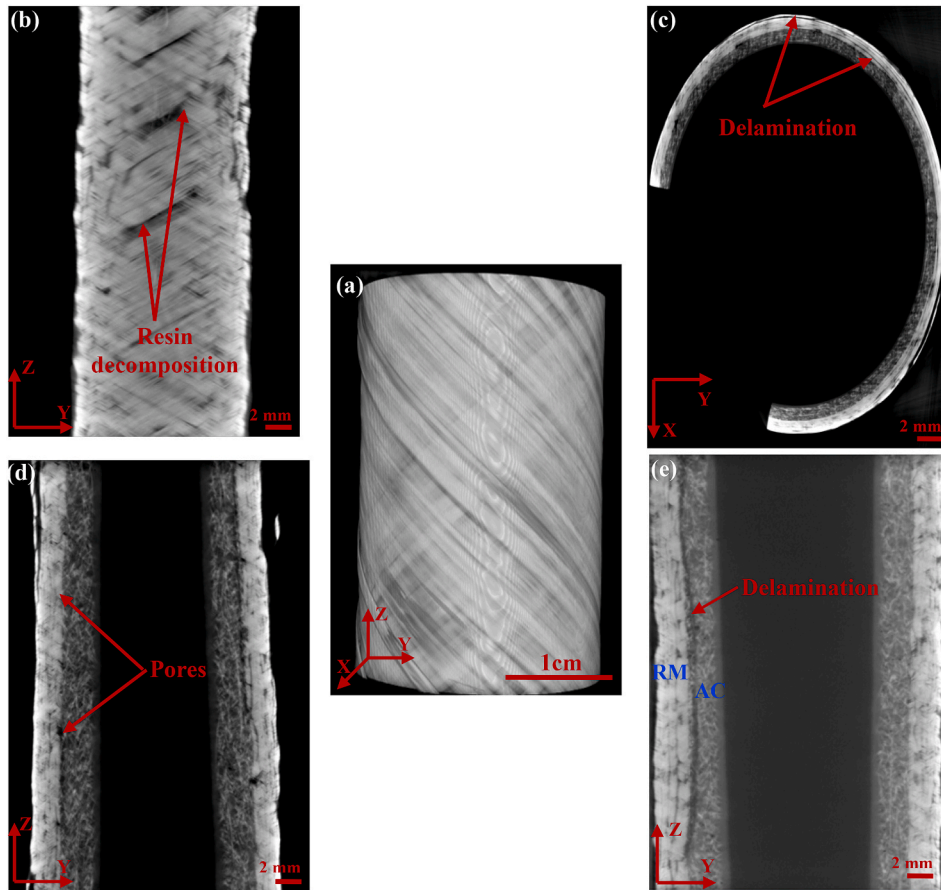
Fig. 8. X-ray tomographic images of burnt E glass/Vinylester 411 composite tube showing the fire induced damage. With (a) 3D image, (b) Resin decomposition, (c) Delamination between the tube plies, (d) Pores, and (e) Delamination between AC and RC plies.

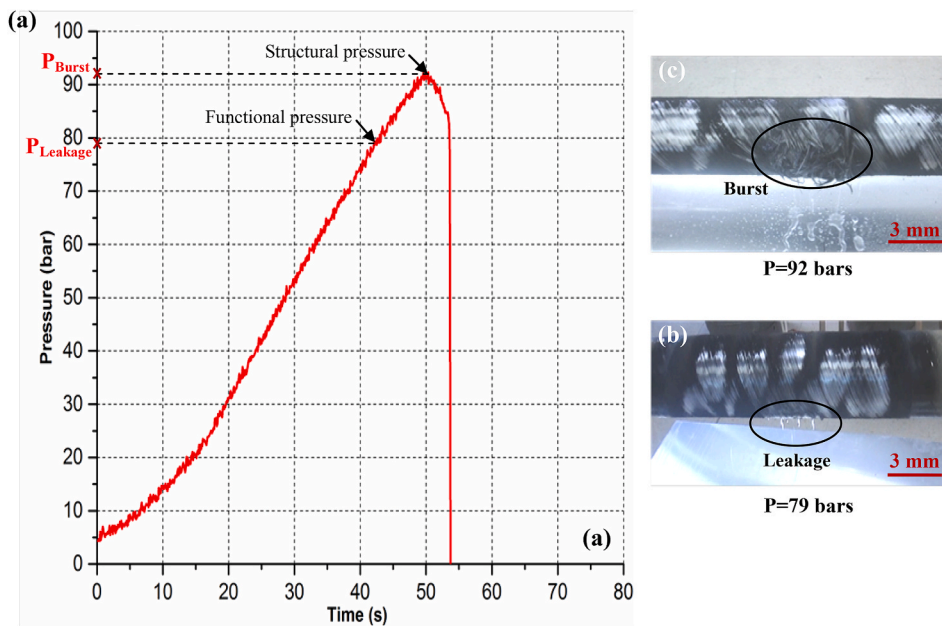
Fig. 9. Internal pressure test until failure. With (a) Pressure-time response of the burnt composite tube under pressure loading, (b) Tube leakage and (c) Tube burst.

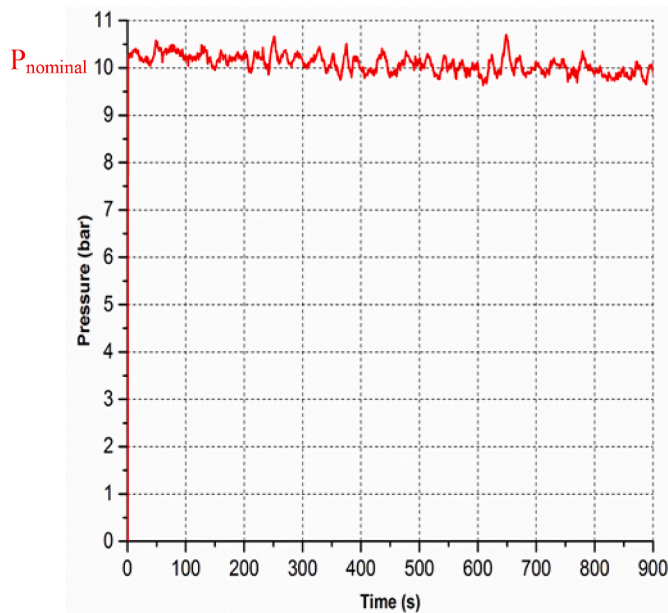
Fig. 10. Hydrostatic test conducted on E glass/Vinylester composite tube after the fire endurance test.

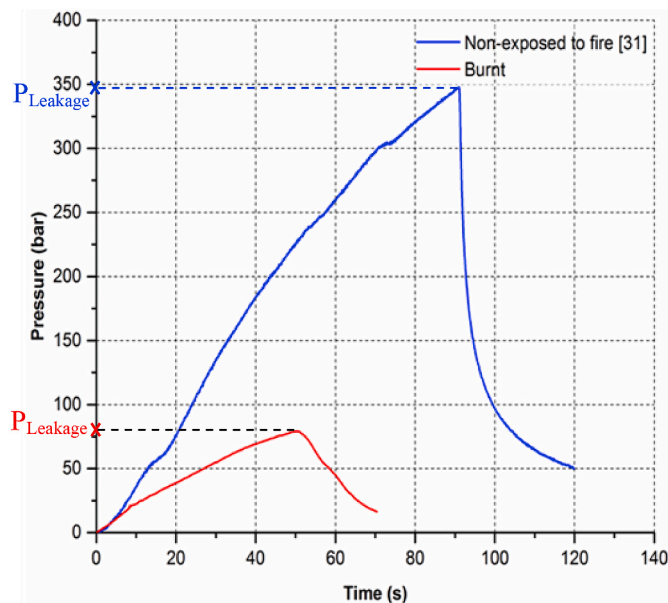
Fig. 11. Comparison between the pressure evolution of the non-exposed to fire and the burnt single composite tube made of E glass fiber reinforced VE411 resin.

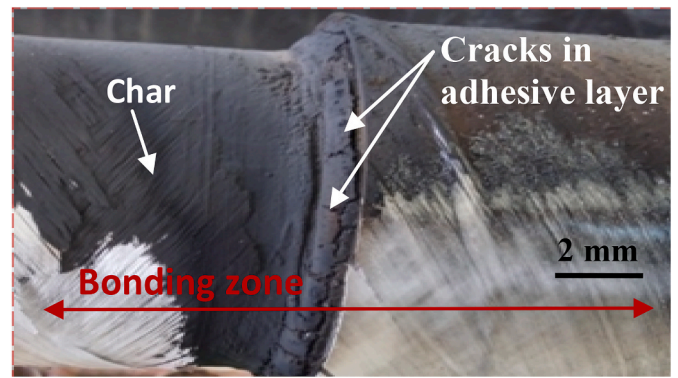
Fig. 12. The adhesively bonded composite tube subsequent to the fire endurance test.

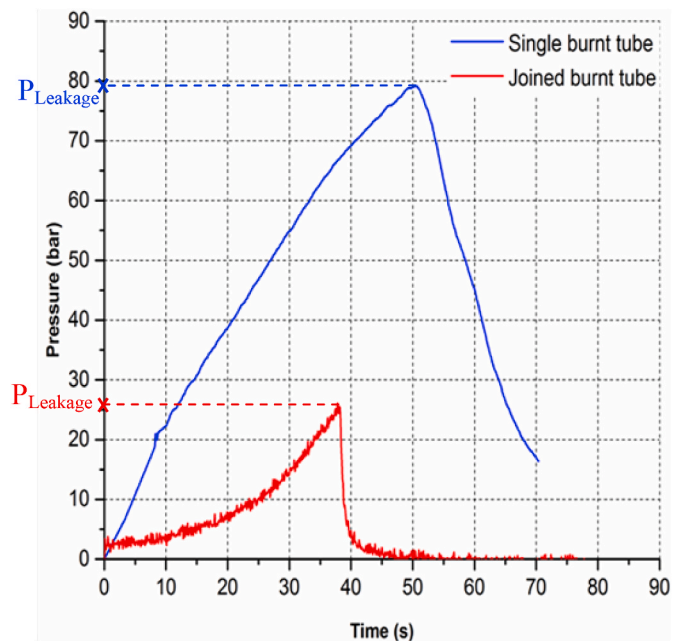
Fig. 13. Comparison between the pressure evolution of the single burnt tube and the joined burnt tube made of E glass/VE411 resin.

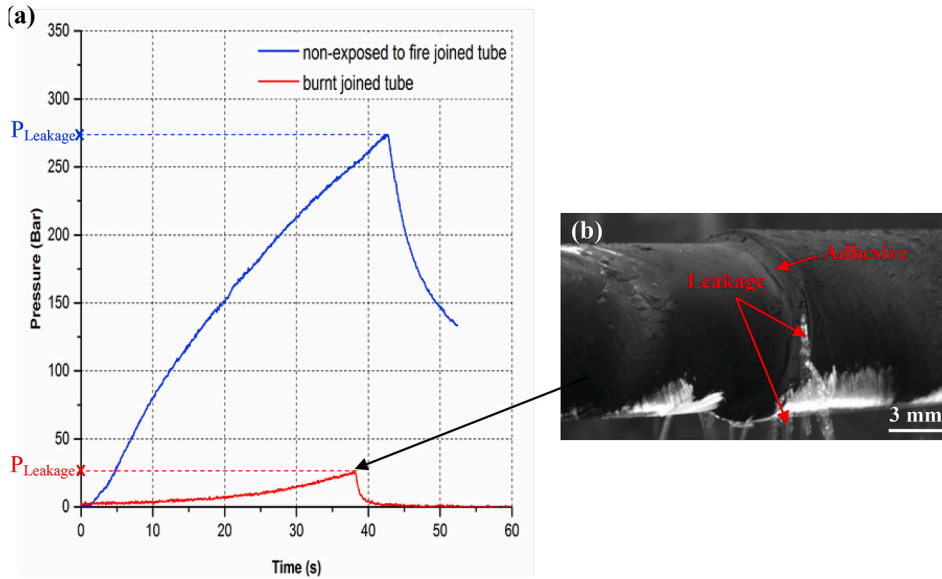
Fig. 14. Internal pressure until leakage tests. With (a) Comparison between the pressure evolution of non-exposed to fire and the burnt joined composite tubes, and (b) The burnt joined tube leakage on the bonding zone.

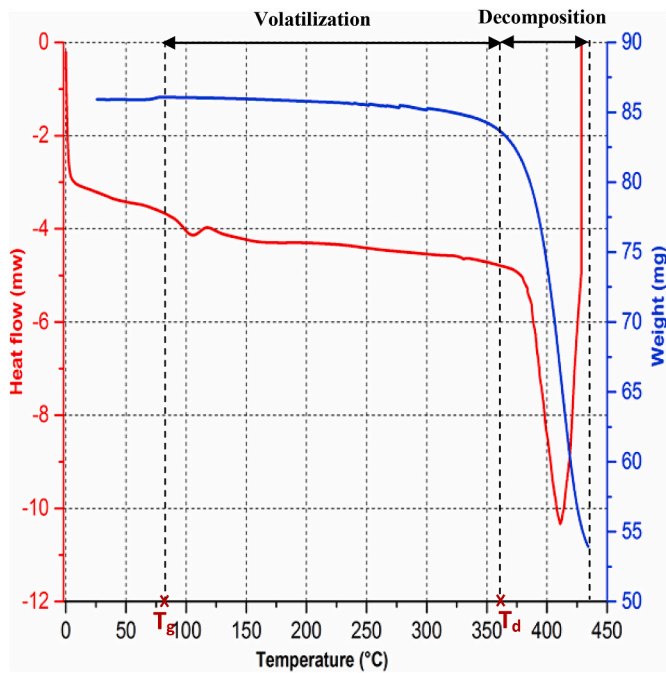
Fig. 15. DSC and TGA test results of E glass reinforced Vinylester 411 composite.

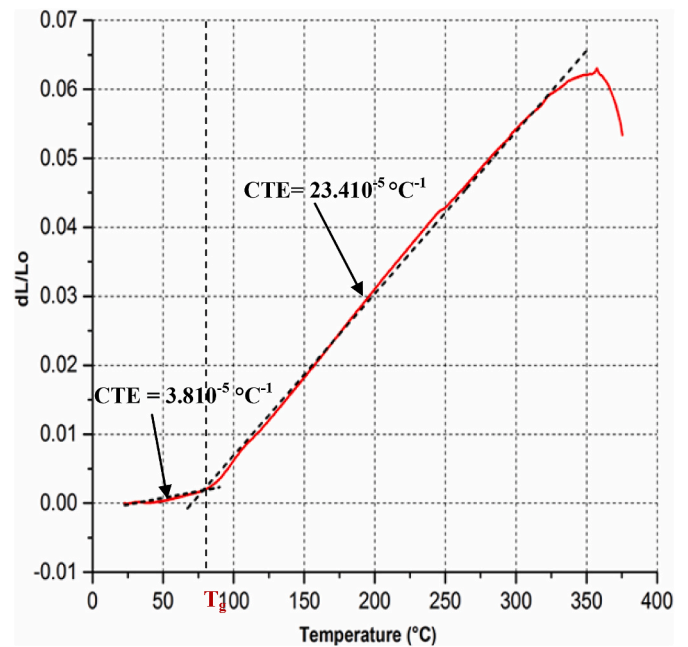
Fig. 16. TMA test result of E glass/Vinylester 411 composite.

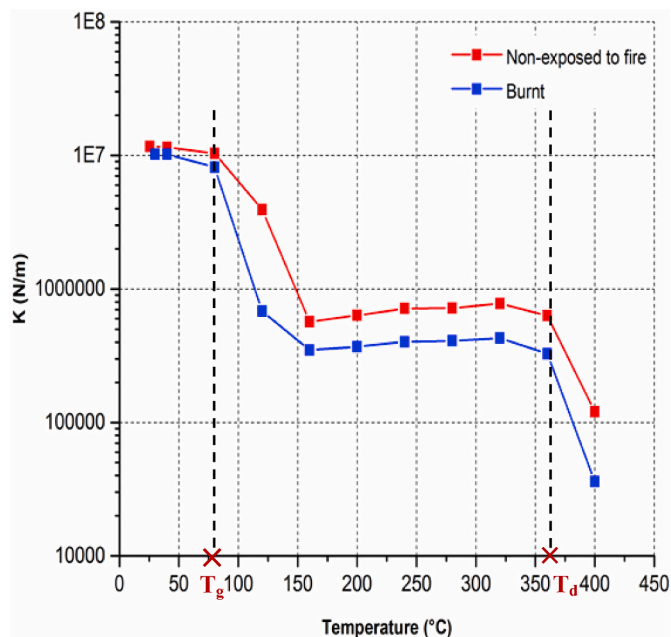
Fig. 17. DMA result of E glass/Vinylester 411 resin composite.

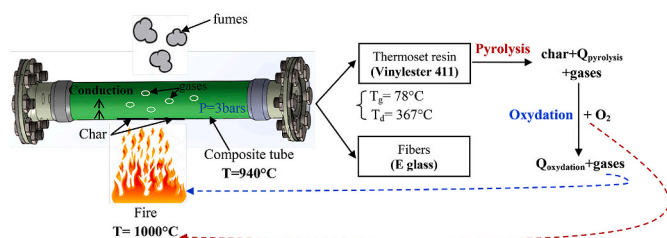
Fig. 18. Chemical processes of E glass/Vinylester 411 tube under fire.
