**HAL**  
open science

# High cycle fatigue behavior of 316L steel fabricated by laser powder bed fusion: effects of surface defect and loading mode

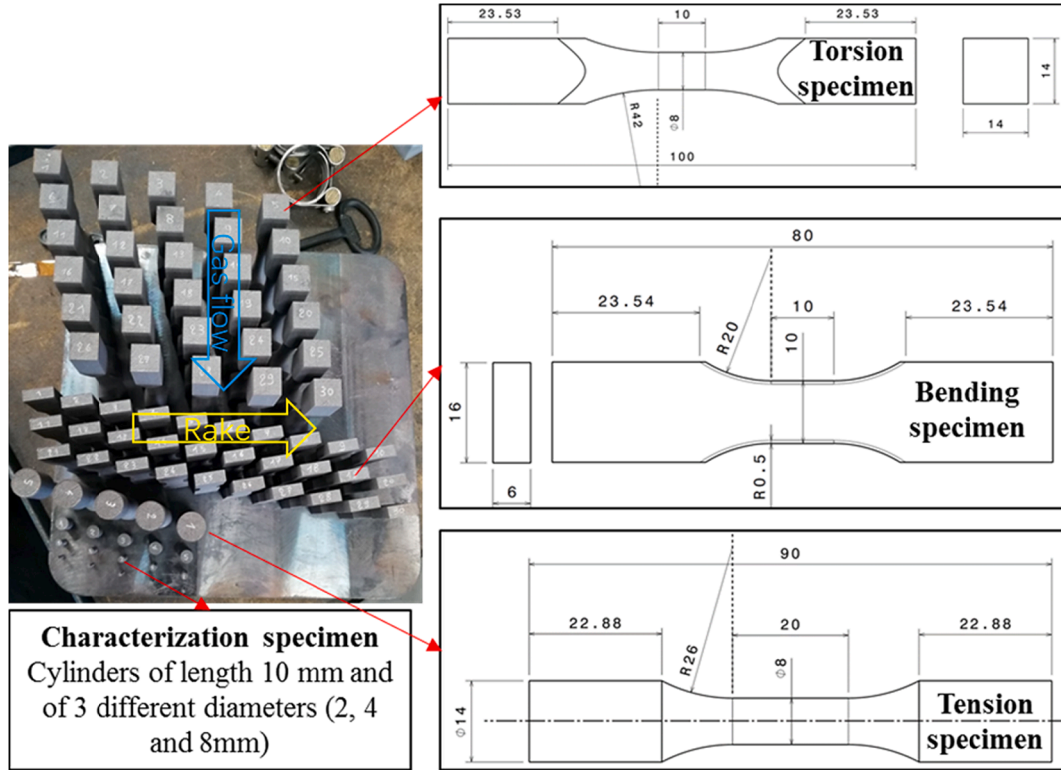
**Fig. 2.** One fabricated tray with the geometries of specimens (dimensions in mm): Characterization specimens (microstructure); Tension specimens (cyclic behavior and fatigue); Bending specimens (fatigue); Torsion specimens (fatigue).**Table 2**

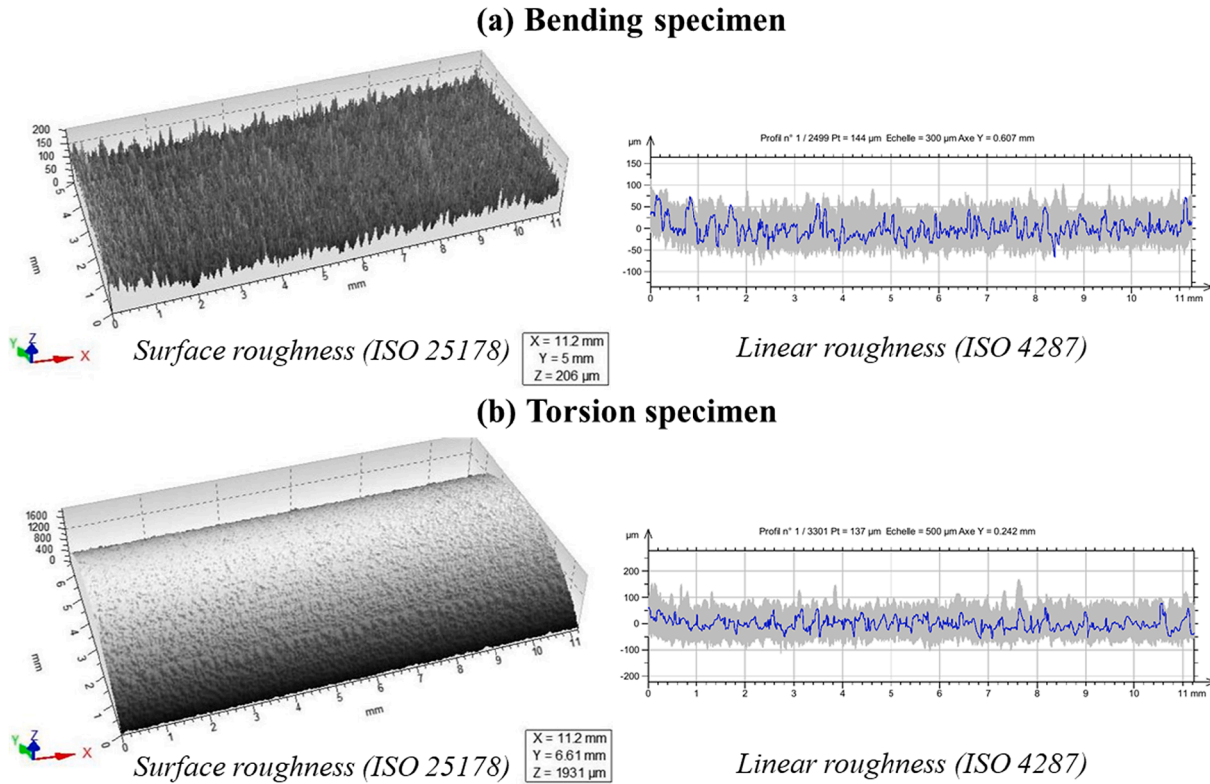
Fig. 3. Surface and linear roughness in (a) bending specimen and (b) torsion specimen.

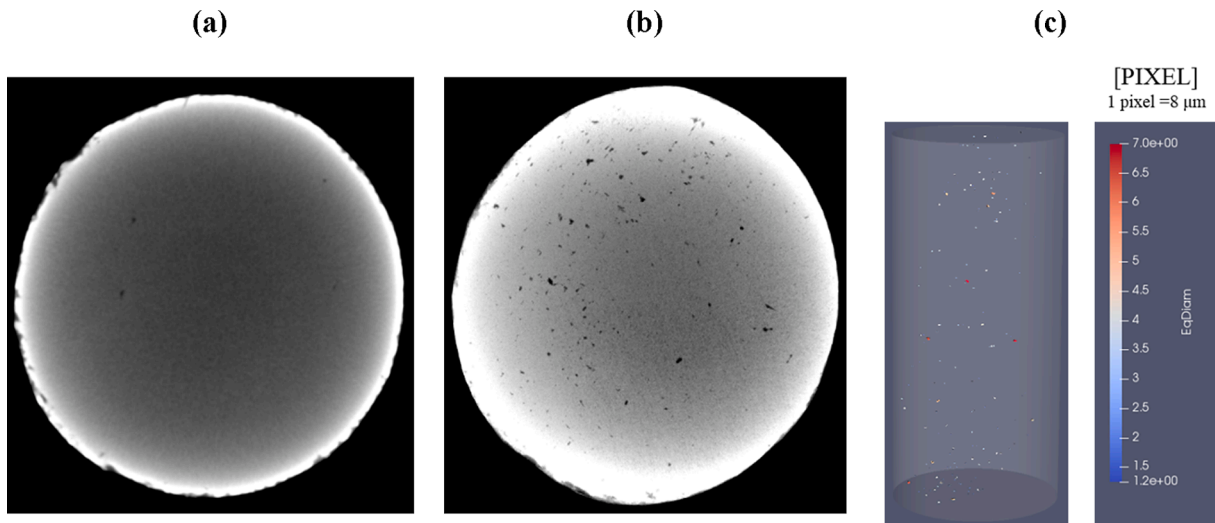
Fig. 4. Tomography in Z-plane: (a) slice No.250, (b) superimposing all slices and (c) 3D size and spatial distribution of the detected defects.

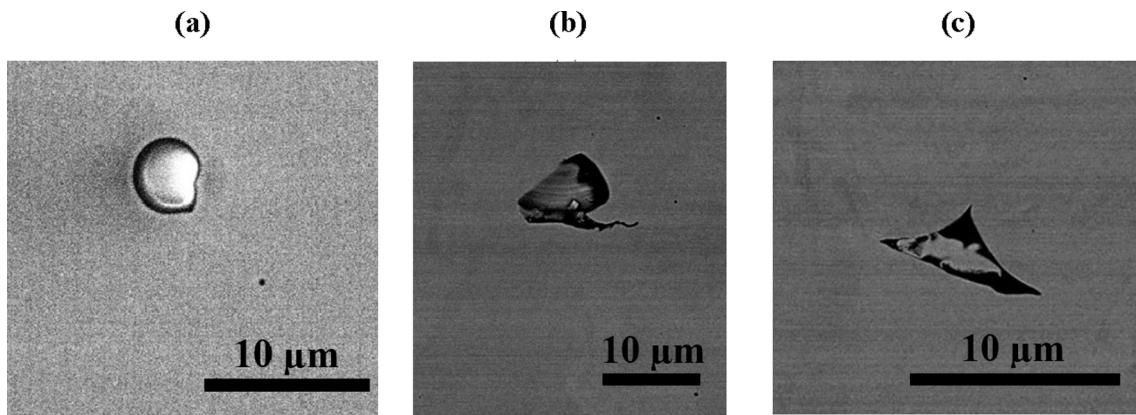
Fig. 5. Process-induced defects observed under SEM: (a) un-melted powder, (b) lack of powder, and (c) pore formed between the particles of powder.

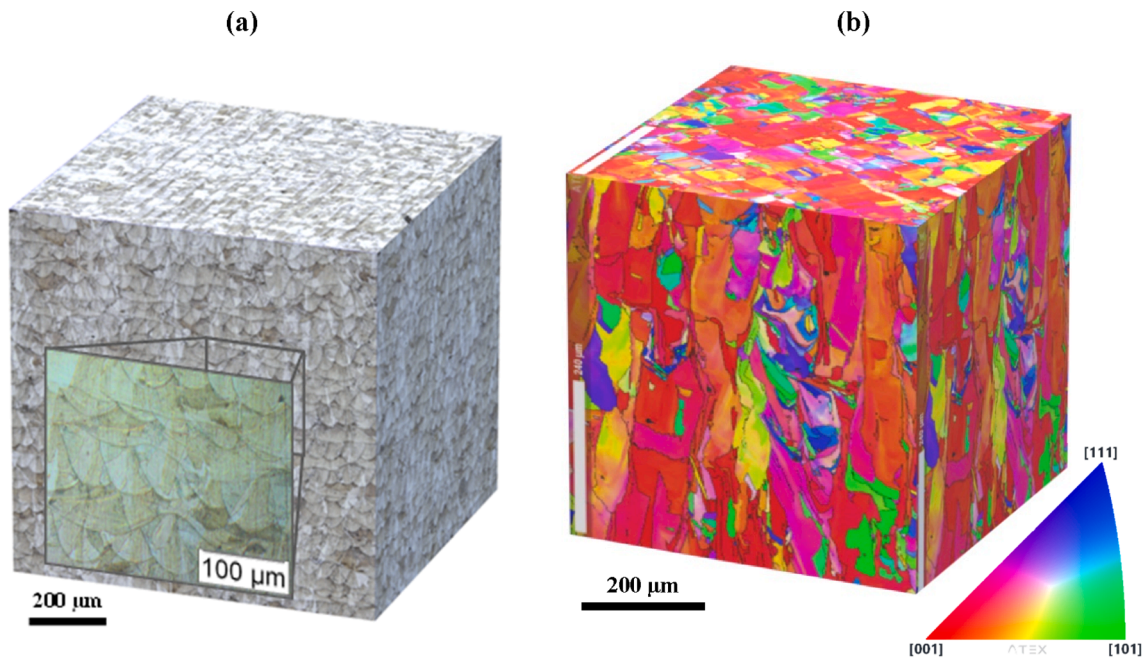
Fig. 6. (a) 3D microstructure of the LPBF 316L SS observed by (a) optical microscopy ( $\times 100$  and  $\times 250$ ) and (b) SEM- EBSD (the building direction was vertical).

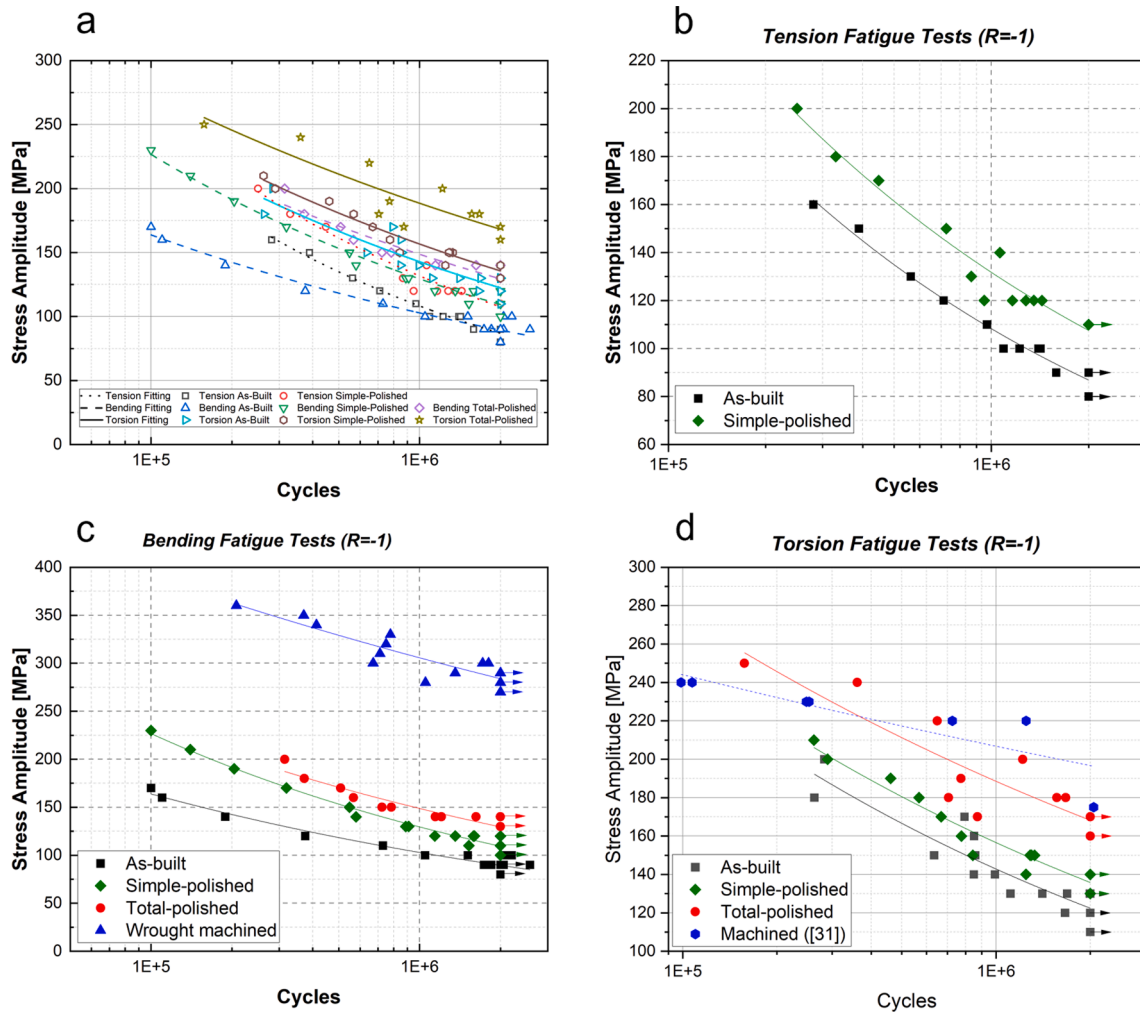
Fig. 7. S-N curves for different surface state conditions in different fully reversed loading modes: (a) summary plots; (b) tension-compression; (c) plane bending; The fatigue test results for machined specimens of wrought 316L steel are also given for comparison; (d) torsion; with reference from [31].

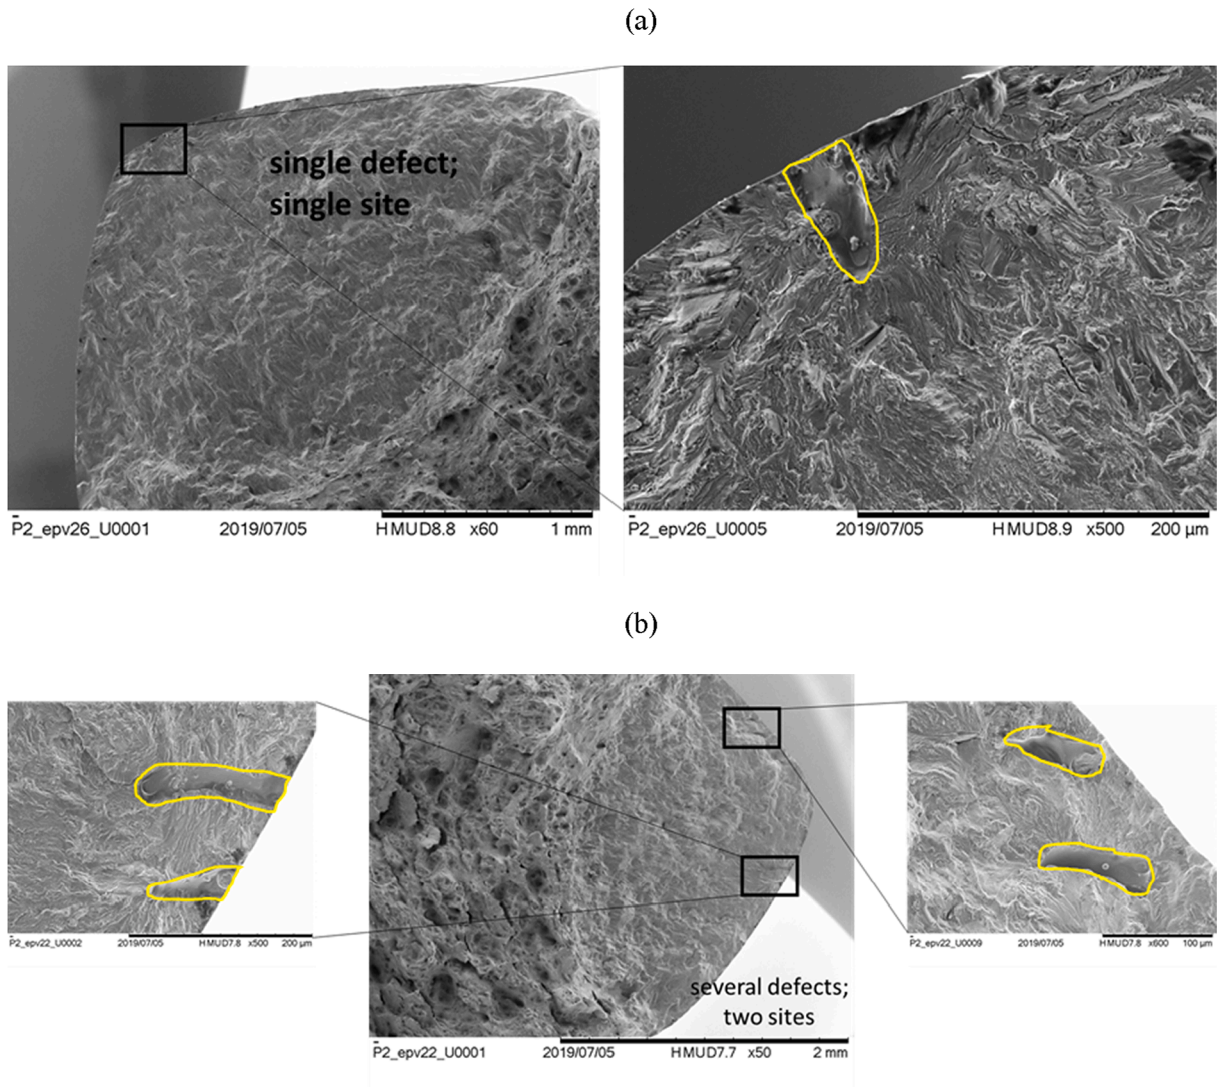
**Fig. 8.** SEM observations on fatigue crack initiation site(s) in total-polished LPBF 316L bending specimens: (a) single defect at one initiation site (Tray2-S26); (b) several defects at two initiation sites (Tray2-S22). Elongated-shaped defects can be seen.

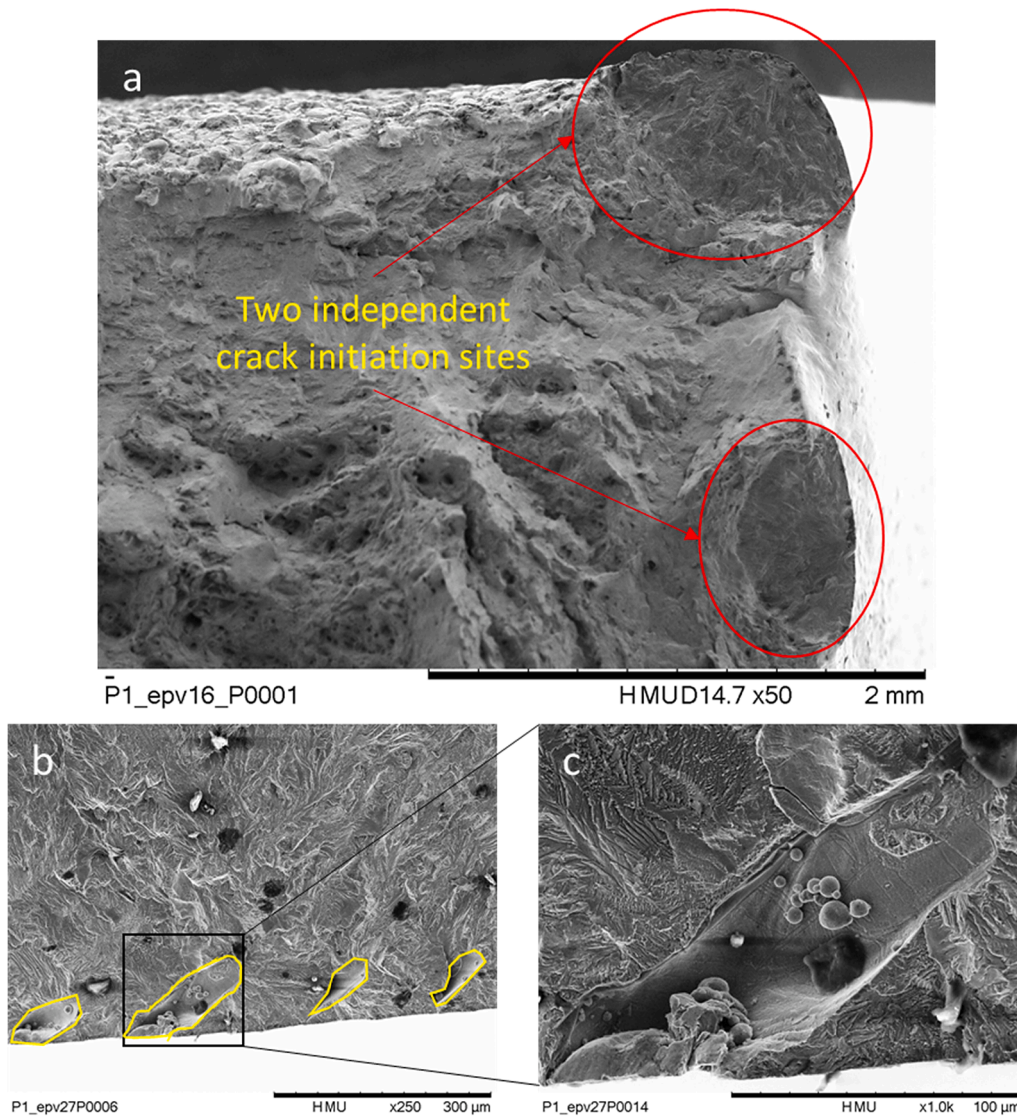
**Fig. 9.** SEM observations on fatigue crack initiation site(s) in simple-polished LPBF 316L bending specimens: (a) two independent fatigue crack initiation sites in the specimen (Tray1-S16); (b) parallel adjacent defects at one crack initiation site and (c) a zoomed view of one LoF defect (Tary1-S27).

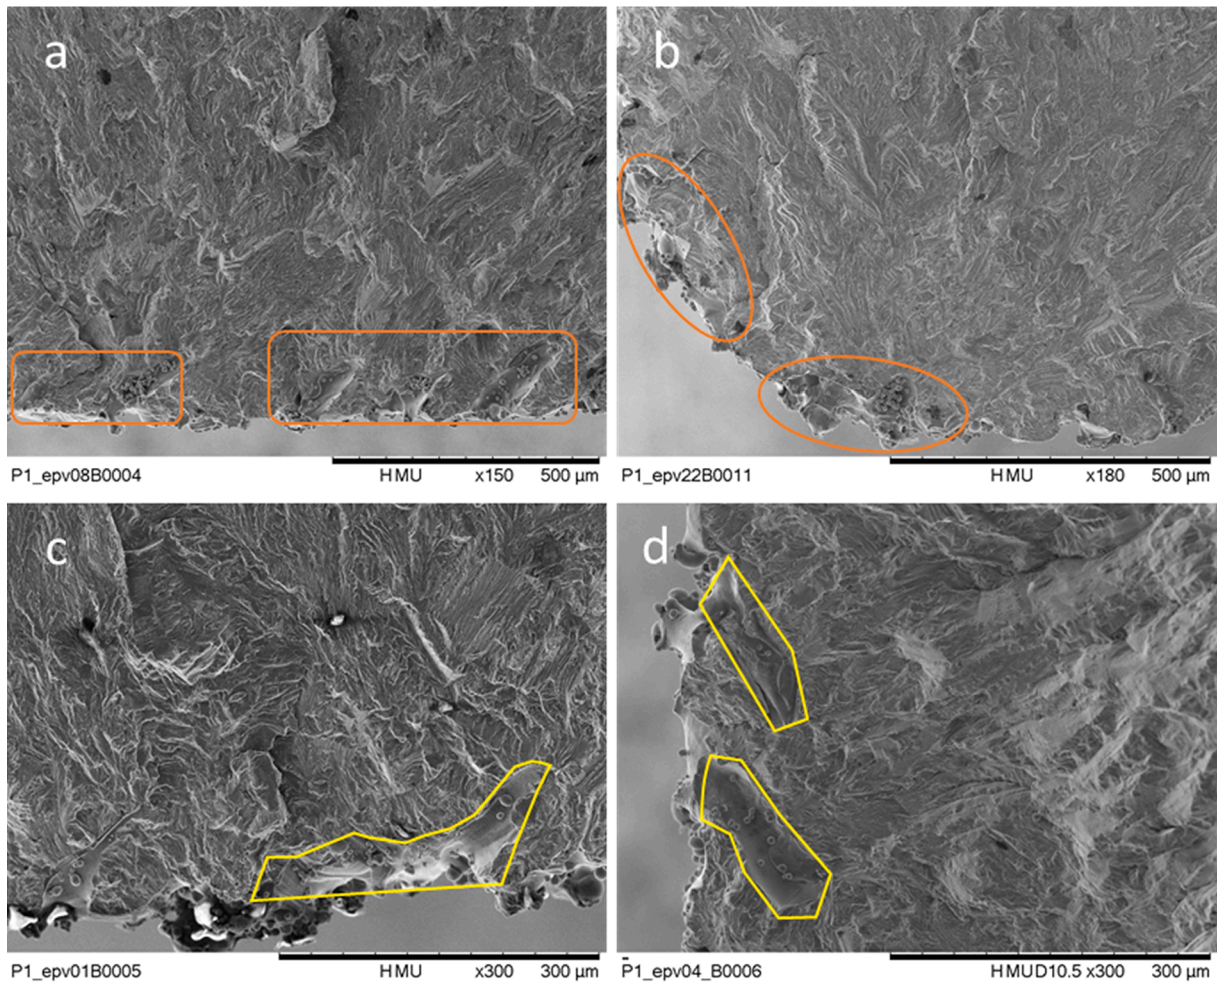
**Fig. 10.** SEM observations on fatigue crack initiation site(s) in as-built LPBF 316L bending specimens: representative crack initiation sites (a) in the middle of the top surface and (b) in the edge of top surface; typical presences of defects: (c) open defect due to roughness and LoF; (d) subsurface defect from LoF.

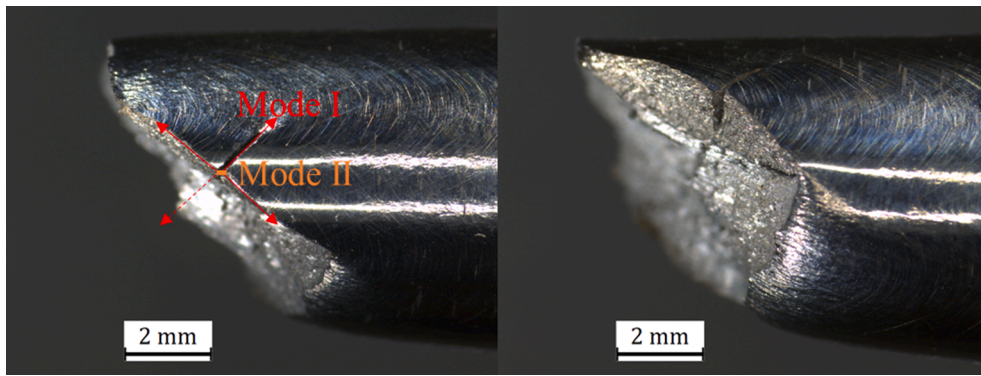
Fig. 11. Macroscopic crack path in total-polished torsion specimen: stage I (mode II) followed by stage II (mode I).

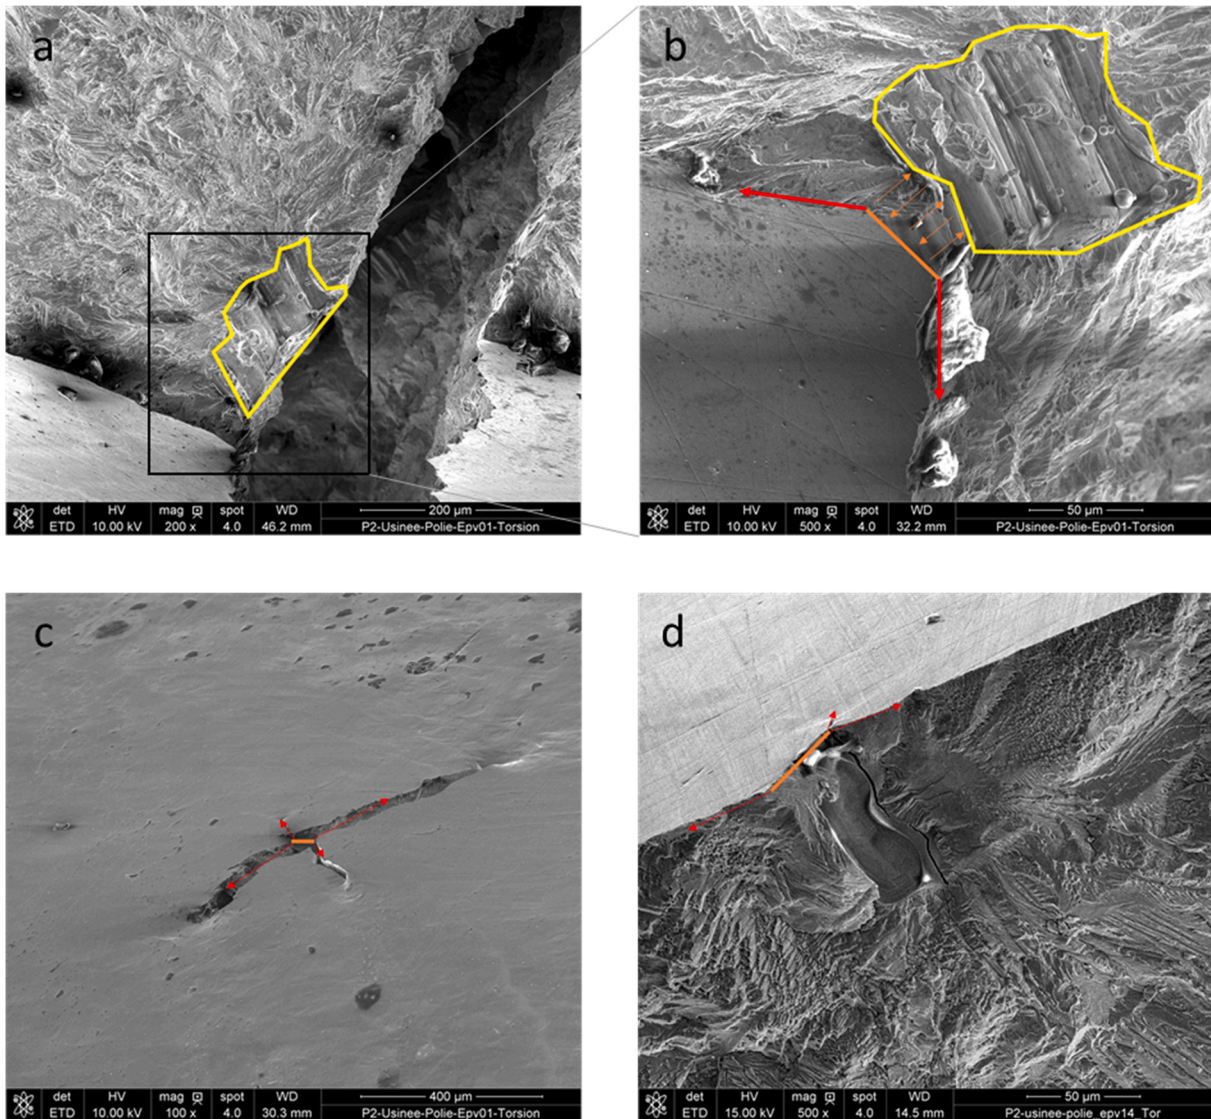
Fig. 12. SEM observations of total-polished LPBF 316L torsion specimens: (a and b) fracture surfaces and (c) secondary crack of one same specimen; (d) example of the fatigue crack initiation and growth mechanism from defect under torsional loading, two stages are visible.

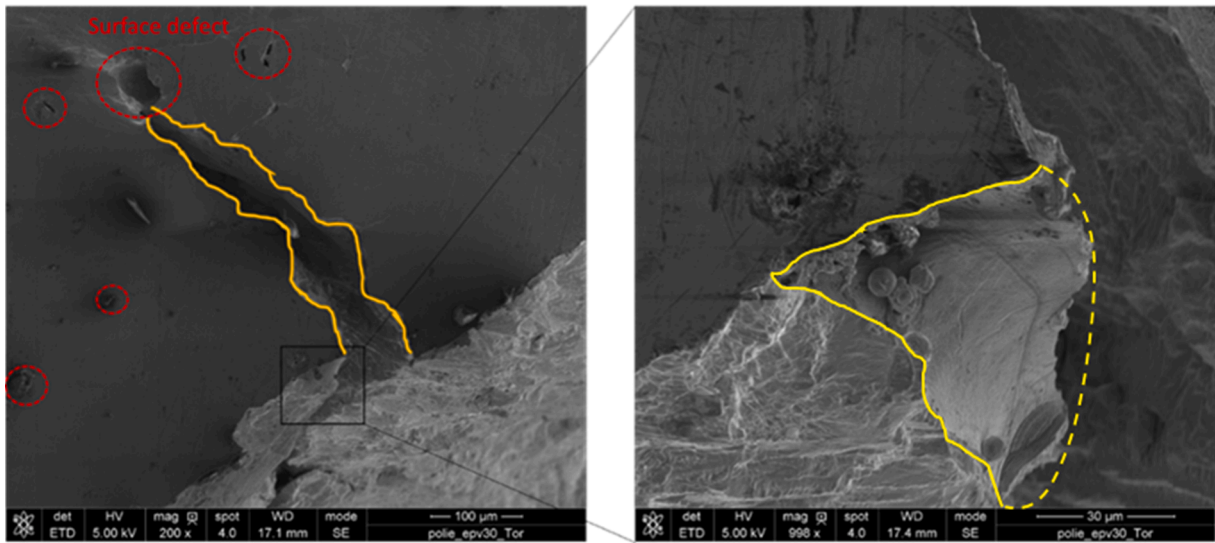
Fig. 13. Fracture surface observation on the simple-polished LPBF 316L torsion specimen.

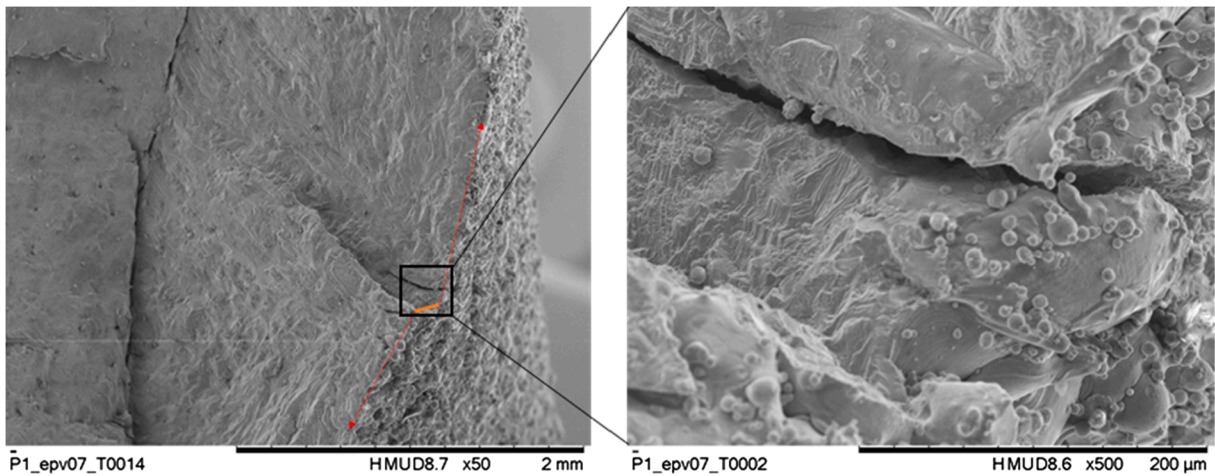
Fig. 14. Crack path and defects at the origin of failure in an as-built LPBF 316L torsion specimen.

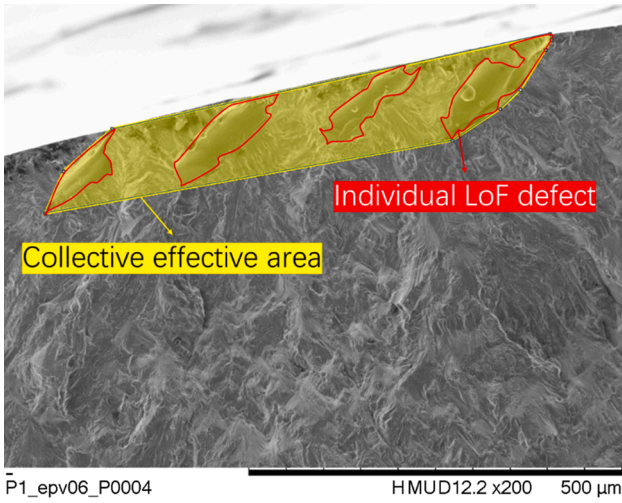
Fig. 15. Two measurement techniques to assess the size of a cluster of adjacent defects: consider only the largest defect and treat all defects as one.

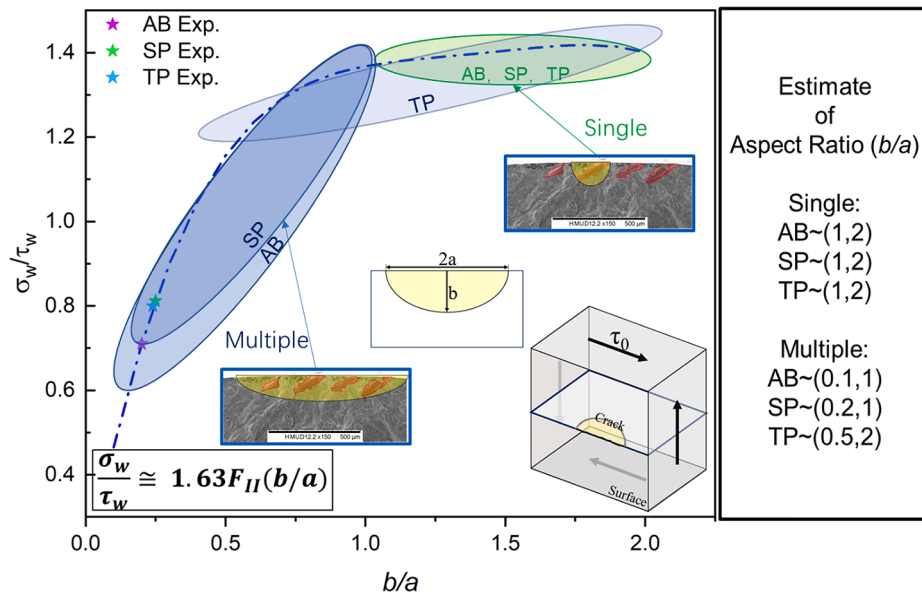
Fig. 16. A plot of the relationship between aspect ratio ( $b/a$ ) and fatigue strength ratio ( $\sigma_w/\tau_w$ ). In the plot, the two different measurement methods are schematically presented to give estimates for the aspect ratio. The fatigue strength ratios from experimental results are shown for reference.
