# A wear damage assessment of high temperature forging tool

**Keywords:** Hardfaced hot forging die, Stellite 21, MIG welding process, texture, plastic deformation, tribological test

**Abstract.** High temperature forging tools are highly damaged by wear shearing under cyclic loading which reduces the life of tools. In real conditions, depending upon the tool areas, the level of wear can change. The surfaces of tools can be treated by cobalt-based hardfacing using different welding processes. This study focuses on tribological damages of Stellite 21 deposited by MIG process. Wear tests are carried out at room and high temperature on a ring on disc tribometer under high normal load. Different testing conditions are examined. The surface plastic strain due to the friction shear stresses is demonstrated by different methods like SEM observations, micro-hardness measurements and XRD analyses.

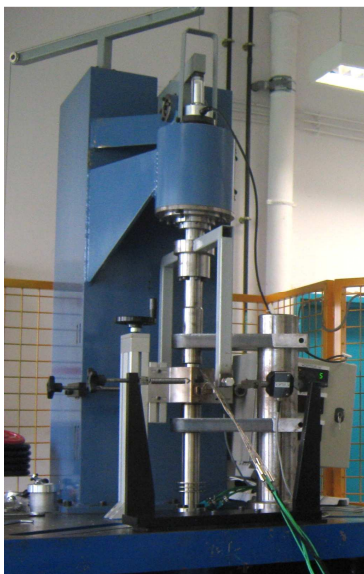
Fig. 1: Photo of the high load tribometer (equipped with a three-zone resistive furnace)

**Experimental procedure.** Tribological tests are performed on a high load ring on disc tribometer (Fig. 1) in configuration cylinder (ring contact surface) on a flat disk (Fig. 2). The normal force is applied by dead weights applied via a level arm for high loads (up to 800 DaN). The disk is driven by a stepping motor and its movement can be a continuous rotation or a reciprocating rotation. A three-zone resistance furnace is used for high temperature tests (up to 1000°C).

The normal force and the tangential forces are continuously measured by sensors and recorded by a Labview software. As presented in Fig. 2, the ring (upper sample) is a 40NiCrMo18 steel grade (AD820<sup>®</sup>) hardfaced with Stellite 21<sup>®</sup> and the disk (bottom sample) is a Nickel-based superalloy grade (Inconel 718<sup>®</sup>). The chemical compositions are given in Table 1.
