A wear damage assessment of high temperature forging tool

Keywords: Hardfaced hot forging die, Stellite 21, MIG welding process, texture, plastic deformation, tribological test

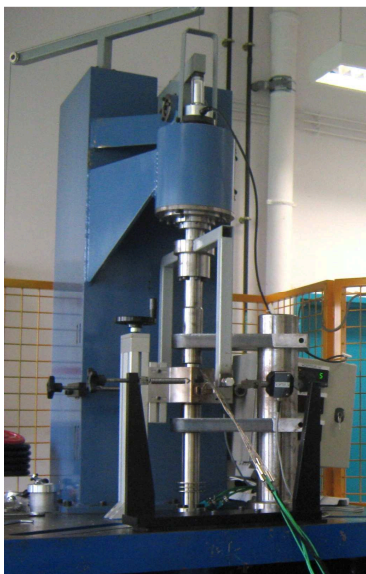
Fig. 1: Photo of the high load tribometer (equipped with a three-zone resistive furnace)

Experimental procedure. Tribological tests are performed on a high load ring on disc tribometer (Fig. 1) in configuration cylinder (ring contact surface) on a flat disk (Fig. 2). The normal force is applied by dead weights applied via a level arm for high loads (up to 800 DaN). The disk is driven by a stepping motor and its movement can be a continuous rotation or a reciprocating rotation. A three-zone resistance furnace is used for high temperature tests (up to 1000°C).

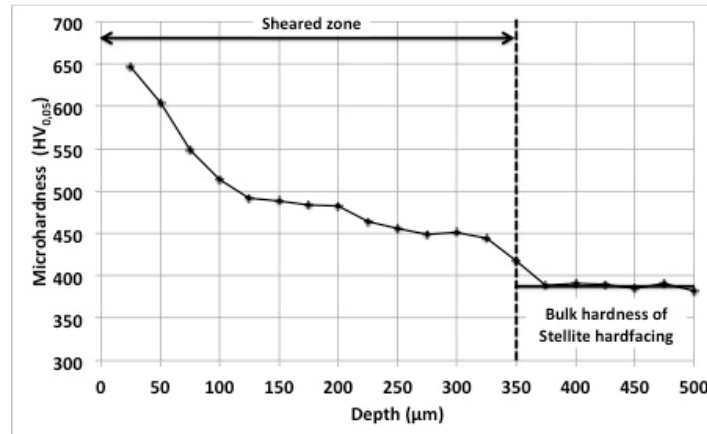
Fig. 8: Gradient of micro-hardness along worn cross-section of a ring, after tribological test n°4

Plastic deformation depths are estimated with microstructure observations on worn ring cross-sections after polishing and chemical etching (Table 5). We can consider that the thickness of the plastic deformation depends on the measured areas but it is less than 400µm depth. The affected friction depths are approximately similar for each wear test and about 350µm. Note that the thickness is highly linked with micro-hardness evolution (Fig. 8).

Micro-hardness measurements show a Stellite hardening under friction tests. In sheared areas, the Stellite micro-hardness increases up to maximum value of 650HV_{0,05} (Fig. 8). This last value seems to be the highest level of strain hardening rate which can be measurable in highly plastically sheared zones near the contact surface: regardless the plastic deformation, hardening does not exceed this value or a very close value. The stacking fault energy is considered as weak in Stellites and would facilitate the high level of Stellite work-hardening.

A hardening gradient is then measured in the depth of the plastic shear zone. The evolution of the micro-hardness is related to the plastic deformation of dendritic matrix. In addition, the ultimate value of shear-hardening is in good correlation with that observed in industrial worn hardfaced tools. The glaze layer micro-hardness is very hard and about 950HV_{0,05}.
