Effect of porosities on brazed martensitic steel tensile properties: 2D and 3D pre-mortem vs post-mortem characterizations

N. Vanderesse, Damien Texier, P. Bocher

N. Vanderesse, Damien Texier, P. Bocher. Effect of porosities on brazed martensitic steel tensile properties: 2D and 3D pre-mortem vs post-mortem characterizations. *Materials Characterization*, 2020, 160, pp.110084. 10.1016/j.matchar.2019.110084 . hal-02430629

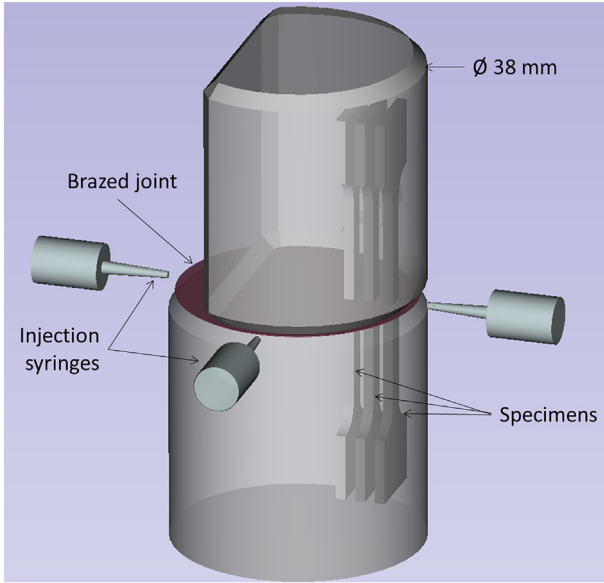
Fig. 1. Brazing process and position of the specimens (schematic).

Cylindrical 38-mm-diameter and 38-mm-long blocks made of 17-4 PH® martensitic precipitation-hardening stainless steel (17-4PH SS) were brazed together with a Palmicro™-36M filler metal in the form of paste (Fig. 1). This Ni-base brazing alloy contains a substantial amount of Pd that reduces its melting temperature and enhances its wettability [35]. The nominal composition (weight percent) of the two materials is

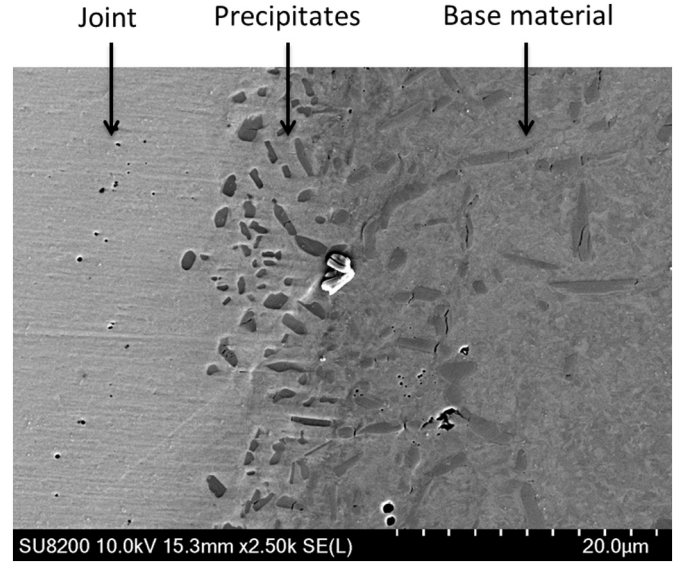
Fig. 2. SEM micrograph of intermetallic precipitates (borides) at the interface between the substrate and the filler material.

This brazing condition ensured the absence of eutectic phase in the joint thanks to the diffusion of boron in the base metal. Intermetallic precipitates were observed at the interface between the brazed joint and the base material (Fig. 2). Due to the large dimension of the surface to be brazed, the process generated a gradient of porosity from the edge to the center, allowing samples with various porosity levels to be extracted.

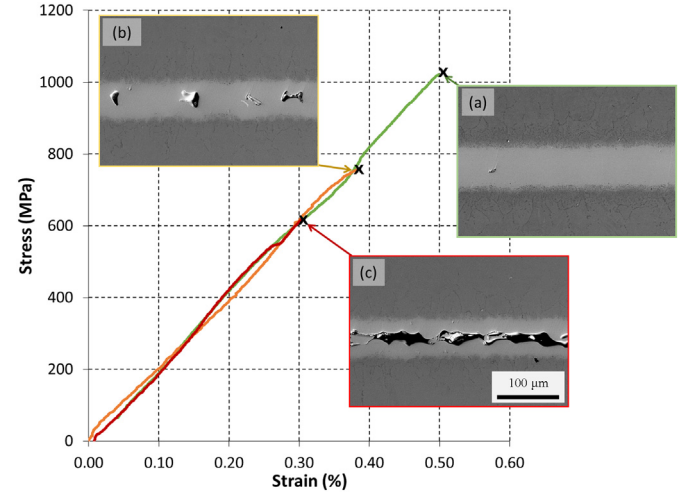
Fig. 3. Tensile stress-strain curves of the high, medium, and low strength specimens, and corresponding SEM lateral micrographs before fracture ((a) to (c), respectively).

apparent porosity observed at the surface, with tens-of-micrometer large pores mostly located in the mid-section of the joint (Fig. 3(a), (b) and (c)). Tensile tests were performed using a 5 kN microtensile machine (Kammrath & Weiss, Germany) at strain rate 4.10^{-5} s^{-1} . They were strained up to about 85–90% of the expected ultimate tensile strength before being *pre-mortem* analyzed in XCT.

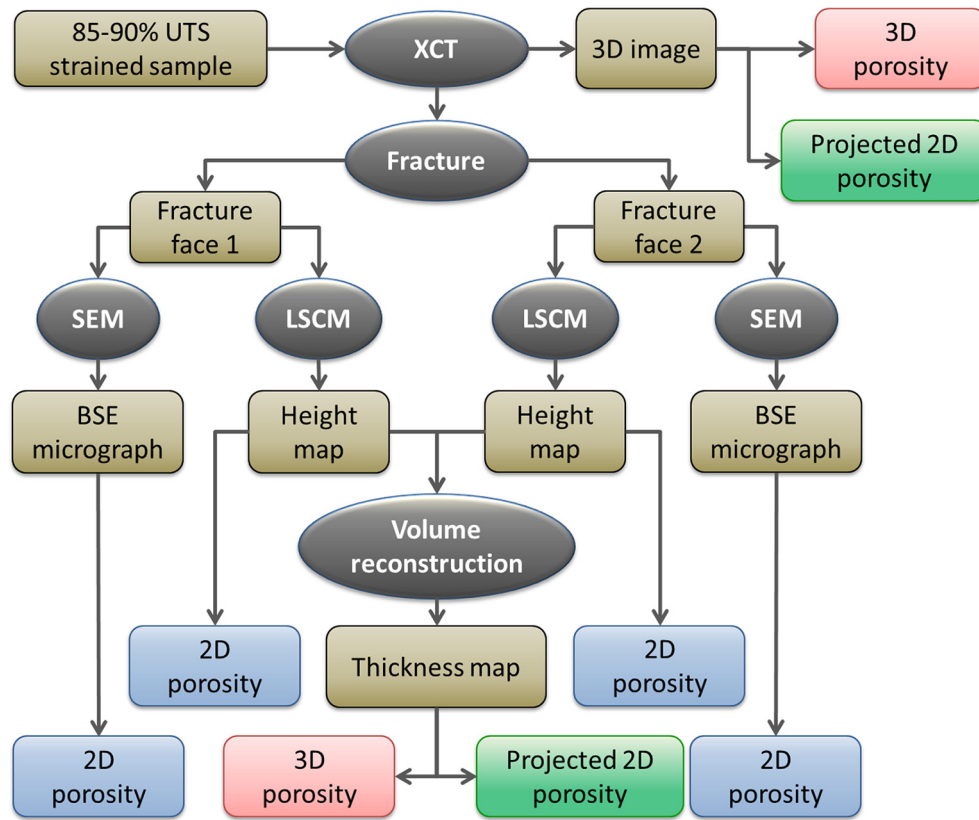
Fig. 4. Flowchart analysis detailing the characterization of a specimen.

Fig. 4 presents the processing pipeline for each specimen and the associated results. The XCT 3D images were processed to provide 3D porosity measurement and 2D apparent porosity projected along the specimen axis (Section 2.2). After XCT, the specimens were strained again and fractured. All of them demonstrated macroscopic brittle tensile behavior but significantly different tensile strengths (Fig. 3 and Table 2). In the following, the specimens are labelled as high, medium and low strength. They were then investigated *post-mortem* in SEM and LSCM. The SEM images of the opposite fracture surfaces were quantitatively analyzed, providing measurement of 2D porosity (Section 2.3). The LSCM height maps were also analyzed for 2D porosity, and combined together to produce 3D thickness maps. The latter was then analyzed for 2D projected porosity and 3D porosity in the same manner as the XCT 3D image (Section 2.4).

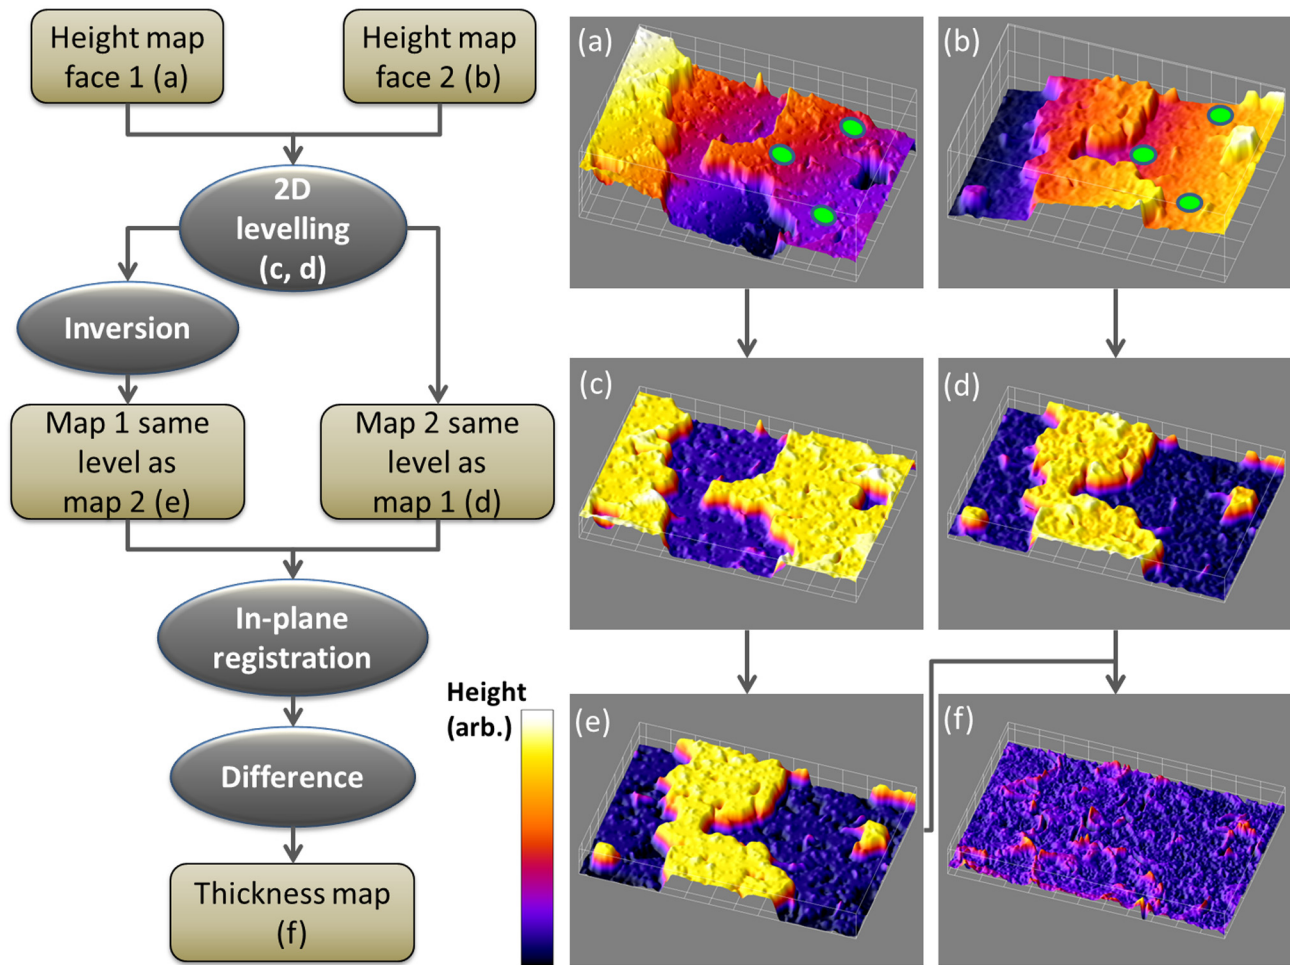
Fig. 5. Flowchart and key images for LSCM volume reconstruction of opposite fracture surfaces (tilting angle amplified for visualization purpose). (a), (b): height maps with green disks indicating the points for levelling; (c), (d): levelled height maps; (e): invert of height map (c); (f): thickness map obtained by combining (d) and (e). (For interpretation of the references to colour in this figure legend, the reader is referred to the web version of this article.)

The fracture surface height maps were processed with the open source scanning probe microscopy analysis program Gwyddion [6]. The operations are schematically summed up in Fig. 5. For each specimen, the height maps were levelled to ensure their horizontality. Three non-aligned points were selected on an iso-height plateau on the surfaces. The whole map was then reoriented so that the points lie at the same height. The height position of each point was averaged over a disk with a radius of $4 \mu\text{m}$. The same points were selected in the second fracture surface to reorient it. The process is illustrated in Fig. 5, with the reference points marked as green disks in Fig. 5(a) and (b), and the

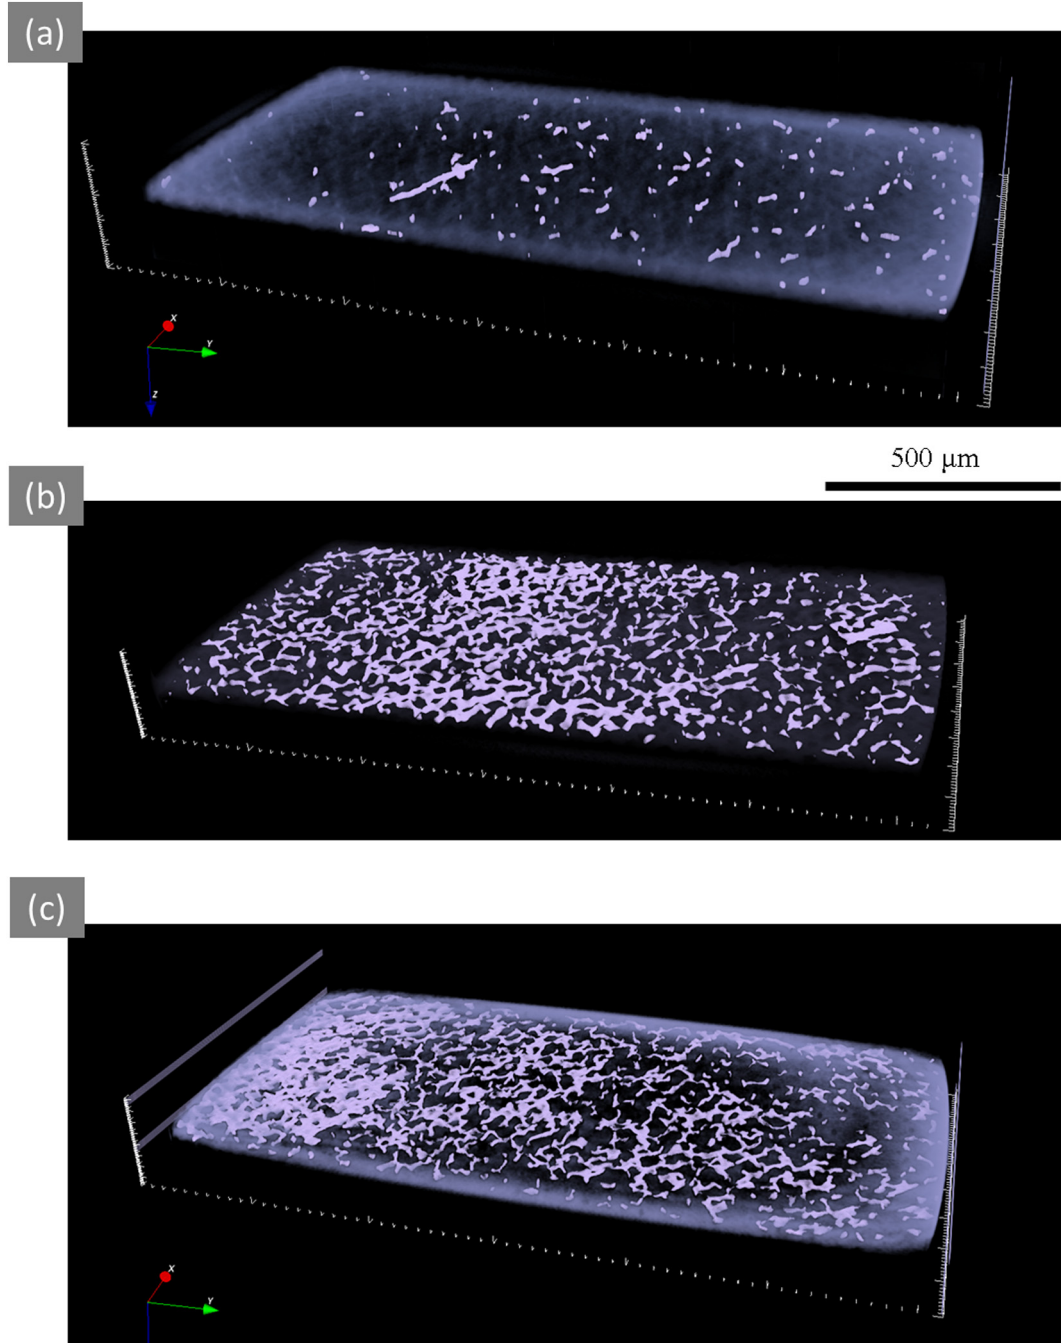
Fig. 6. 3D views of the pores at the mid-section of the specimens characterized by XCT. The blurry region corresponds to the joint. (a), (b), (c): high, medium and low strength samples, respectively.

Pre-mortem XCT 3D images are pictured in Fig. 6. For the three specimens, the pores are concentrated within the joint, with varying quantities and planar spatial distributions. The high strength specimen presents a few sparse pores, while the medium and low strength specimens present higher porosity contents. The porosity network in the medium strength specimen appears approximately homogeneous, which contrasts with the low strength specimen that exhibits a large interconnected pore on its left side. Further quantitative

The 3D porosity values for the low and medium strength specimens are very close, despite different UTS. However, as already noted, the pores are differently distributed (Fig. 6): the medium strength specimen presents an interconnected porosity network, while the low strength specimen has an extended porous region extending from one of its sides. Therefore, at equal porosity level in the joint, an interconnected network is more favorable for mechanical strength.

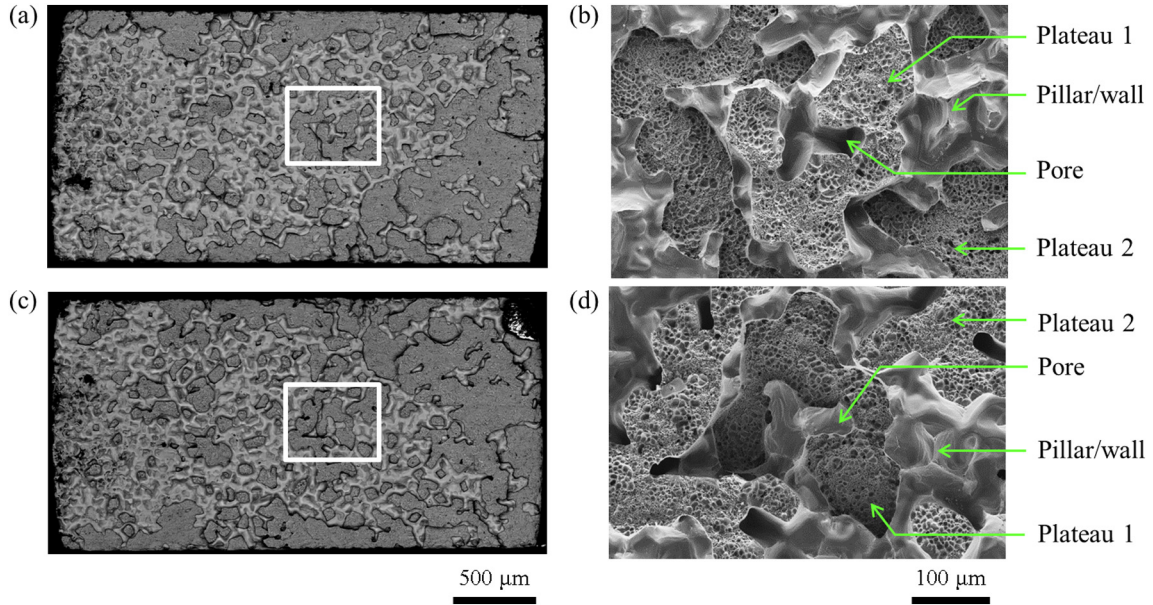
Fig. 7. SEM-BSE micrographs of opposite fracture surfaces (low strength specimen). (a), (c): Global micrographs highlighting interfacial fracture and smooth porous regions (medium and light gray regions, respectively). (b), (d): High magnification micrographs showing interfacial fractured regions covered by dimples (plateaus), pores and necked pillars/walls caused by plastic tearing.

SEM backscattered electrons (BSE) fractographies of both fracture surfaces of the medium strength specimen are shown in Fig. 7. Both images are very similar, with uniform and textured areas (Fig. 7(a) and (c)). Observations at higher magnification (Fig. 7(b) and (d)) allow identifying two kinds of features:

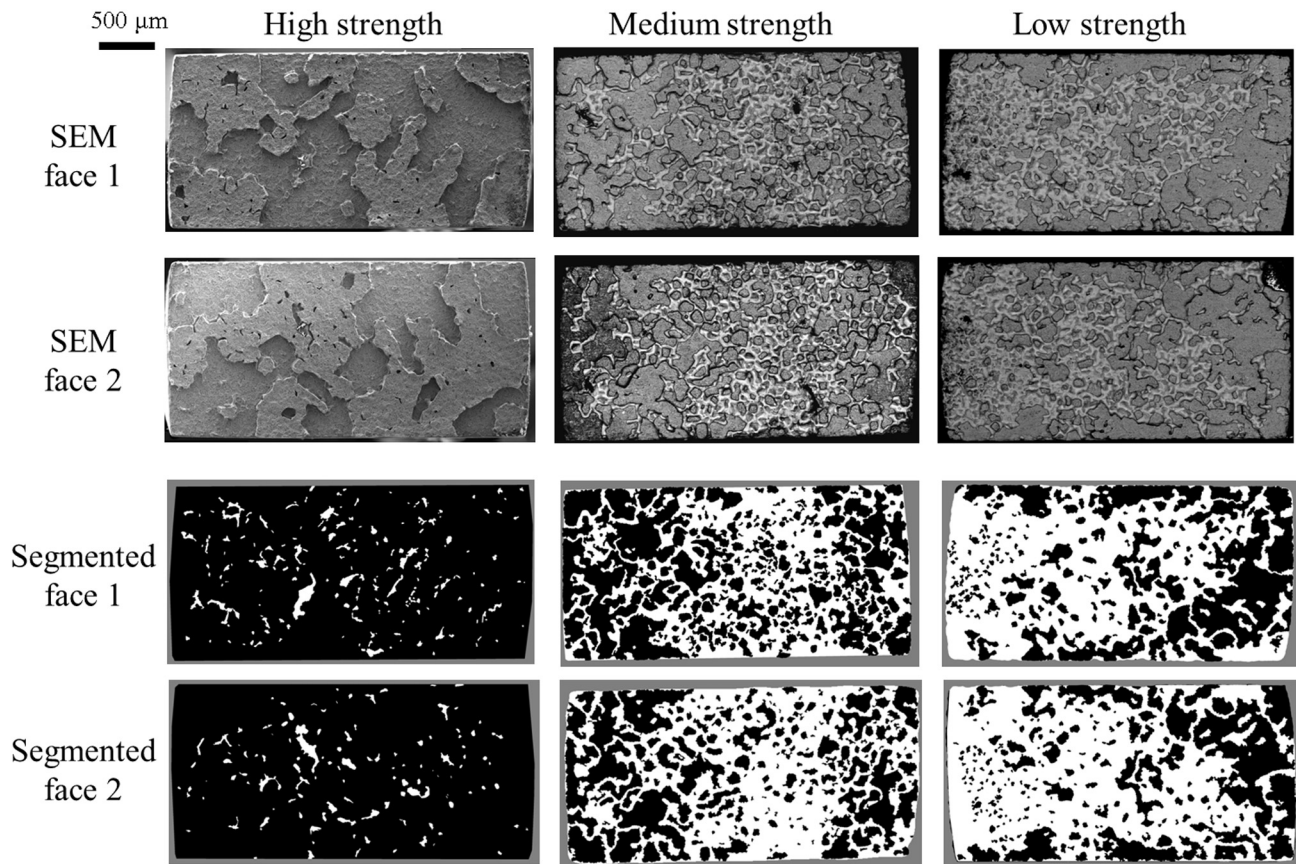
Fig. 8. BSE and segmented SEM images for the three specimens.

Fig. 8 presents the original BSE micrographs of the fracture surfaces and the result of the segmentation operation discriminating the plateaus from the pillars/walls (Section 2.3). The specimens exhibit very different porosity spatial distribution, as was already observed by XCT. The high strength specimen has a few sparsely distributed pores, the medium strength specimen presents a connected porosity network, and

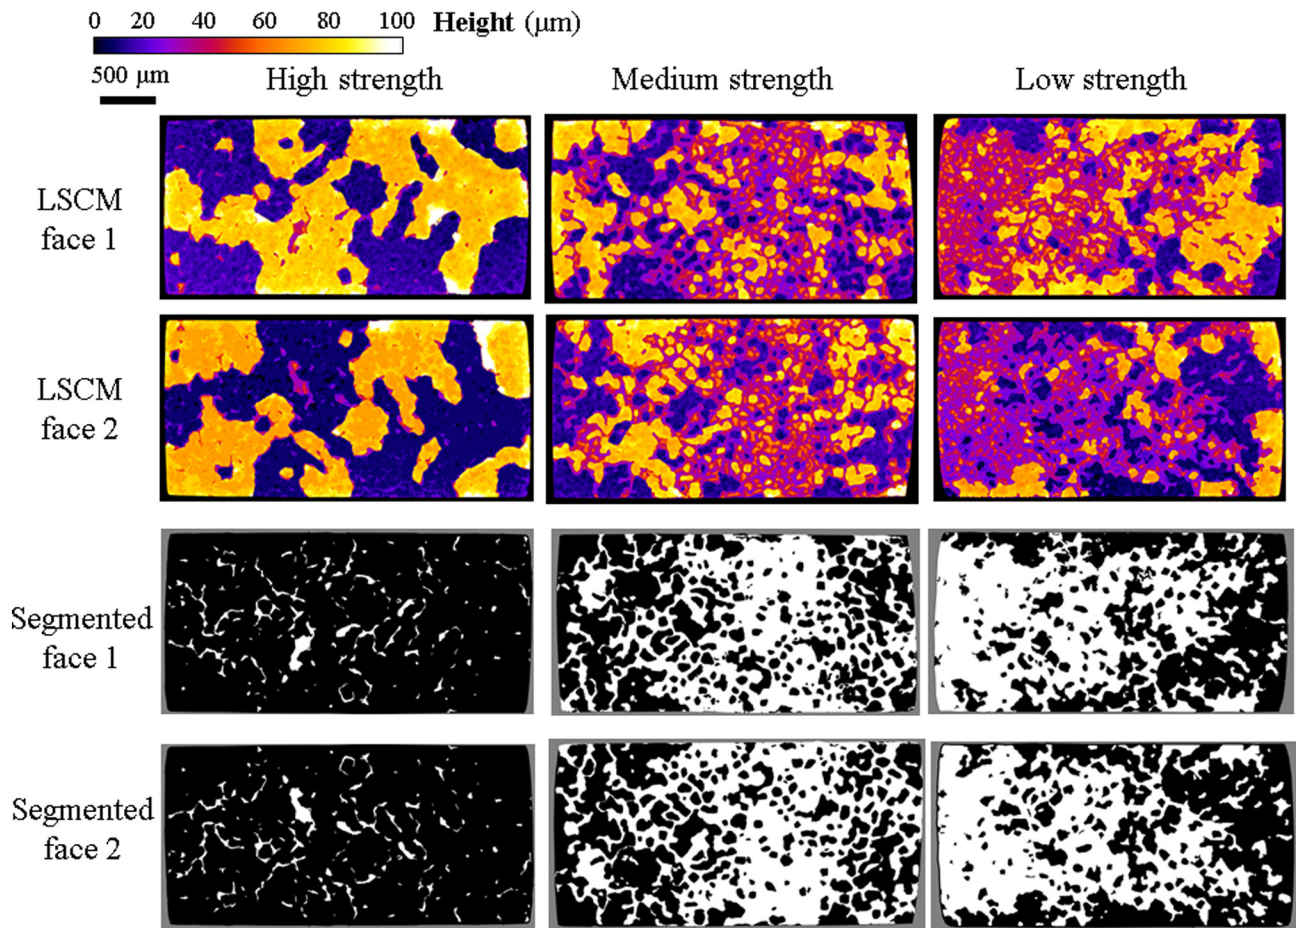
Fig. 9. LSCM height maps of opposite fracture surfaces and corresponding segmented images highlighting the pores (white regions on the segmented faces). (For interpretation of the references to color in this figure, the reader is referred to the web version of this article.)

Height measurements were performed on both opposite fracture surfaces for each specimen (Fig. 9). As previously shown by SEM fractographic analyses, large “plateau” regions corresponding to interfacial fractures were found. The height difference between minimal (dark blue regions) and maximal (yellow-orange regions) height plateau is about 60 μm. This corresponds to the initial thickness of the brazed joint, and evidences the interfacial nature of the fracture mechanism. The fracture surfaces of the high strength specimen were essentially constituted by large flat regions (“plateaus”) and some small pores sparsely distributed, illustrated by purple areas on the height maps. For the medium and low strength specimens, rough regions located in the mid-plane of the joint (at ca. 30 μm height) were noticed. These regions result from highly torn “pillars/walls” regions surrounded by interconnected porosity reported earlier from SEM imaging (Section 3.1). The height maps were segmented in order to discriminate the plateaus from the pores in the mid-plane (Fig. 9, lower). The binarized images were then analyzed in terms of apparent 2D porosity (Section 3.5).

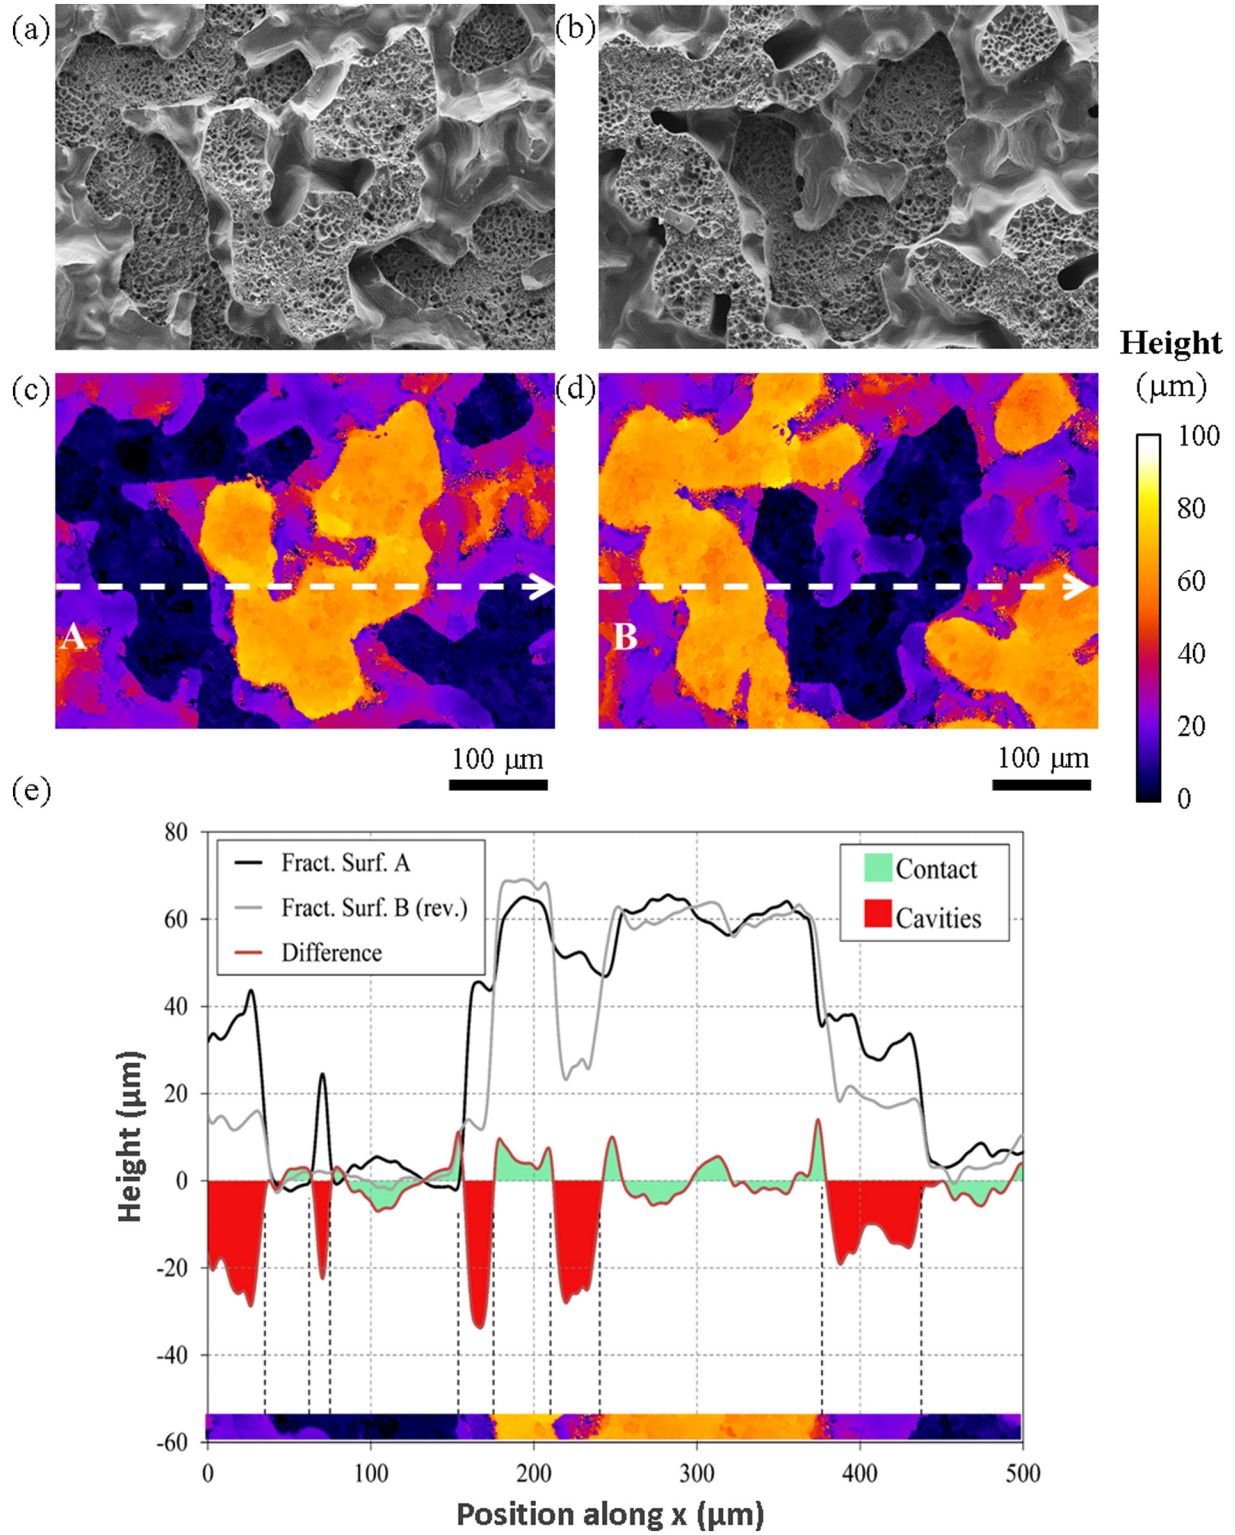
Fig. 10. Height distribution and interlock possibility of two opposite fracture surfaces presenting both plateau and “pillars/walls” features. (a), (b): SEM micrographs (image (b) has been mirrored horizontally); (c), (d): corresponding LSCM height maps; (e) height and thickness profiles demonstrating the possibility of 3D reconstruction.

Two opposite fracture surfaces of a local area presenting both interfacial and “pillars/walls” features are displayed at high magnification by SEM and LSCM in Fig. 10(a) to (d) to illustrate the cavities reconstruction and material interpenetration. Two height profiles A and B over the same region in both faces are plotted in Fig. 10(e). The profile of the second fracture surface (B, gray plot) was inverted in height and direction to be directly compared with the first one (A, black plot). The region corresponding to profile A in Fig. 10(a) is reported

below the graph to allow direct comparison between height variations and the local fractured features. Both profiles show similar variations, which demonstrates that the height measurement and the maps registration are sufficiently resolved so that quantitative analyses can be conducted.

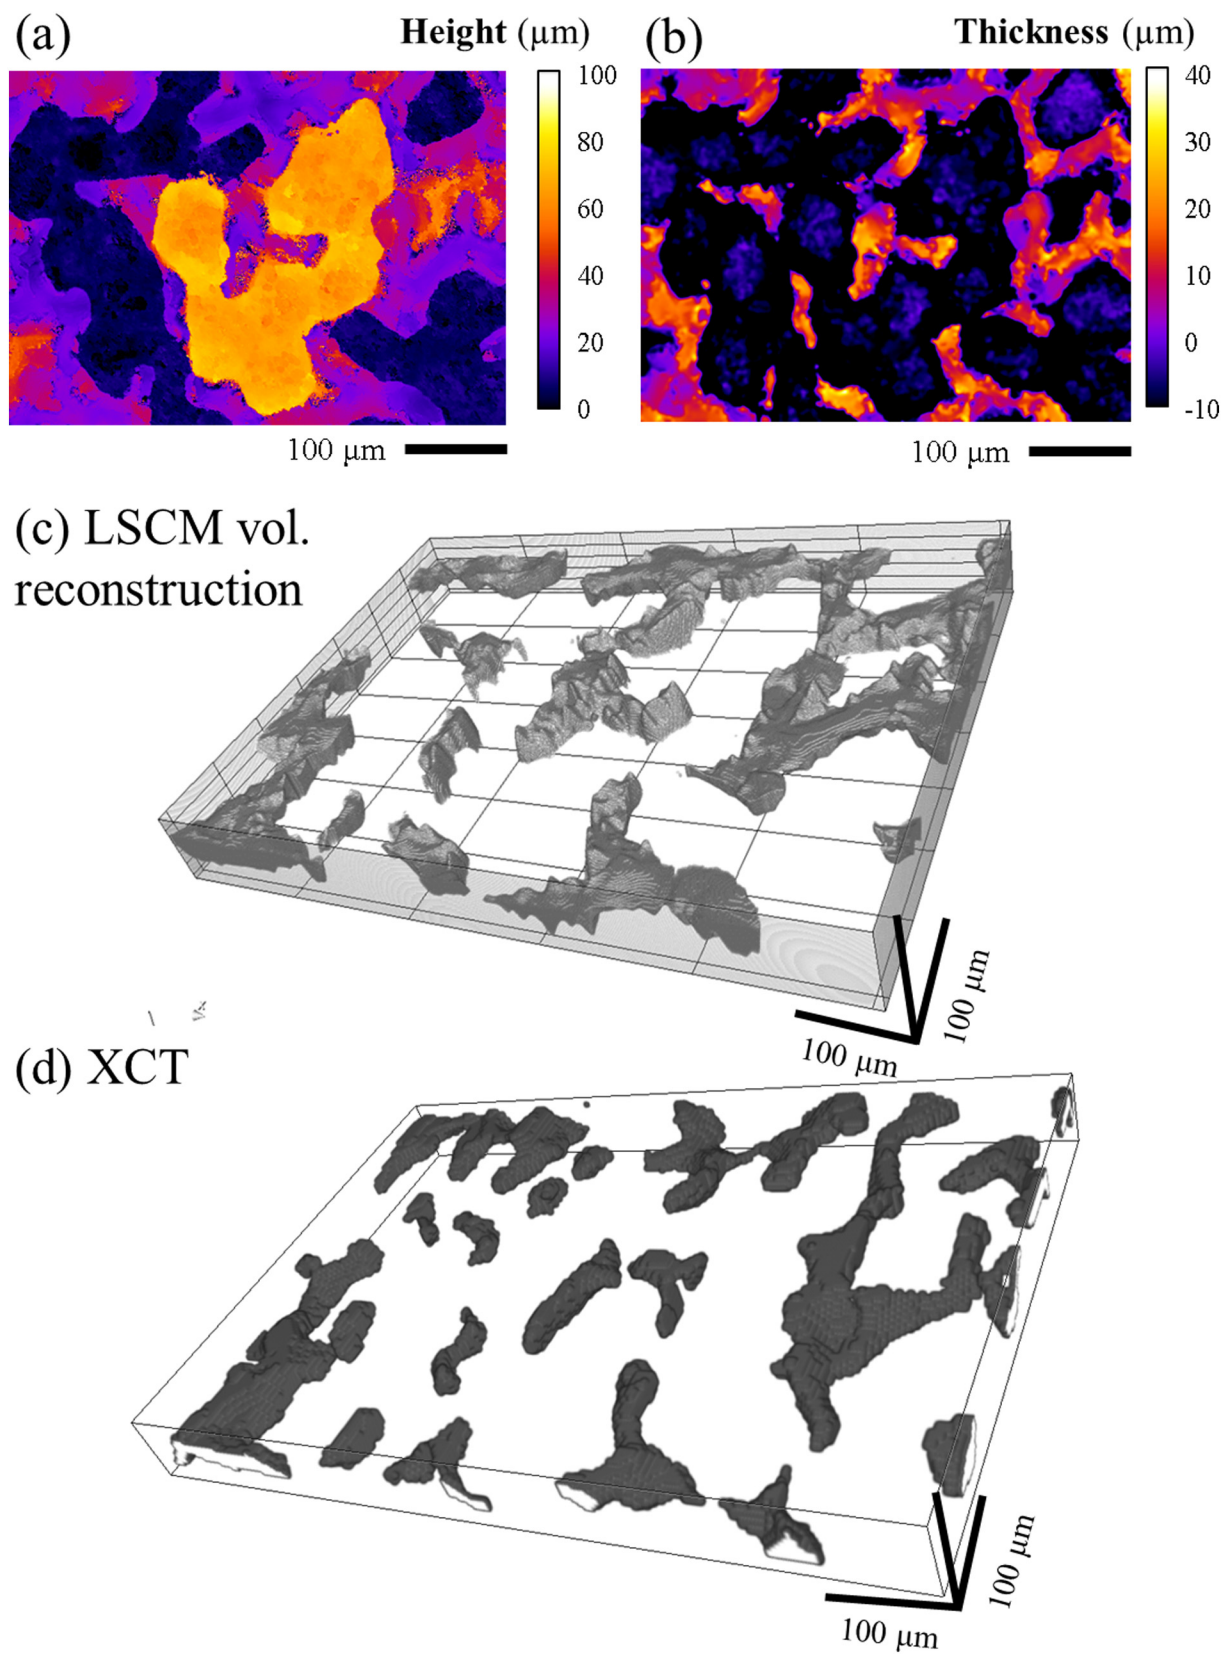
Fig. 11. Close-up 2D and 3D views of a fracture surface presenting both interfacial and "pillars/walls" features. (a) LSCM height map; (b) LSCM thickness map; (c) 3D view of the LSCM thickness map; (d) 3D XCT view of the same zone. (For interpretation of the references to color in this figure, the reader is referred to the web version of this article.)

The 2D and 3D porosity values measured on the reconstructed LSCM images and XCT images (pink solid line in Fig. 13) are close, as could be expected from visual appreciation of Fig. 11(c) and (d). The values are much lower than the 2D fractions. The 2D and 3D porosities assessed by XCT were found smaller compared to LSCM and could be explained by the deformation state prior and after fracture. This means that the segmented pores are larger when measured by fractography on opposite surfaces in SEM or LSCM than by 3D LSCM and XCT. The reason is that the pores extend due to plastic shearing at fracture, as evidenced by the presence of pillars/walls already noted in SEM micrographs (Fig. 7). Fractographic observations do not allow the direct segmentation of fine pillars/walls and result in higher porosity content in comparison with the projected 2D porosity from reconstructed volume.

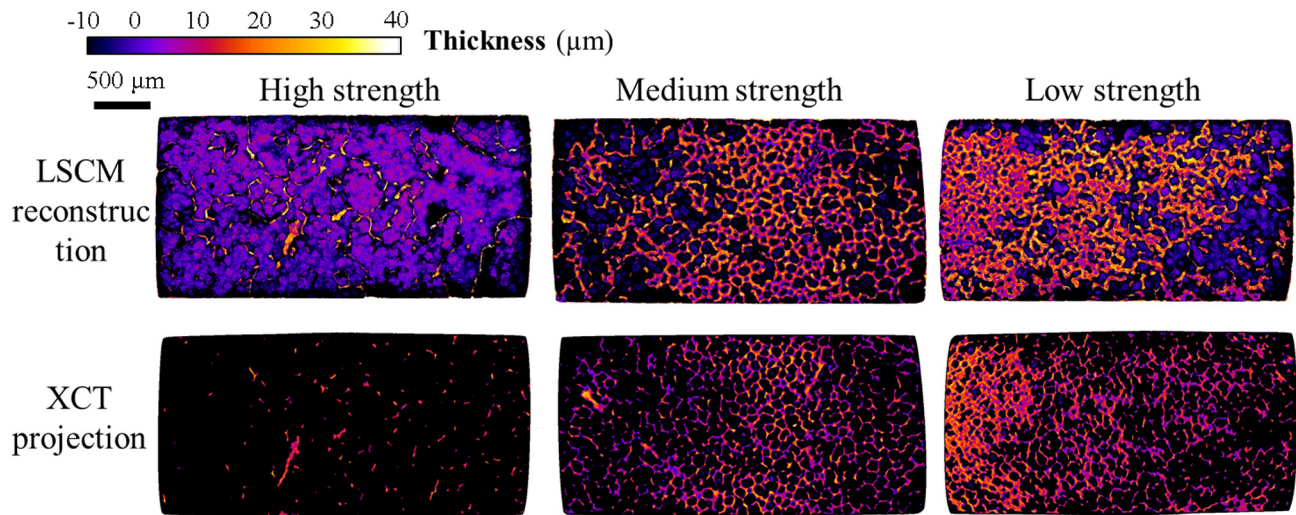
Fig. 12. Thickness maps obtained by LSCM volume reconstruction and XCT. (For interpretation of the references to color in this figure, the reader is referred to the web version of this article.)

the three specimens and compared to XCT projected porosity (Fig. 12). A dark layer at the border of the specimen can be observed on each of the LSCM reconstructed images, especially the high strength specimen. This corresponds to a zone of material interpenetration characterized by negative thickness values lower than -5 μm . The rest of the specimen shows mostly positive values, indicating that the fracture surfaces are concave and present shear lips at the border. Similarly, as already noted in Fig. 11, most of the plateaus comprise a central region characterized by positive thickness values in the range of 5 to 10 μm (blue areas in the thickness maps in Figs. 11(b) and 12) with negative or near zero values at their border. This is especially visible for the low strength specimen. These interfacial voids are not yet present on the pre-mortem XCT results. This confirms that the plateaus are not strictly planar, but rather slightly concave from their border towards their center. From these fractographic topographic results, it is not possible to discriminate the location of the onset of plasticity. However, damage seems to develop on various locations at the interface, forming plateaus after void coalescence. These two distinct observations at the scale of the fracture surface and at the scale of the plateaus, point towards a fracture scenario involving interfacial debonding between the joint and the base material, occurring within the core of the specimen and extending towards its surface. A more detailed discussion of the fracture mechanism is detailed in Section 4.2.

More importantly, the thickness maps in Fig. 12 puts into evidence the presence of voids at the center of the plateaus that are not present before fracture, showing that interfacial rupture develops more and earlier in the center region of the brazed interface. This point is further addressed in the fracture scenario proposed below.

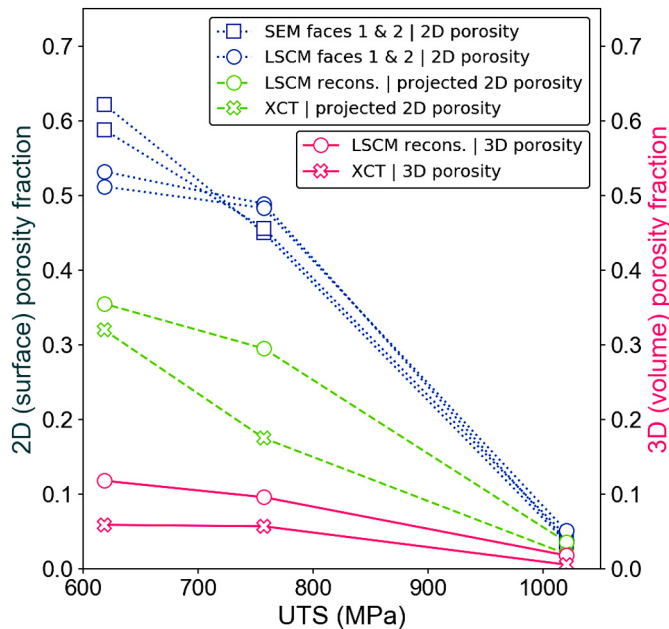
Fig. 13. Surface and volume porosity fractions (Table 3) measured by SEM (squares), LSCM (disks) and XCT (crosses) vs ultimate tensile strength (Table 2). Dotted lines refer to 2D measurements on fracture surfaces, and solid lines refer to 3D porosities.

(UTS, Table 2) in Fig. 13.

Good agreement is observed between the measurements of 2D fractions on opposite faces characterized in SEM and LSCM for the three specimens. This confirms the visual appreciation that the fracture surfaces are similar (Figs. 8 and 9) and that the data processing is reproducible for both techniques. For this reason, the data for opposite faces are not distinguished on the graph (blue dotted lines in Fig. 13). The results follow the same trend, but are contrasted. The ultimate tensile strength decreases with the porosity, yet with different values depending on the measurement technique.

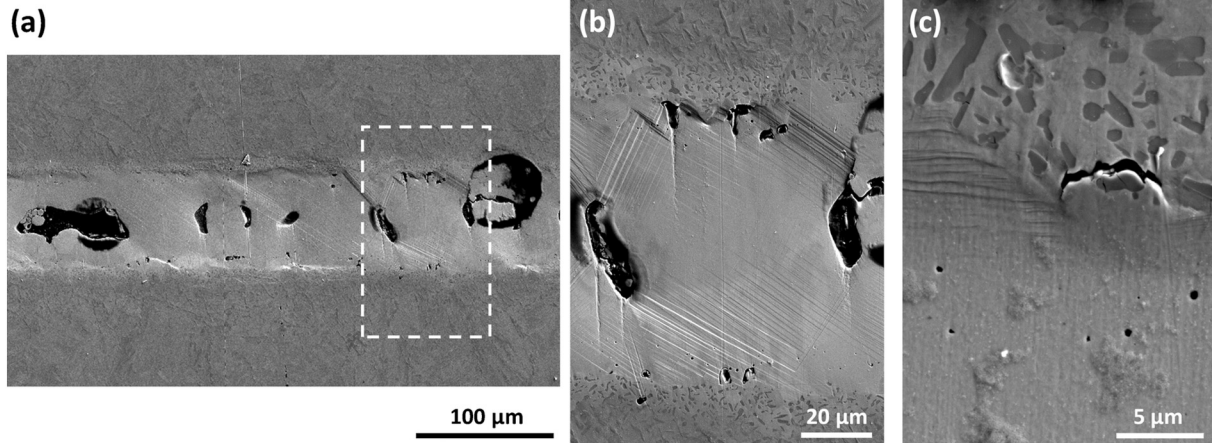
Fig. 14. SEM-BSE micrographs of pre-mortem specimen gage zone showing different deformation and damage processes. (a) Medium strength specimen: low magnification of the showing intense slip activity in the vicinity of pores and non-slip transfer into the substrate, (b) magnified region of the white dashed box depicted in panel (a) showing slip bands parallel to each other and inclined at 45° (vertical lines are traces of polishing lines), (c) high strength: specimen interfacial deformation and related debonding damage at an interface boride.

The gage sections of the specimens were observed with SEM prior to fracture (Fig. 14). At 85–90% of the ultimate tensile strength, several slip bands were noticed in the vicinity of pores, parallel to each other and inclined 45°. Slip bands were not transmitted into the substrate material and were confined in the filler material (Fig. 14(a) and (b)). Such observations were typical for low strength and medium strength specimens. Voids/cracks were found to develop at the substrate/filler material interface, most likely due to slip accumulation, leading to the fracture and debonding of the intermetallic borides present at the interface between the joint and the base metal (Fig. 14(b)). For high strength specimens, the limited density of pores leads to another deformation processes: slip bands nearly parallel to the substrate/filler material interface were found and related to the fracture and debonding of intermetallic borides (Fig. 14(c)).

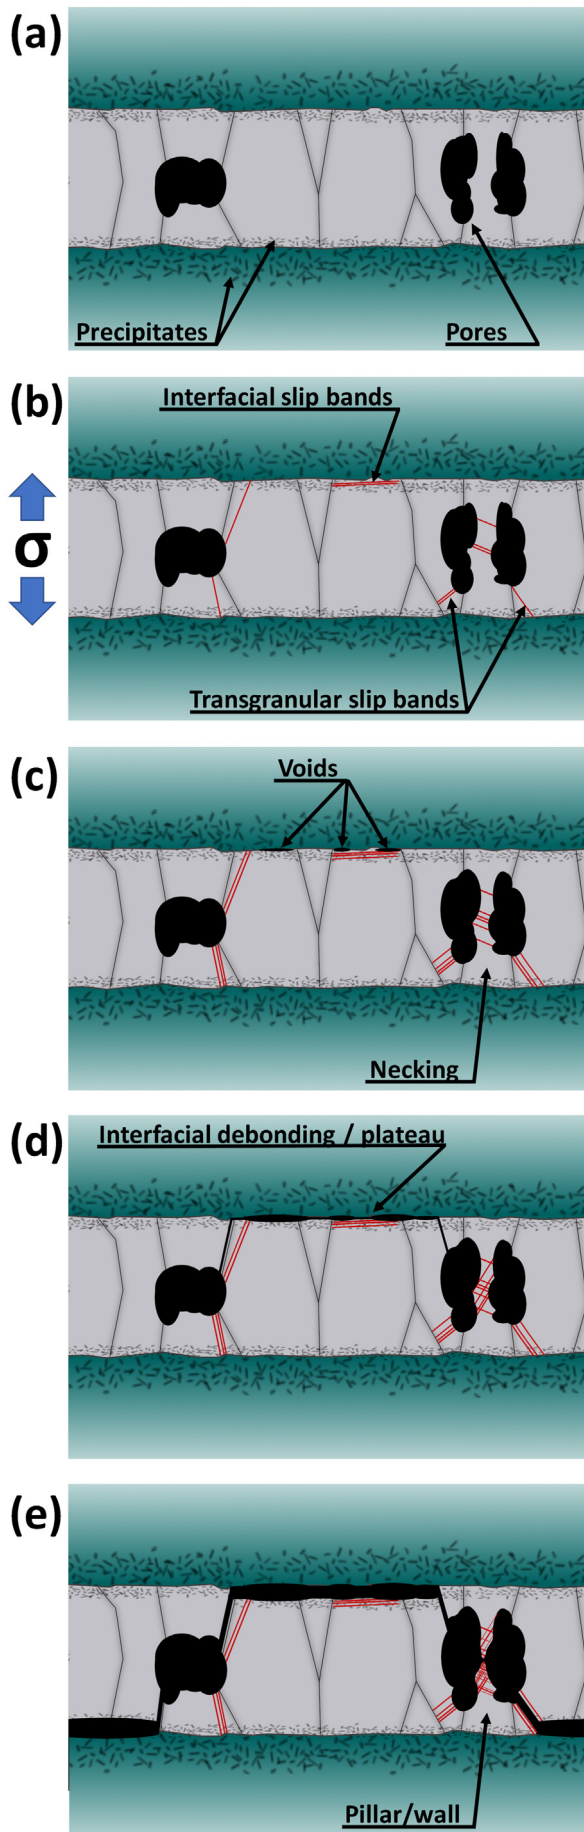
Fig. 15. Schematic sequence of events leading to fracture. (a): Initial state with pores, (b): slip activity in the vicinity of pores and at the brazing interface; (c) nucleation of voids at the interface due to strain accumulation and necking between close pores; (d) growth of a crack at the joint/substrate interface leading to voids coalescence (interfacial debonding/plateaus formation); (e): sudden fracture, local necking between the pores after interfacial decohesion has completed.

More specifically, the stress state in the material separating the pores depends on the distance between the pores and their interconnectivity. In the case of low porosity fraction (high strength specimen), these regions are wide and undergo moderate stress triaxiality, which results in high critical strains for interface crack nucleation. By contrast, joints with higher porosity fraction and connectivity induce higher stress triaxiality between the pores, resulting in lower local critical strains for interface crack nucleation, and consequently lower macroscopic strains for fracturing the sample. To this regard, the main difference between the medium and low stress specimen resides in the porosity spatial distribution and their interconnection (the volume fractions measured by XCT and LSCM reconstruction being very close in both samples). In the low strength specimen, the cracks must nucleate first in the narrow plateaus on the left (Fig. 12), and then extend to the right resulting in a fast failure as these represent less than half of the section of the joint. In the medium strength specimen, an intermediate strain level is required as a combination of large and narrow plateaus is found.
