Effect of porosities on brazed martensitic steel tensile properties: 2D and 3D pre-mortem vs post-mortem characterizations

N. Vanderesse, Damien Texier, P. Bocher

N. Vanderesse, Damien Texier, P. Bocher. Effect of porosities on brazed martensitic steel tensile properties: 2D and 3D pre-mortem vs post-mortem characterizations. *Materials Characterization*, 2020, 160, pp.110084. 10.1016/j.matchar.2019.110084 . hal-02430629

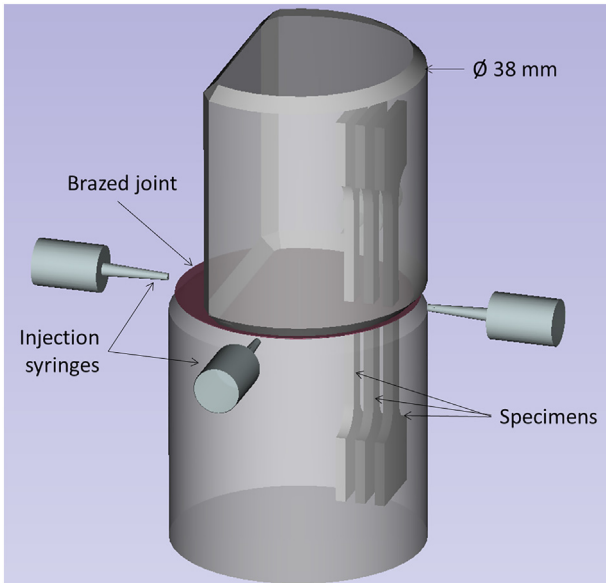
Fig. 1. Brazing process and position of the specimens (schematic).

Cylindrical 38-mm-diameter and 38-mm-long blocks made of 17-4 PH[®] martensitic precipitation-hardening stainless steel (17-4PH SS) were brazed together with a Palnico[™]-36M filler metal in the form of paste (Fig. 1). This Ni-base brazing alloy contains a substantial amount of Pd that reduces its melting temperature and enhances its wettability [35]. The nominal composition (weight percent) of the two materials is

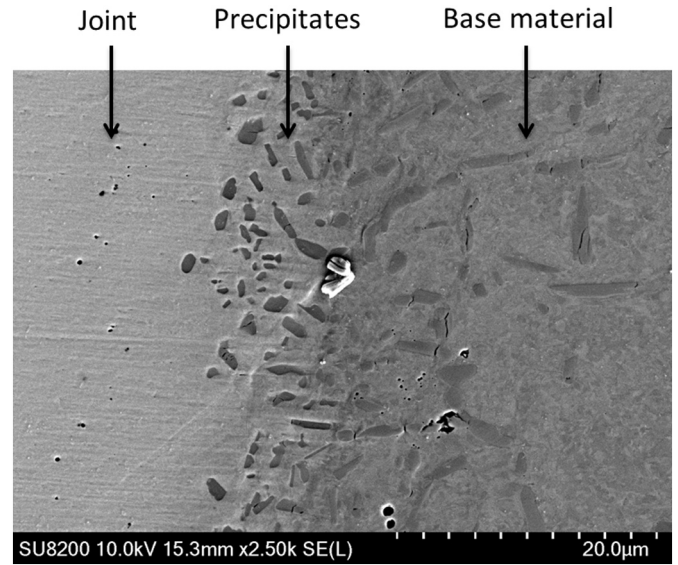
Fig. 2. SEM micrograph of intermetallic precipitates (borides) at the interface between the substrate and the filler material.

This brazing condition ensured the absence of eutectic phase in the joint thanks to the diffusion of boron in the base metal. Intermetallic precipitates were observed at the interface between the brazed joint and the base material (Fig. 2). Due to the large dimension of the surface to be brazed, the process generated a gradient of porosity from the edge to the center, allowing samples with various porosity levels to be extracted.

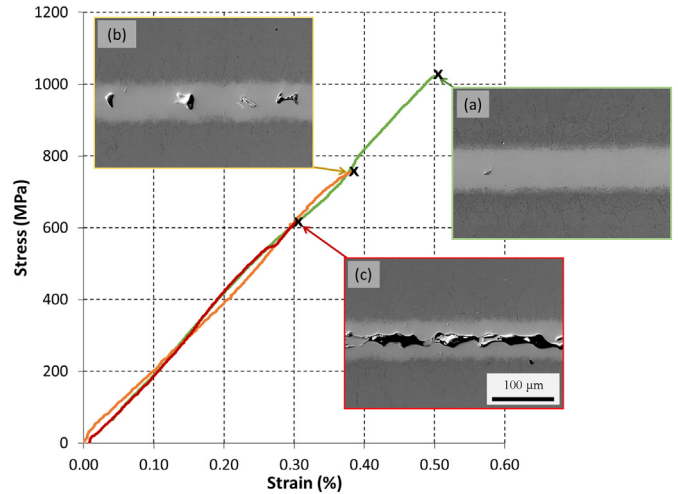
Fig. 3. Tensile stress-strain curves of the high, medium, and low strength specimens, and corresponding SEM lateral micrographs before fracture ((a) to (c), respectively).

apparent porosity observed at the surface, with tens-of-micrometer large pores mostly located in the mid-section of the joint (Fig. 3(a), (b) and (c)). Tensile tests were performed using a 5 kN microtensile machine (Kammrath & Weiss, Germany) at strain rate 4.10^{-5} s^{-1} . They were strained up to about 85–90% of the expected ultimate tensile strength before being *pre-mortem* analyzed in XCT.

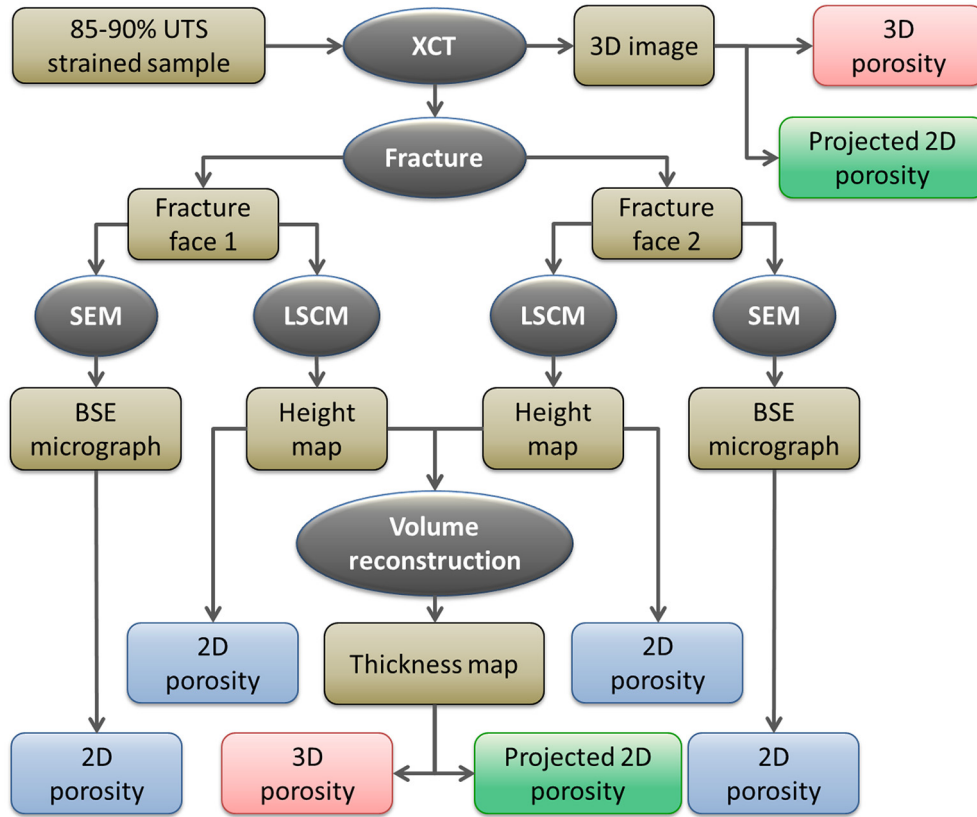
Fig. 4. Flowchart analysis detailing the characterization of a specimen.

Fig. 4 presents the processing pipeline for each specimen and the associated results. The XCT 3D images were processed to provide 3D porosity measurement and 2D apparent porosity projected along the specimen axis (Section 2.2). After XCT, the specimens were strained again and fractured. All of them demonstrated macroscopic brittle tensile behavior but significantly different tensile strengths (Fig. 3 and Table 2). In the following, the specimens are labelled as high, medium and low strength. They were then investigated *post-mortem* in SEM and LSCM. The SEM images of the opposite fracture surfaces were quantitatively analyzed, providing measurement of 2D porosity (Section 2.3). The LSCM height maps were also analyzed for 2D porosity, and combined together to produce 3D thickness maps. The latter was then analyzed for 2D projected porosity and 3D porosity in the same manner as the XCT 3D image (Section 2.4).

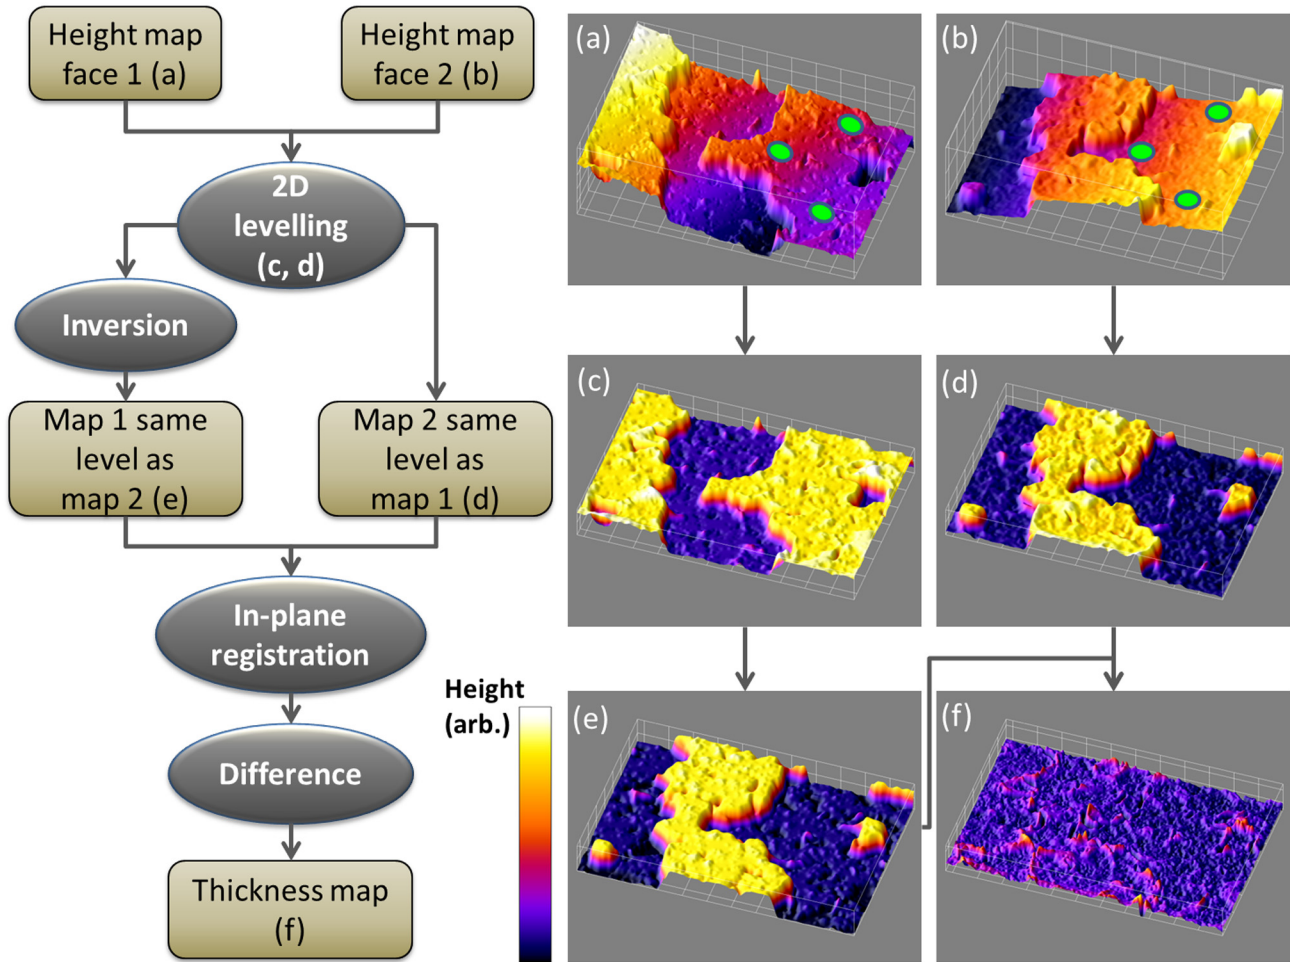
Fig. 5. Flowchart and key images for LSCM volume reconstruction of opposite fracture surfaces (tilting angle amplified for visualization purpose). (a), (b): height maps with green disks indicating the points for levelling; (c), (d): levelled height maps; (e): invert of height map (c); (f): thickness map obtained by combining (d) and (e). (For interpretation of the references to colour in this figure legend, the reader is referred to the web version of this article.)

The fracture surface height maps were processed with the open source scanning probe microscopy analysis program Gwyddion [6]. The operations are schematically summed up in Fig. 5. For each specimen, the height maps were levelled to ensure their horizontality. Three non-aligned points were selected on an iso-height plateau on the surfaces. The whole map was then reoriented so that the points lie at the same height. The height position of each point was averaged over a disk with a radius of $4 \mu\text{m}$. The same points were selected in the second fracture surface to reorient it. The process is illustrated in Fig. 5, with the reference points marked as green disks in Fig. 5(a) and (b), and the

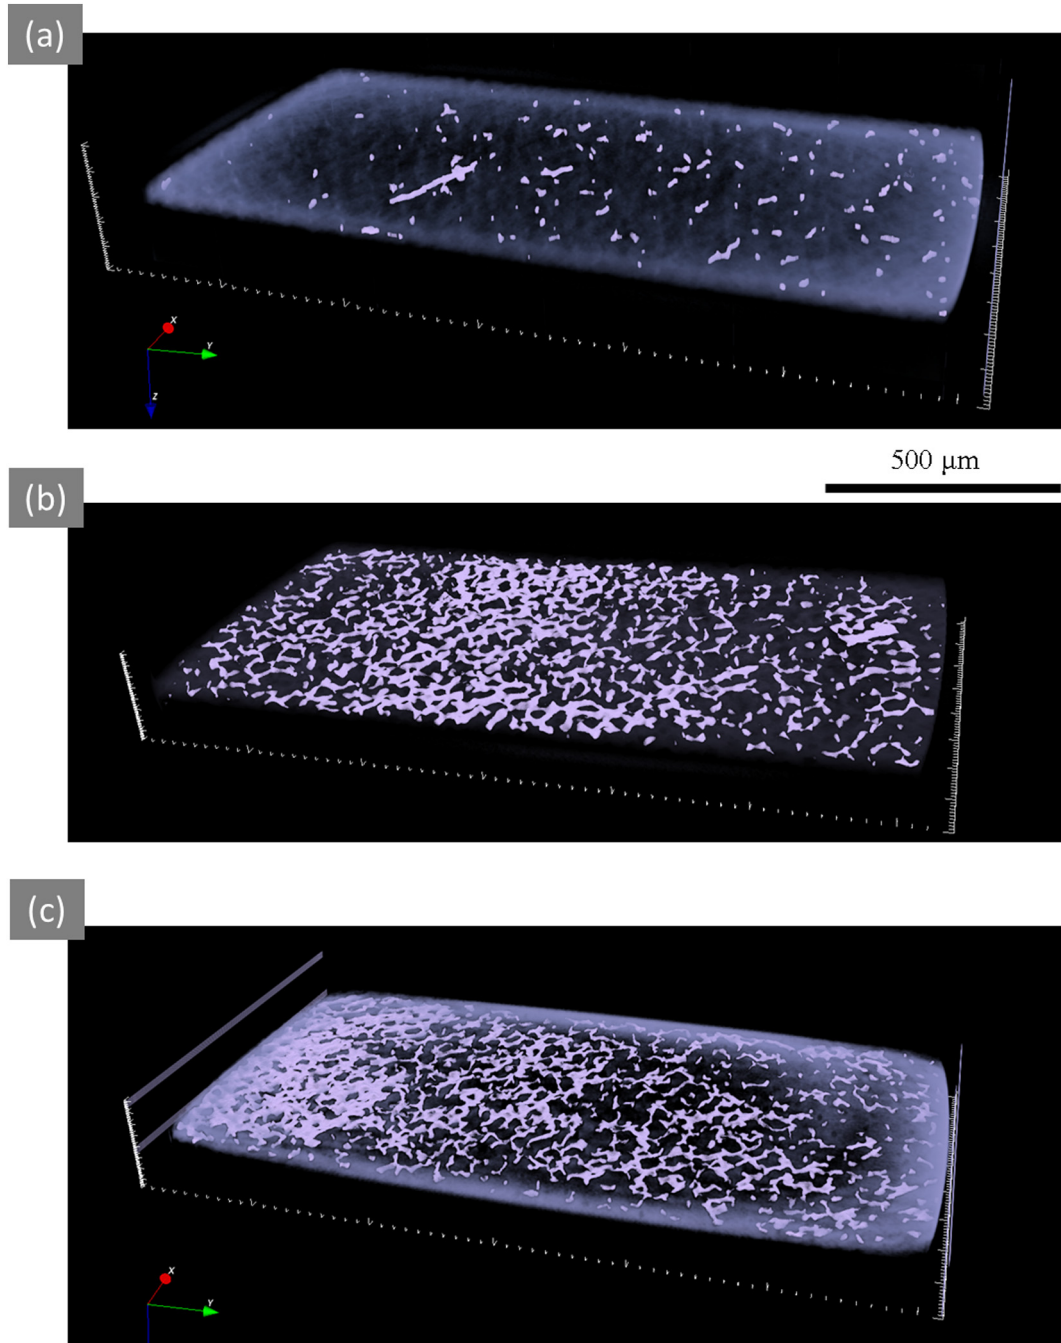
Fig. 6. 3D views of the pores at the mid-section of the specimens characterized by XCT. The blurry region corresponds to the joint. (a), (b), (c): high, medium and low strength samples, respectively.

Pre-mortem XCT 3D images are pictured in Fig. 6. For the three specimens, the pores are concentrated within the joint, with varying quantities and planar spatial distributions. The high strength specimen presents a few sparse pores, while the medium and low strength specimens present higher porosity contents. The porosity network in the medium strength specimen appears approximately homogeneous, which contrasts with the low strength specimen that exhibits a large interconnected pore on its left side. Further quantitative

The 3D porosity values for the low and medium strength specimens are very close, despite different UTS. However, as already noted, the pores are differently distributed (Fig. 6): the medium strength specimen presents an interconnected porosity network, while the low strength specimen has an extended porous region extending from one of its sides. Therefore, at equal porosity level in the joint, an interconnected network is more favorable for mechanical strength.

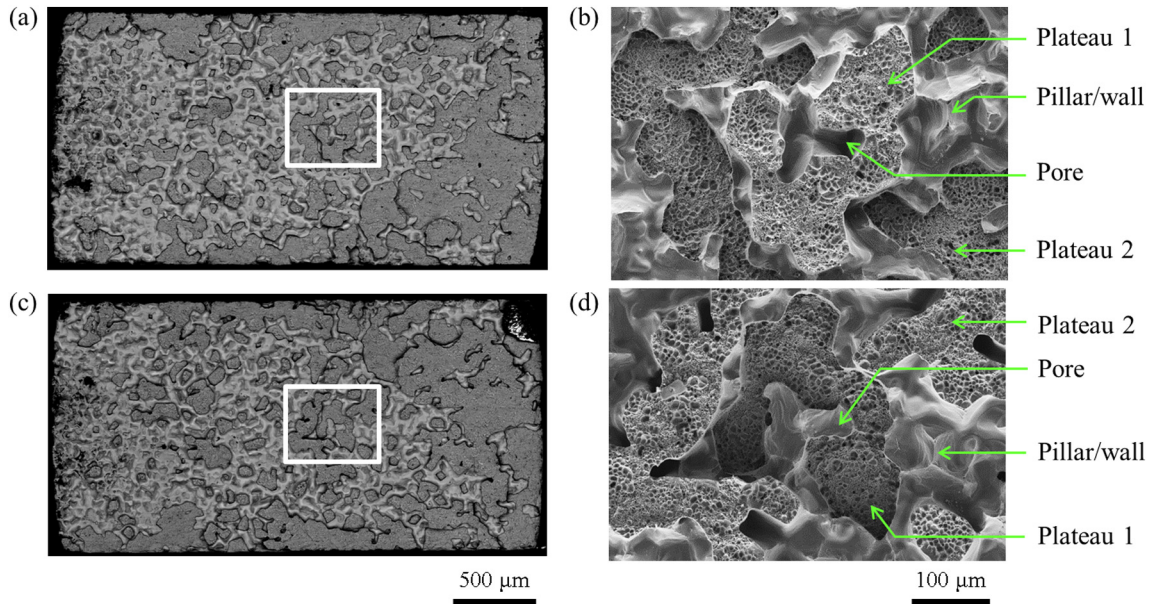
Fig. 7. SEM-BSE micrographs of opposite fracture surfaces (low strength specimen). (a), (c): Global micrographs highlighting interfacial fracture and smooth porous regions (medium and light gray regions, respectively). (b), (d): High magnification micrographs showing interfacial fractured regions covered by dimples (plateaus), pores and necked pillars/walls caused by plastic tearing.

SEM backscattered electrons (BSE) fractographies of both fracture surfaces of the medium strength specimen are shown in Fig. 7. Both images are very similar, with uniform and textured areas (Fig. 7(a) and (c)). Observations at higher magnification (Fig. 7(b) and (d)) allow identifying two kinds of features:

Two different fracture mechanisms were conjectured from this characterization: (i) interfacial fracture leading to the formation of large islets of brazed material with micro-sized dimples, (ii) complete necking/tearing of the brazed material due to the presence of surrounding pores, leading to the formation of pillars/walls. It is worth noting that the presence of dimples and complete necking are typical signatures of highly ductile materials, whereas the specimens investigated in this work exhibit macroscopic brittle behavior.

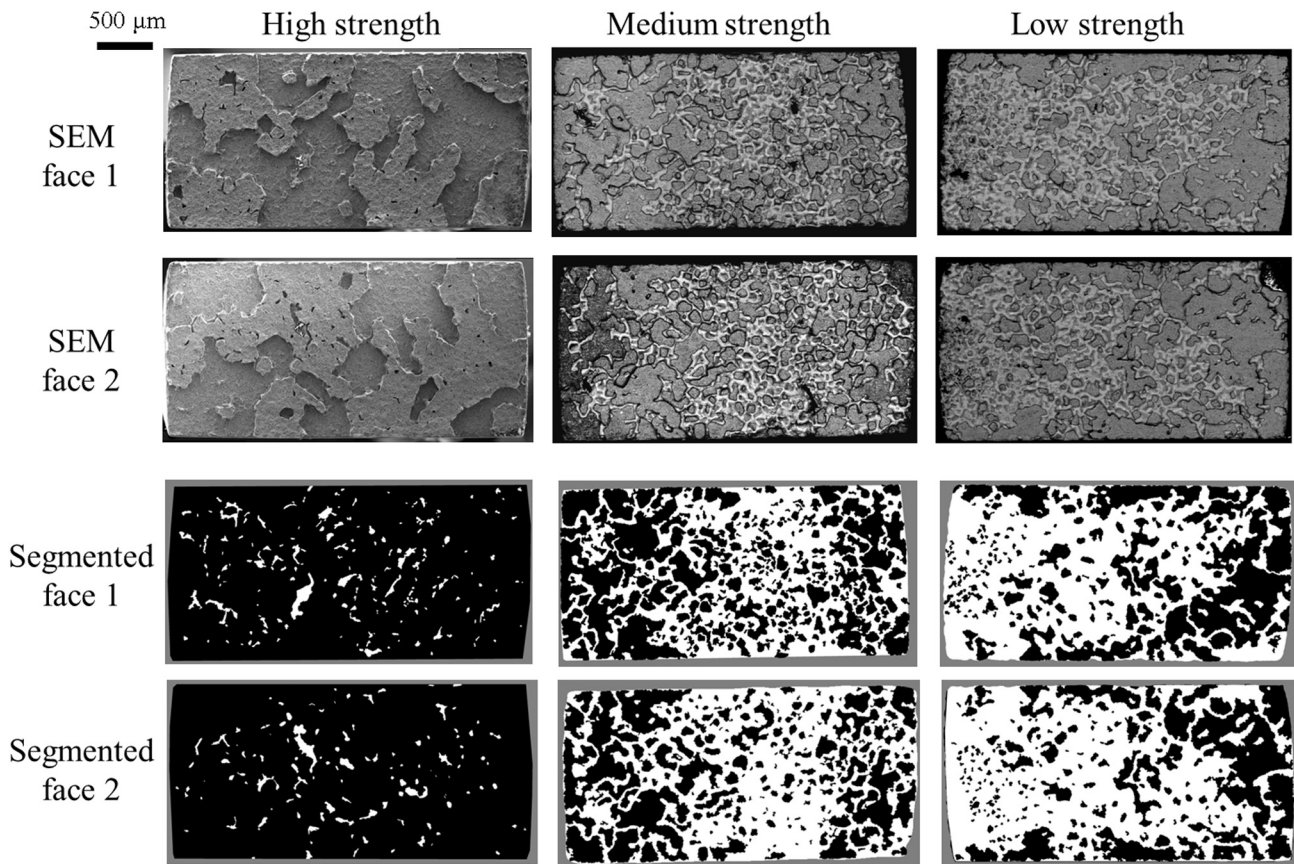
Fig. 8. BSE and segmented SEM images for the three specimens.

Fig. 8 presents the original BSE micrographs of the fracture surfaces and the result of the segmentation operation discriminating the plateaus from the pillars/walls (Section 2.3). The specimens exhibit very different porosity spatial distribution, as was already observed by XCT. The high strength specimen has a few sparsely distributed pores, the medium strength specimen presents a connected porosity network, and

Good agreement is observed between the measurements of 2D fractions on opposite faces characterized in SEM and LSCM for the three specimens. This confirms the visual appreciation that the fracture surfaces are similar (Figs. 8 and 9) and that the data processing is reproducible for both techniques. For this reason, the data for opposite faces are not distinguished on the graph (blue dotted lines in Fig. 13). The results follow the same trend, but are contrasted. The ultimate tensile strength decreases with the porosity, yet with different values depending on the measurement technique.

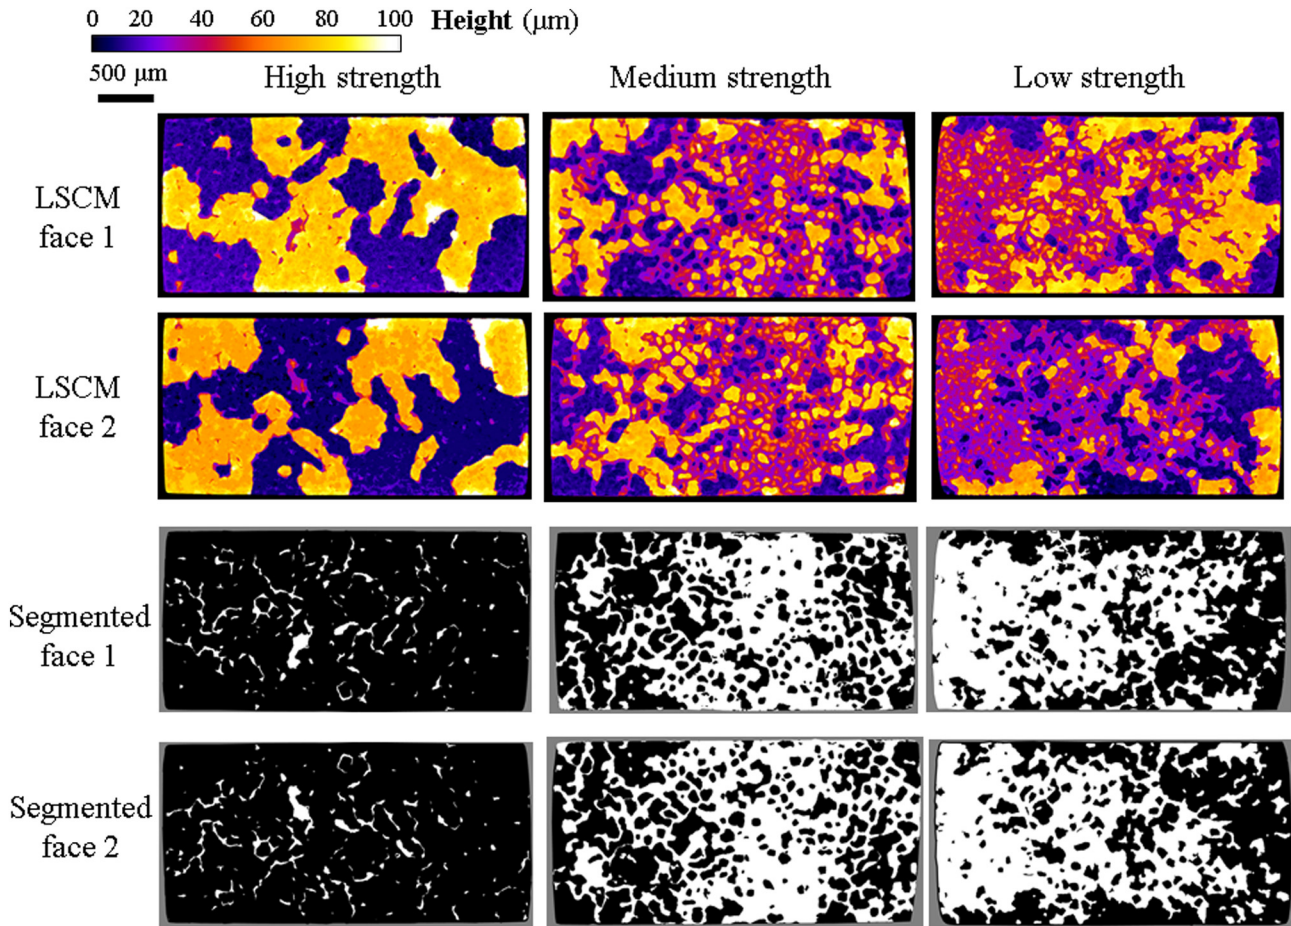
Fig. 9. LSCM height maps of opposite fracture surfaces and corresponding segmented images highlighting the pores (white regions on the segmented faces). (For interpretation of the references to color in this figure, the reader is referred to the web version of this article.)

Height measurements were performed on both opposite fracture surfaces for each specimen (Fig. 9). As previously shown by SEM fractographic analyses, large “plateau” regions corresponding to interfacial fractures were found. The height difference between minimal (dark blue regions) and maximal (yellow-orange regions) height plateau is about 60 μm. This corresponds to the initial thickness of the brazed joint, and evidences the interfacial nature of the fracture mechanism. The fracture surfaces of the high strength specimen were essentially constituted by large flat regions (“plateaus”) and some small pores sparsely distributed, illustrated by purple areas on the height maps. For the medium and low strength specimens, rough regions located in the mid-plane of the joint (at *ca.* 30 μm height) were noticed. These regions result from highly torn “pillars/walls” regions surrounded by interconnected porosity reported earlier from SEM imaging (Section 3.1). The height maps were segmented in order to discriminate the plateaus from the pores in the mid-plane (Fig. 9, lower). The binarized images were then analyzed in terms of apparent 2D porosity (Section 3.5).

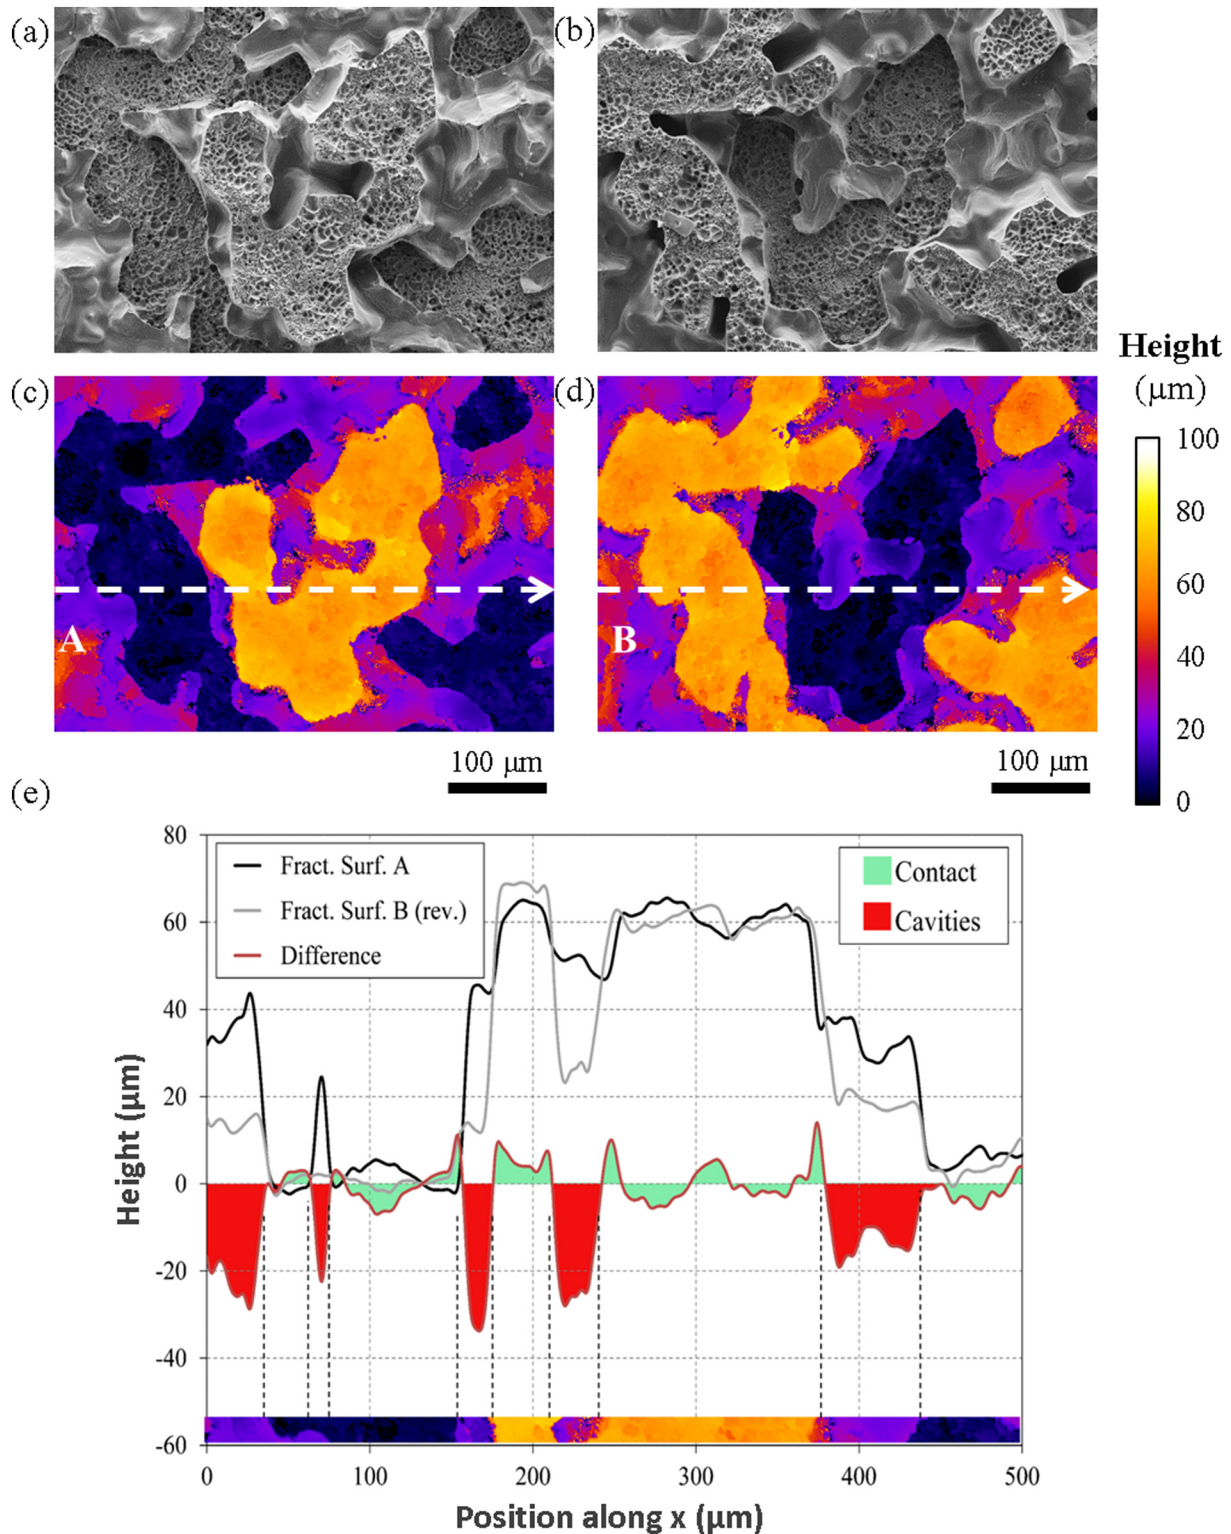
Fig. 10. Height distribution and interlock possibility of two opposite fracture surfaces presenting both plateau and “pillars/walls” features. (a), (b): SEM micrographs (image (b) has been mirrored horizontally); (c), (d): corresponding LSCM height maps; (e) height and thickness profiles demonstrating the possibility of 3D reconstruction.

Two opposite fracture surfaces of a local area presenting both interfacial and “pillars/walls” features are displayed at high magnification by SEM and LSCM in Fig. 10(a) to (d) to illustrate the cavities reconstruction and material interpenetration. Two height profiles A and B over the same region in both faces are plotted in Fig. 10(e). The profile of the second fracture surface (B, gray plot) was inverted in height and direction to be directly compared with the first one (A, black plot). The region corresponding to profile A in Fig. 10(a) is reported

below the graph to allow direct comparison between height variations and the local fractured features. Both profiles show similar variations, which demonstrates that the height measurement and the maps registration are sufficiently resolved so that quantitative analyses can be conducted.

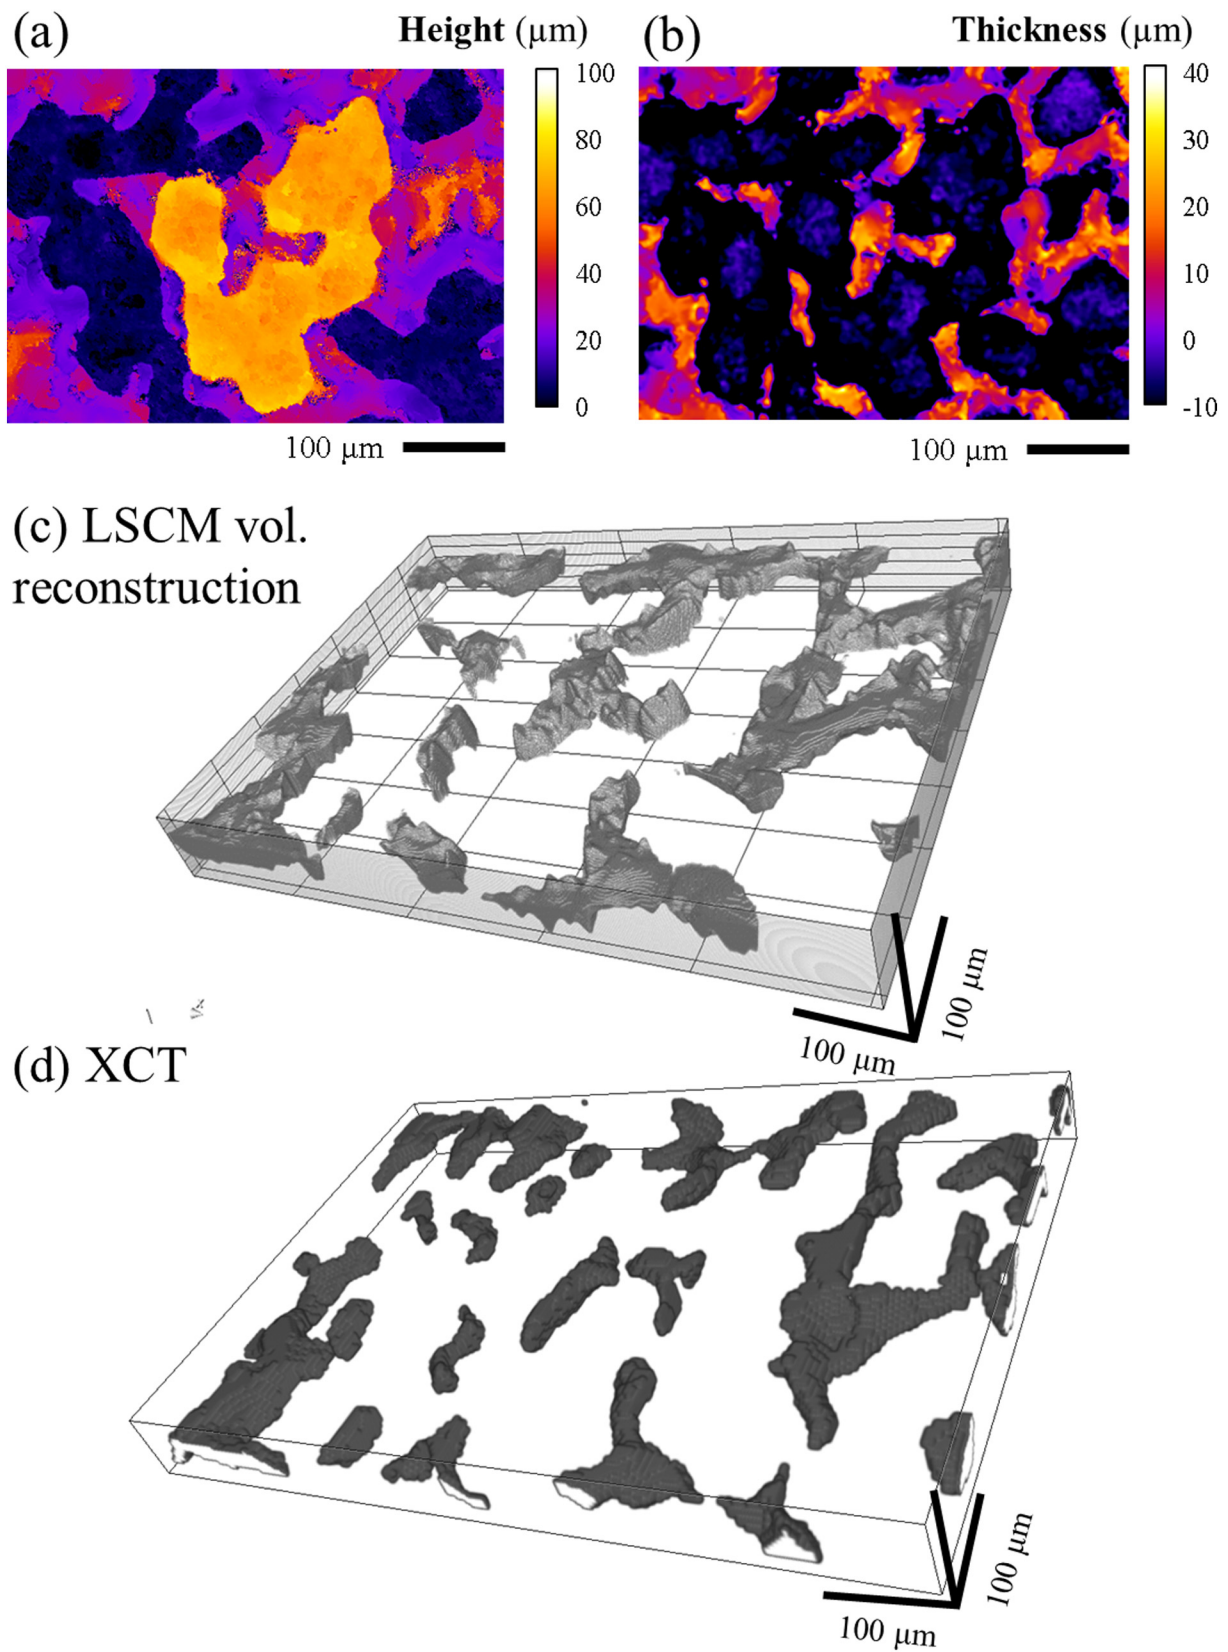
Fig. 11. Close-up 2D and 3D views of a fracture surface presenting both interfacial and “pillars/walls” features. (a) LSCM height map; (b) LSCM thickness map; (c) 3D view of the LSCM thickness map; (d) 3D XCT view of the same zone. (For interpretation of the references to color in this figure, the reader is referred to the web version of this article.)

The 2D and 3D porosity values measured on the reconstructed LSCM images and XCT images (pink solid line in Fig. 13) are close, as could be expected from visual appreciation of Fig. 11(c) and (d). The values are much lower than the 2D fractions. The 2D and 3D porosities assessed by XCT were found smaller compared to LSCM and could be explained by the deformation state prior and after fracture. This means that the segmented pores are larger when measured by fractography on opposite surfaces in SEM or LSCM than by 3D LSCM and XCT. The reason is that the pores extend due to plastic shearing at fracture, as evidenced by the presence of pillars/walls already noted in SEM micrographs (Fig. 7). Fractographic observations do not allow the direct segmentation of fine pillars/walls and result in higher porosity content in comparison with the projected 2D porosity from reconstructed volume.

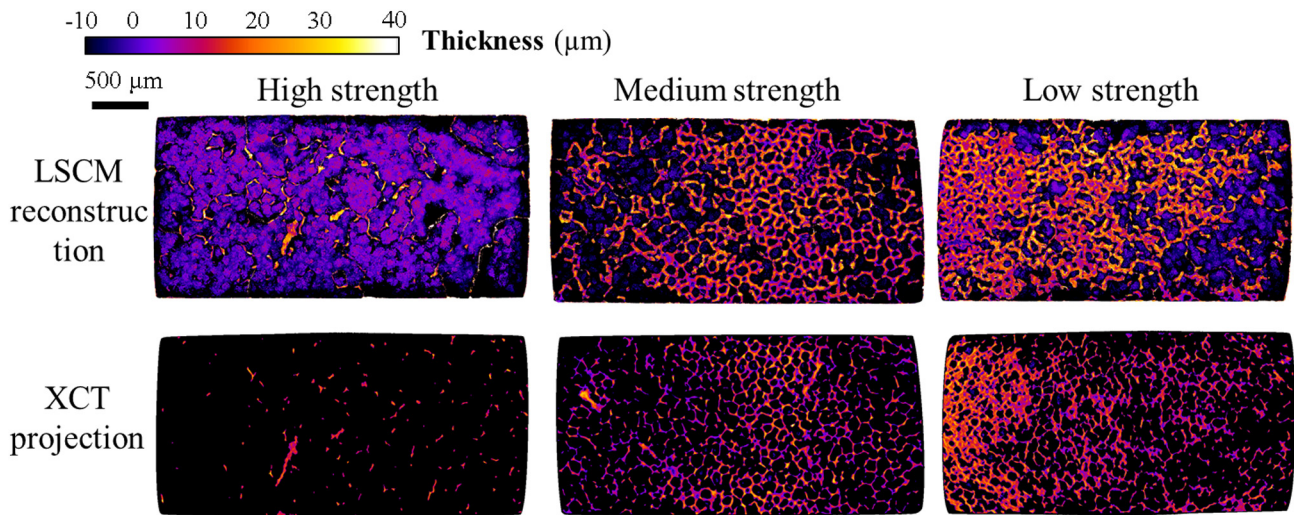
Fig. 12. Thickness maps obtained by LSCM volume reconstruction and XCT. (For interpretation of the references to color in this figure, the reader is referred to the web version of this article.)

the three specimens and compared to XCT projected porosity (Fig. 12). A dark layer at the border of the specimen can be observed on each of the LSCM reconstructed images, especially the high strength specimen. This corresponds to a zone of material interpenetration characterized by negative thickness values lower than -5 μm . The rest of the specimen shows mostly positive values, indicating that the fracture surfaces are concave and present shear lips at the border. Similarly, as already noted in Fig. 11, most of the plateaus comprise a central region characterized by positive thickness values in the range of 5 to 10 μm (blue areas in the thickness maps in Figs. 11(b) and 12) with negative or near zero values at their border. This is especially visible for the low strength specimen. These interfacial voids are not yet present on the pre-mortem XCT results. This confirms that the plateaus are not strictly planar, but rather slightly concave from their border towards their center. From these fractographic topographic results, it is not possible to discriminate the location of the onset of plasticity. However, damage seems to develop on various locations at the interface, forming plateaus after void coalescence. These two distinct observations at the scale of the fracture surface and at the scale of the plateaus, point towards a fracture scenario involving interfacial debonding between the joint and the base material, occurring within the core of the specimen and extending towards its surface. A more detailed discussion of the fracture mechanism is detailed in Section 4.2.

More importantly, the thickness maps in Fig. 12 puts into evidence the presence of voids at the center of the plateaus that are not present before fracture, showing that interfacial rupture develops more and earlier in the center region of the brazed interface. This point is further addressed in the fracture scenario proposed below.

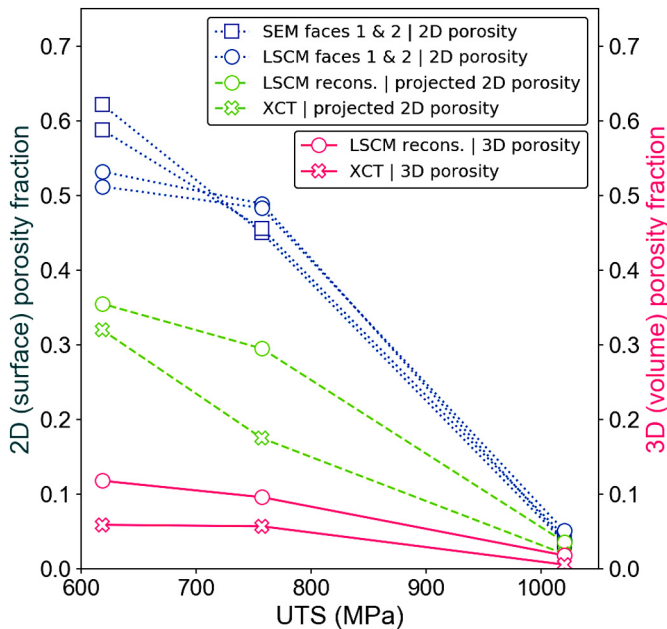
Fig. 13. Surface and volume porosity fractions (Table 3) measured by SEM (squares), LSCM (disks) and XCT (crosses) vs ultimate tensile strength (Table 2). Dotted lines refer to 2D measurements on fracture surfaces, and solid lines refer to 3D porosities.

(UTS, Table 2) in Fig. 13.

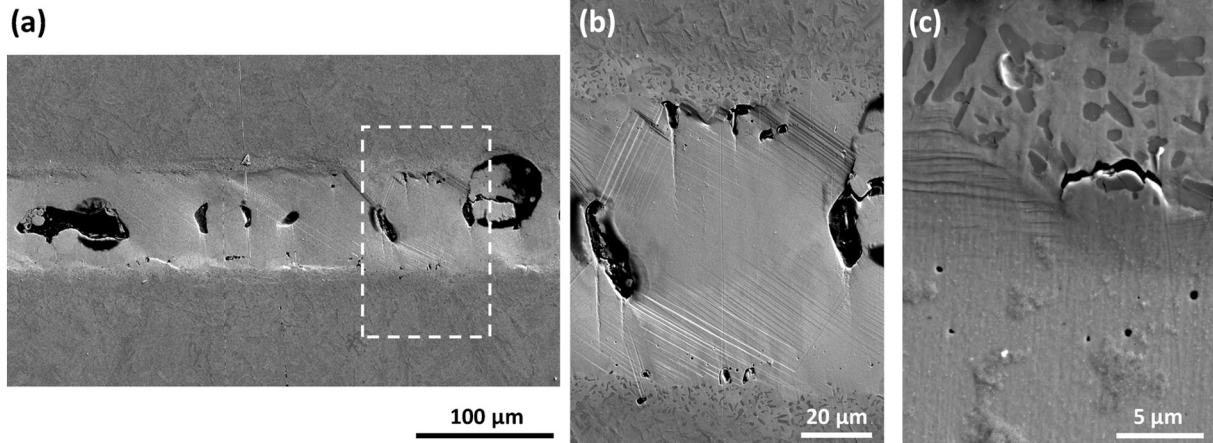
Fig. 14. SEM-BSE micrographs of pre-mortem specimen gage zone showing different deformation and damage processes. (a) Medium strength specimen: low magnification of the showing intense slip activity in the vicinity of pores and non-slip transfer into the substrate, (b) magnified region of the white dashed box depicted in panel (a) showing slip bands parallel to each other and inclined at 45° (vertical lines are traces of polishing lines), (c) high strength: specimen interfacial deformation and related debonding damage at an interface boride.

The gage sections of the specimens were observed with SEM prior to fracture (Fig. 14). At 85–90% of the ultimate tensile strength, several slip bands were noticed in the vicinity of pores, parallel to each other and inclined 45°. Slip bands were not transmitted into the substrate material and were confined in the filler material (Fig. 14(a) and (b)). Such observations were typical for low strength and medium strength specimens. Voids/cracks were found to develop at the substrate/filler material interface, most likely due to slip accumulation, leading to the fracture and debonding of the intermetallic borides present at the interface between the joint and the base metal (Fig. 14(b)). For high strength specimens, the limited density of pores leads to another deformation processes: slip bands nearly parallel to the substrate/filler material interface were found and related to the fracture and debonding of intermetallic borides (Fig. 14(c)).

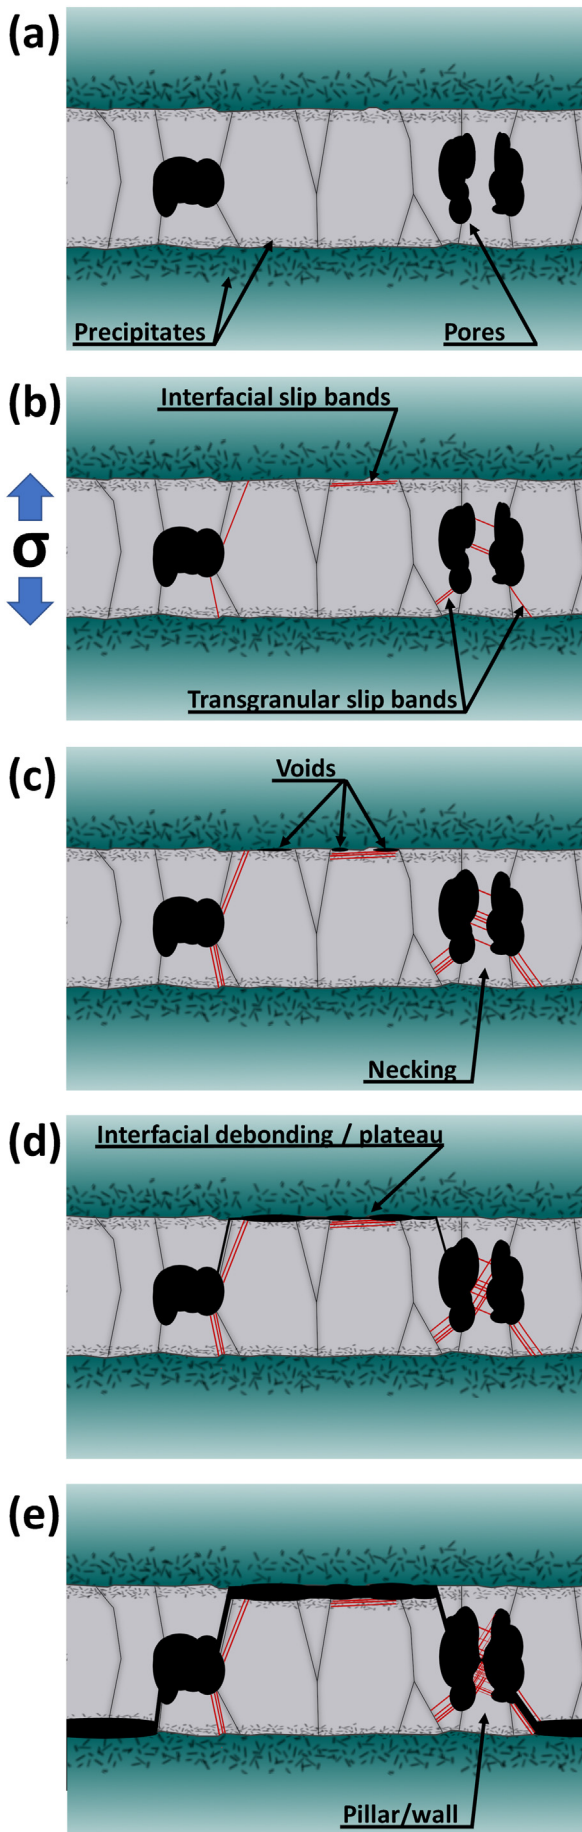
Fig. 15. Schematic sequence of events leading to fracture. (a): Initial state with pores, (b): slip activity in the vicinity of pores and at the brazing interface; (c) nucleation of voids at the interface due to strain accumulation and necking between close pores; (d) growth of a crack at the joint/substrate interface leading to voids coalescence (interfacial debonding/plateaus formation); (e): sudden fracture, local necking between the pores after interfacial decohesion has completed.

On the overall, the three techniques help establishing the most probable scenario for the global and local fracture event. While the macroscopic curves are typically brittle (Fig. 3), the local mechanisms are not, *i.e.* ductile features on the fracture surfaces (Fig. 7) and intense slip bands on the specimen gage (Fig. 14). In order to illustrate the deformation and fracture scenario occurring in brazed joints, schematic illustrations at different deformation stages are presented in Fig. 15. As pores concentrate the macroscopic strain and early plasticity is expected in their proximity, the intense slip activity is activated. However, slip activity is present only in the filler material and not transmitted in the substrate (Fig. 15(b)). Therefore, the surfaces of pores freely accommodate the plastic deformation while the substrate/filler material interfaces are subjected to plastic accumulation. Pores gradually deform as the macroscopic strain increases while the stress increases in the regions supporting the load. The islets of material between the pores lead to two different cases of damage depending on the interconnection between the pores (Fig. 15(c)). In the case of distant pores (high strength specimen), slip bands interact with the substrate/filler material interface and voids develop subsequently at this interface due to local plasticity accumulation, resulting in interfacial debonding when increasing the macroscopic deformation (Fig. 15(d)). In regions where pores are close to each other (medium and low strength specimens), slip activity in the filler material between pores leads to severe deformation and to a complete necking due to deformation accommodation. This is enhanced by the free-surface of pores that increase the local triaxiality. Necking generates elongated walls and pillars on the fracture surface (Fig. 15(e)). This sequence of events is similar to the classical nucleation-growth-coalescence mechanisms undergoing in other materials [22,39]. The cracks nucleate at a brazed interface due to the presence of the precipitates (Figs. 1 and 14), but they coalesce thanks to the contribution of pre-existing pores.

More specifically, the stress state in the material separating the pores depends on the distance between the pores and their interconnectivity. In the case of low porosity fraction (high strength specimen), these regions are wide and undergo moderate stress triaxiality, which results in high critical strains for interface crack nucleation. By contrast, joints with higher porosity fraction and connectivity induce higher stress triaxiality between the pores, resulting in lower local critical strains for interface crack nucleation, and consequently lower macroscopic strains for fracturing the sample. To this regard, the main difference between the medium and low stress specimen resides in the porosity spatial distribution and their interconnection (the volume fractions measured by XCT and LSCM reconstruction being very close in both samples). In the low strength specimen, the cracks must nucleate first in the narrow plateaus on the left (Fig. 12), and then extend to the right resulting in a fast failure as these represent less than half of the section of the joint. In the medium strength specimen, an intermediate strain level is required as a combination of large and narrow plateaus is found.
