Role of Non-metallic Inclusions and Twins on the Variability in Fatigue Life in Alloy 718 Nickel Base Superalloy

Damien Texier, Jean-Charles Stinville, Marie-Agathe Charpagne, Zhe Chen, Valery Valle, Patrick Villechaise, Tresa Pollock, Jonathan Cormier

Abstract

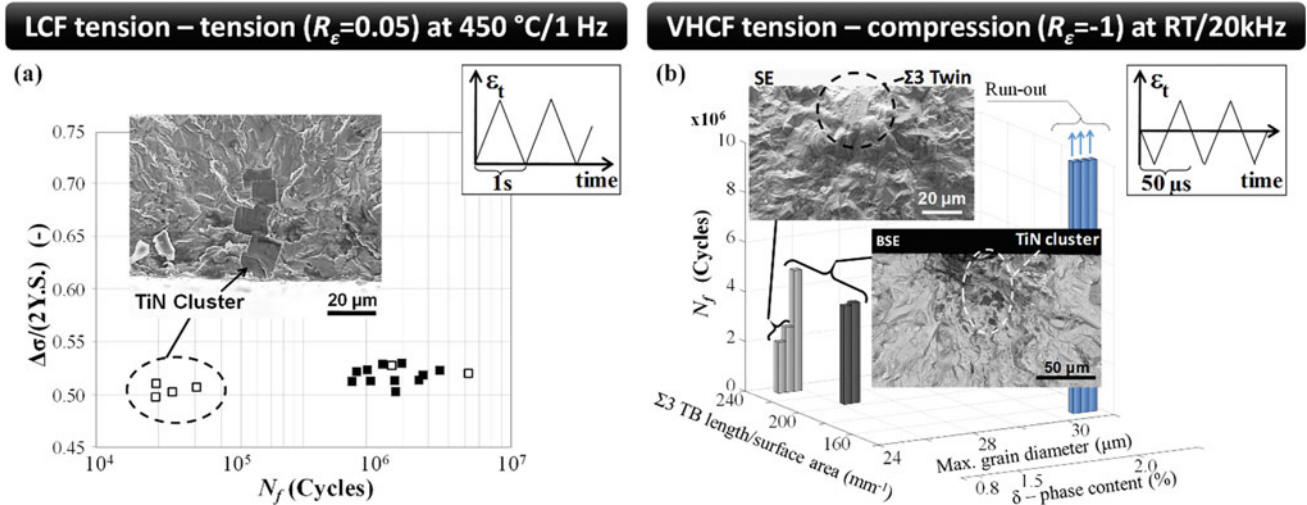
Fig. 1 Influence of microstructural features on the fatigue life of the 718DA showing abnormally low lives and associated crack initiation site: **a** low cycle fatigue (LCF) in tension-tension at intermediate

temperature [5], **b** very high cycle fatigue (VHCF) in tension-compression at room temperature [6]

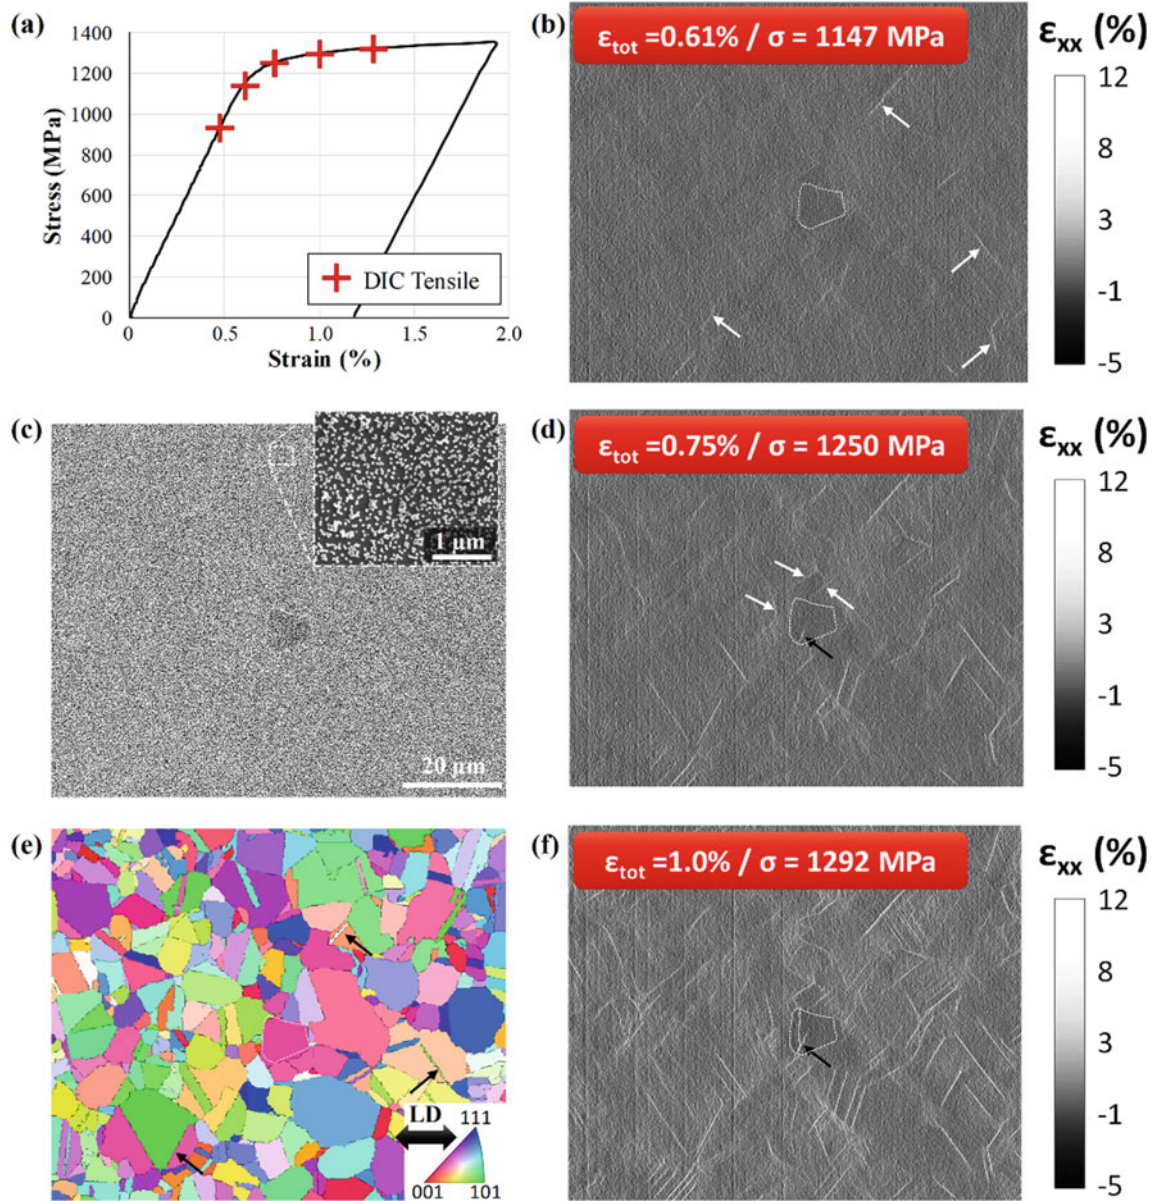
Fig. 2 Evolution of strain localization and cracking under tensile loading: **a** macroscopic stress–strain curve of the tested 718DA and loading steps for high resolution-digital image correlation (HR-DIC) measurements, **c** SEM micrograph used for HR-DIC in the vicinity of a nitride (TiN) inclusion showing the speckle pattern, **e** EBSD map of the ROI colored according the IPF colors with projection along the loading

direction (LD), **b**, **d** and **f** ϵ_{xx} strain maps at different stress–strain levels showing strain localization first in the grains far from the TiN (white arrows Fig. 2b), then strain localization in the grains neighboring the TiN (white arrows in Fig. 2d) and cracking of this NMIs (black arrow in Fig. 2d, f)

loaded in both the macroscopic elastic and plastic deformation domains, as shown with red crosses in Fig. 2a. Macroscopic strain was measured in-situ using fiducial markers located at both ends of the gage length. The loading direction (LD) will be referred as the x -direction and horizontally oriented in all the micrographs and strain fields. High resolution- and Heaviside-digital image correlation (HR-DIC and H-DIC) measurements were performed at macroscopic strain of $\epsilon_{\text{tot}} = 0.45, 0.61, 0.70, 1.0, \text{ and } 1.3\%$ in regions that display NMIs (detailed in Sect. 2.3). Twenty regions of interest (ROIs) were tracked.

A case study of cracking in a TiN inclusion at an intermediate loading condition is illustrated in Fig. 2. The possibility of assessing slip events in the metallic matrix and cracking in the TiN under loading is demonstrated. A white dashed contour identifies the TiN location in ε_{xx} strain maps and EBSD map for reading conveniences.

The onset of plasticity was observed along a few annealing twin boundaries far from NMIs at 90% of Y.S, i.e., $\varepsilon_{\text{tot}} = 0.61\%$ – $\sigma = 1147$ MPa (white arrows in Fig. 2b corresponding to black arrows in Fig. 2e). No evidence of strain localization was found within the NMI or in its neighborhood. Interestingly, the TiN inclusion appears slightly darker than the matrix in ε_{xx} strain fields, resulting from a higher stiffness regardless of the orientation of the NMIs or the grains. This latter observation is similar for all ROIs, i.e., independently of the nature of the NMIs. This difference in elastic properties is in good agreement with the literature [16, 30, 31]. Calculation of the elastic properties of the TiN and NbC inclusions and the superalloy matrix for various directions have shown that the superalloy matrix along its stiffest direction ($E_{[111]} = 260$ GPa) is softer than NbC and TiN inclusions along their softer direction ($E_{[001]} = 416$ GPa for NbC and $E_{[001]} = 417$ GPa for TiN).

At higher stresses, close to the macroscopic yielding of the material ($\varepsilon_{\text{tot}} = 0.75\%$ – $\sigma = 1250$ MPa), more slip bands developed in the surrounding grains, even in contact with the NMI (white arrows in Fig. 2d). At this macroscopic

For stress–strain conditions in the macroscopic plastic domain, strain localization is more and more intense near TB but a greater number of slip bands developed transgranularly (Fig. 2f). This multiplicity of transgranular slip activity was confirmed by Liu et al. [15]. At this stress–strain level, the TiN inclusion fully cracked with a complex crack path. Slip events are now observed within adjacent grains on both NMI crack tips. This specific ROI is thus a typical case of damage transfer from a cracked NMI to the superalloy matrix but NMI cracking was not assisted by slip deformation in the adjacent grains.

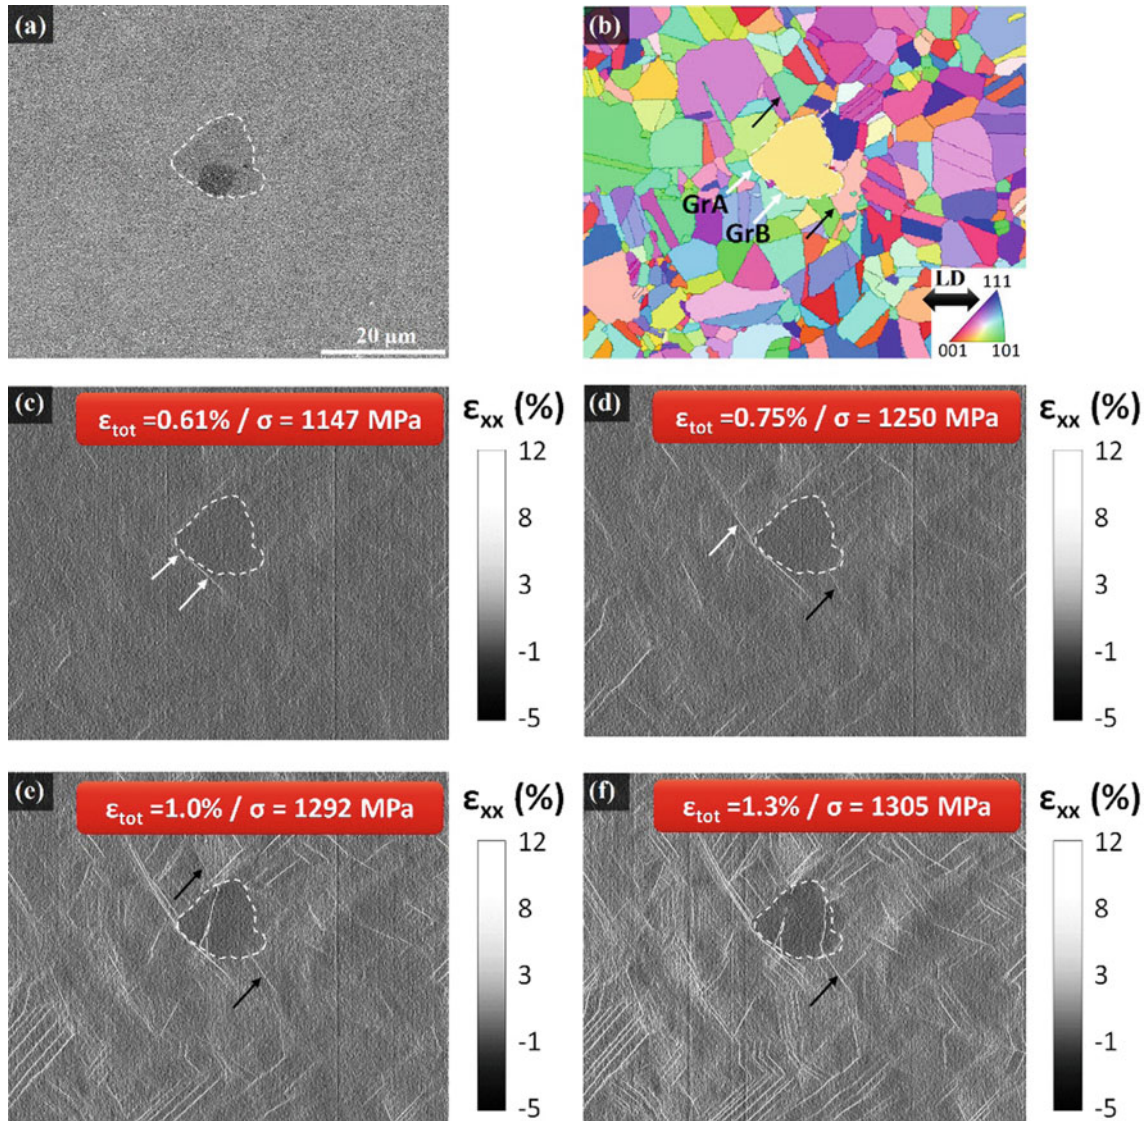
Fig. 3 Evolution of strain localization and cracking under tensile loading: **a** SEM micrographs used for HR-DIC showing the region of interest (ROI) in the vicinity of a carbonitride (NbCTiN), **b** EBSD map of the ROI represented as inverse pole figures (IPF) maps in reference

to the loading direction (LD), **c-f** ϵ_{xx} strain maps at different stress-strain levels showing strain localization parallel to the NMI/matrix interface (white arrows in Fig. 3c), then strain localization near a TB (black arrows in Fig. 3d, e), leading to the NMI cracking (Fig. 3f)

A second case study is presented in Fig. 3 to show a different scenario of slip/cracking interaction for a carbonitride. As for the former case study, a white dashed contour was used to locate the NbCTiN in ε_{xx} strain maps and EBSD map. Despite different compositions (gray contrast in Fig. 3a), NbC and TiN inclusions were found to have very similar orientations (less than 2° misorientation, i.e., same color code on IPF map in Fig. 3b) due to epitaxial growth and similar elastic properties.

arrow in Fig. 3d). As aforementioned, other slip bands develop in other locations in the superalloy matrix. At 1.0% total strain, the carbonitride cracked in the region where microplasticity started to develop parallel and close to the NMI/matrix interface. Interestingly, a slip band along a TB was observed to develop at the NMI crack tip (upper black arrow in Fig. 3b, e). At this point, it is not possible to identify whether the first event was either slip activity along the TB or NMI cracking. In addition, strain localization intensifies in the former slip bands near the TB (lower black arrow in Fig. 3e).

Slip traces parallel to the NMI/matrix interface were observed as early plasticity events developing near the NMI in the ROI for the case study #2 (Fig. 3c), prior to NMI

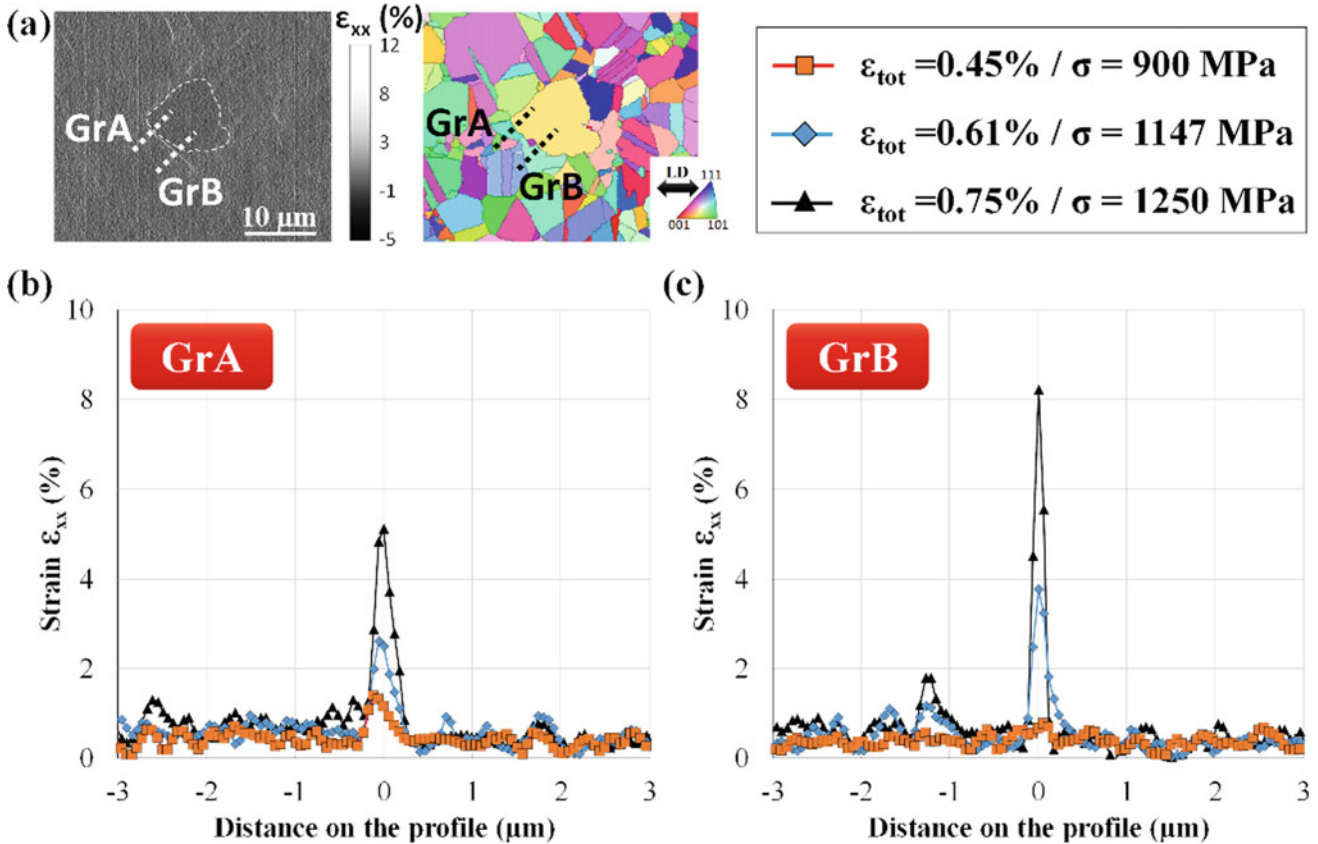
Fig. 4 Profile plot of the strain intensity across slip bands in GrA and GrB near and parallel to the NMI/matrix interface. **a** Illustration of both the profile lines in GrA and GrB in the strain and EBSD maps, profile

plot of the strain intensity (ϵ_{xx}) for the three first stress–strain conditions for **b** GrA, and **c** GrB

cracking. A closer examination of such strain localization is thus needed. Strain profiles (ϵ_{xx}) across the slip bands developing in GrA and GrB (grains labeled in Sect. 3.2) were extracted from ϵ_{xx} maps to document slip activity with the onset of microplasticity (Fig. 4). Interestingly, strain localization is observed in GrA but not in GrB for the stress–strain conditions at 70% of Y.S ($\epsilon_{\text{tot}} = 0.45\%$ – $\sigma = 900$ MPa). As aforementioned, slip traces observed on the ϵ_{xx} maps correspond to the $(\bar{1}11)$ and $(1\bar{1}1)$ planes from GrA and GrB, respectively.

At 90% of Y.S ($\epsilon_{\text{tot}} = 0.61\%$ – $\sigma = 1147$ MPa), strain localization intensifies across GrA slip band, but the slip band across GrB produced more intense strain localization than for GrA. Similar slip system analyses of GrB slip band were conducted using HR-DIC and H-DIC measurements. The $(\bar{1}\bar{1}1)[\bar{1}01]$ slip system was activated with a μ equal to 0.382, i.e., not the highest μ of the $(\bar{1}\bar{1}1)$ plane (green column in Table 1). The scalar products between the Burgers vector identified in GrA and the three possible Burgers vectors in GrB were calculated and reported in Table 1. Interestingly, the Burgers vector of the active slip system in GrB, i.e. $(\bar{1}\bar{1}1)[\bar{1}01]$, was less misoriented from the initial slip

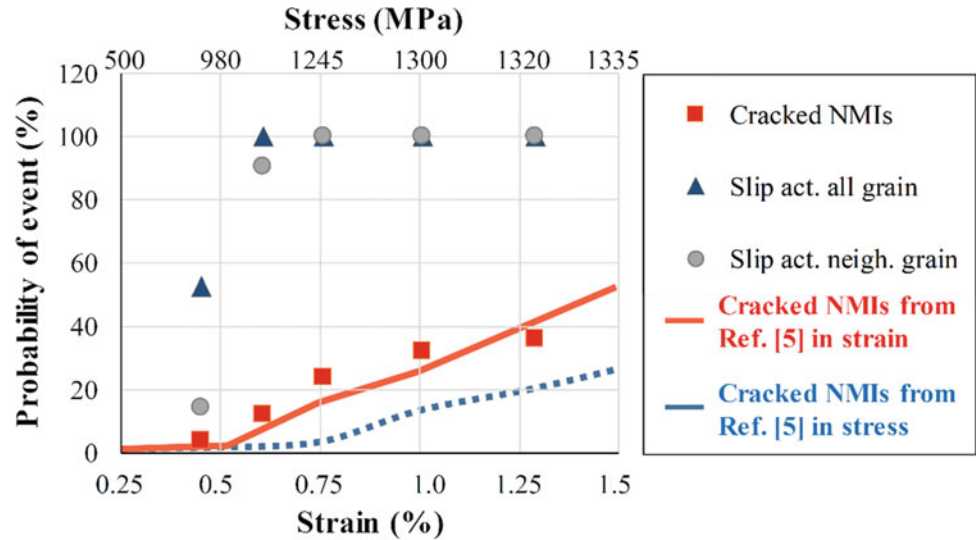
Fig. 5 Probability of slip events near and far from NMIs as well as NMI cracking, denoted as probability of event (POE) for all the loading conditions. Comparison with POE from Ref. [5]

grain” is 25% (5 ROIs over 20 ROIs in total). POE increased for the three events with the stress–strain increase. POE for slip rapidly saturates at 100% at 0.2% offset yield strength while POE for NMI cracking gradually increases. POE of NMI cracking is equal to 24 and 36% at 0.75 and 1.3% total strain, while all ROIs exhibit slip activity in grains adjacent to NMIs. For comparison, POE curves for cracked NMIs taken from Ref. [5] were added in Fig. 5. Owing to the higher yield strength of the 718DA in Ref. [5], the POE was plotted as a function of the macroscopic stress (blue dashed curve) and of the total strain (red unbroken curve). The good agreement between the present results and the POE representation as a function of the strain from Ref. [5] demonstrates the strain-controlled mechanism to crack NMIs. In other words, the sensitivity to crack NMI is directly correlated to the macroscopic yield strength of the Alloy 718. This point is crucial since it shows the damage density present after the first cycle in fatigue depending on the stress–strain amplitude. Despite a huge difference in stiffness between NMIs and the metallic matrix, the probability of slip within grains is higher far from the NMIs compared to the grains adjacent to NMIs at low stress–strain levels. This difference in POE could arise from the sampling method, taking into account more grains in the region far from NMIs.
