A microscopy study of nickel-based superalloys performance in type I hot corrosion conditions

Manon Waeytens, Adnan. Syed, Tracey Roberts, Fabian Duarte Martinez, Simon Gray, et al.. A microscopy study of nickel-based superalloys performance in type I hot corrosion conditions. *Materials at High Temperatures*, 2023, 40 (4), pp.272-282. 10.1080/09603409.2023.2188355 . hal-04026361

ABSTRACT

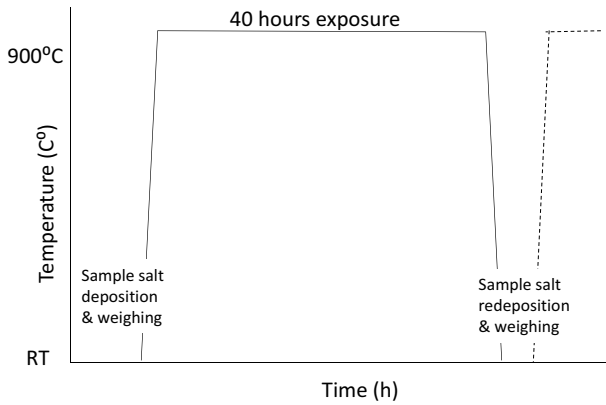
Figure 1 further illustrates each cycle, sample exposure of 40 h in a vertical controlled atmosphere furnace at 900°C . After 40 h of exposure in the furnace, the sample were weighed, resalted, and reweighed again. Each sample was salted using a deposit salt solution at a flux rate of $1.5 \mu\text{g}/\text{cm}^2/\text{h}$ and placed on a hot plate at 180°C to be certain of the evaporation of the water.

Figure 1. Schematic of a cycle of exposure [6].

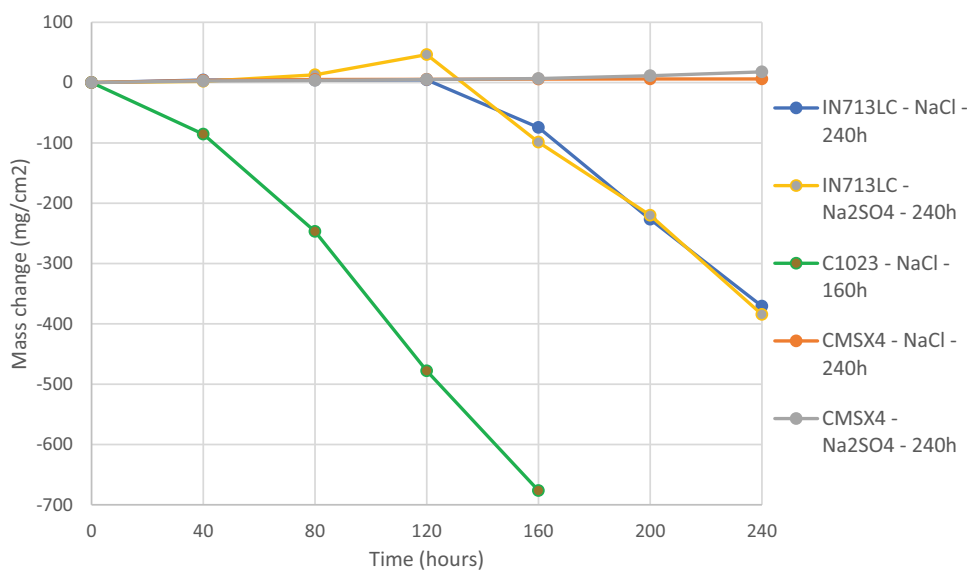
Figure 2 illustrate the mass change data of all three superalloys (IN713LC, C1023 and CMSX-4) covered with sodium sulphate and sodium chloride for 160 and 240 h at 900°C.

The mass change data for samples CMSX-4, covered with sodium sulphate or sodium chloride, exhibit very little mass change. However, IN713LC and C1023 showed significant mass loss. C1023 showed the highest mass loss values of $\sim 700 \text{ mg/cm}^2$ after 160 h of exposure. IN713LC interestingly showed approximately 400 mg/cm^2 mass loss covered with both salts (sodium sulphate and sodium chloride) after exposure of 240 h. The mass change data for IN713LC showed a significant downward trend initiated at 120 h, which suggested a change from incubation to propagation. However, alloy C1023 showed rapid mass loss showing an incubation time shorter than 40 h, and rapid propagation.

Figure 2. Mass change data of alloys IN713LC, C1023, and CMSX-4 covered with salts deposits exposed to air + 300 ppm SO_x gaseous atmosphere gas for 160 and 240 h at 900°C.

much less corrosion damage than C1023 and IN713LC after 240 h of exposure. The dimensional metrology data shown in Figure 6 is in good agreement with mass change data in Figure 2

It was also observed from Figure 2 that IN713LC and C1023 differ in their incubation time; thus the onset of propagation not only depends on the microstructure but also on the alloy chemistry. Figures 4 and 9 indicate that CMSX-4, when covered with sodium chloride or sodium sulphate, shows greater degradations; thus, CMSX-4 is not resistant to corrosion but, has an incubation time greater than 240 h of exposure at 900°C . Both IN713LC and C1023 alloys are chromia formers. These chromium oxides on the layers help them to prevent corrosion, but this is not quite effective. Presence of grains and the level of refractory elements within both polycrystal alloys are deciding factors. Park and co-workers [22] studied the role of chromium, aluminium, and the effect of refractory elements on nickel-based super alloys in high-temperature oxidation environment. Their findings suggest that the appropriate level of refractory elements such as molybdenum is key to have alloys minimum oxidation rates or it may hinder the formation of chromia or alumina, as well as the volatilisation of their oxides. High valence ion of molybdenum is likely to have consumed high level of oxygen and formed molybdenum oxides. Molybdenum oxides can be readily fluxed by alkali salt forming acid melts containing sodium molybdate increasing the rate of type

The various salts used in this study have different impacts on each alloy. Sodium chloride and sodium sulphate seem to have a similar corrosion damage results (as shown in Figure 2 mass change data), whereas samples covered with calcium chloride salts (Figure 3 mass change data) show a more minimal effect on the corrosion of the alloys.

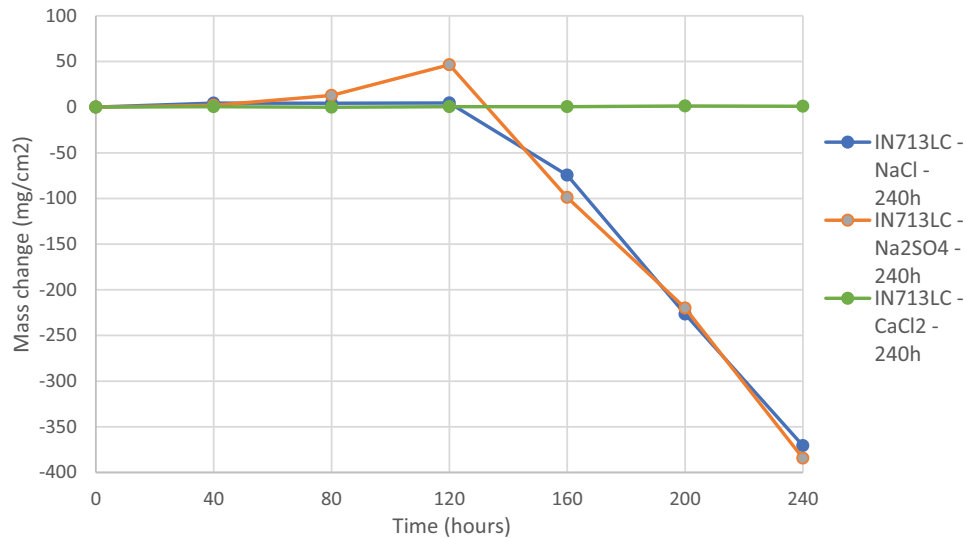
Figure 3 demonstrates the effect of three salts (sodium chloride, sodium sulphate, and calcium chloride) on mass change data for IN713LC alloy.

It is noticeable in Figure 3 that sodium sulphate and sodium chloride play a similar role on IN713LC and leads to a loss of mass of $\sim 375 \text{ mg/cm}^2$ after 240 h of exposure at 900°C. It is also noticeable that these two molten salts have the same incubation time of 120 h and the same corrosion rate after this time of incubation of respectively $-141,34 \text{ mg/cm}^2/\text{h}$ for IN713LC salted with sodium sulphate and $-127,79 \text{ mg/cm}^2/\text{h}$ for IN713LC salted with sodium chloride. However, calcium chloride seems benign with negligible mass change was observed for the sample during the 240 h of exposure of IN713LC sample. The sample of IN713LC salted with this calcium chloride salt showed no sign of corrosion. The data suggest that calcium chloride salt deposits are not as reactive, and contributing to corrosion damage, as the other salts. This behaviour suggests possible formation of CaSO_4 , which exhibit high melting points value $\sim 1460^\circ \text{C}$ [11,16].

Figure 3. Mass change data of alloys INC713-LC covered with various salts deposits exposed to air + 300 vppm SO_x gaseous atmosphere gas for 240 h at 900°C.

change data for IN713LC (in [Figure 3](#)) are also in line with these metal loss data (i.e. higher mass loss value when covered with sodium chloride salt).

This was observed on Figure 3 that IN713LC has exhibited the same mass change when exposed to sodium chloride and sodium sulphate. Sodium chloride may react with SO_2/SO_3 in the gas phase, forming a corrosive environment leading the formation of sodium sulphate and hydrogen chloride. This reaction could explain why sodium chloride and sodium sulphate have the same impact on the alloy. We can also conclude from Figure 3 that the sulphation of sodium chloride to sodium sulphate chemical reaction decreases the incubation period, i.e. 120 h. Indeed, the two curves corresponding to sodium chloride and sodium sulphate are similar and correspond to the same molten salt corroding the alloy, i.e sodium sulphate. This reaction sequence likely to cause the formation of hydrogen chloride [2,23] which may be lost to the gaseous environment.

Figures 5 and 10 show some attack with calcium salts. However, it was observed in Figure 3 that calcium chloride salt seems to be benign and have no effect on mass change. It can be expected a loss of mass when salting the alloy with calcium chloride because it

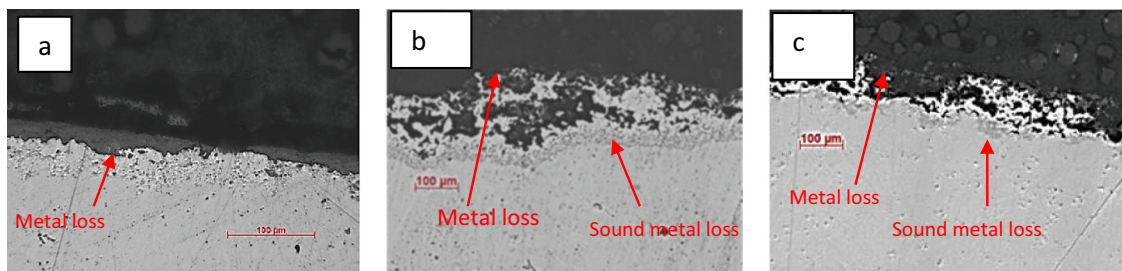
The three alloys were observed under the optical microscope after 240 and 160 h of exposure and salted with sodium chloride.

Images presented in Figure 4 show that both IN713LC and C1023 alloys suffer damage on the edge of the samples. However, the surface of CMSX-4 sample showed less degradations compared to the other two alloys. The loss of metal around the edges of both IN713LC and C1023 showed a similar morphology at scale/gas interface, whereas IN713LC showed

a consistent internal layer suggests uniform internal damage around the specimen.

Figure 4. Optical images of cross-sections through alloy CMSX-4 (a) and IN713LC (b) covered with sodium chloride deposits exposed to air + 300 vppm SO_x gaseous atmosphere gas for 240 h and C1023 (c) covered with sodium chloride deposits exposed to air + 300 vppm SO_x gaseous atmosphere gas for 160 h at 900°C.

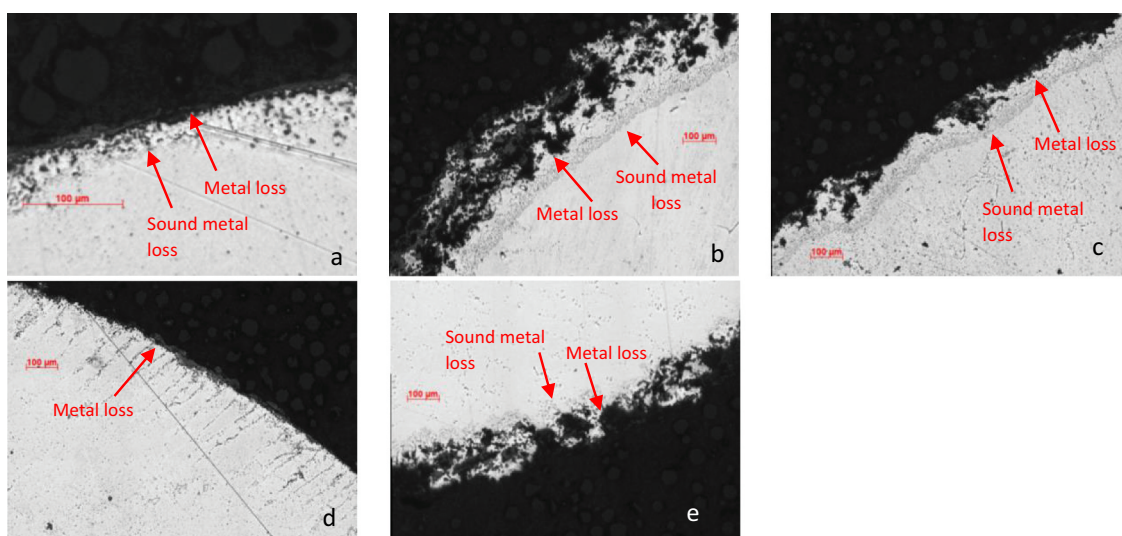
In [Figure 5](#), the images under the optical microscope showed that the degradation on the edge of

IN713LC samples was more severe when salted with sodium chloride and sodium sulphate ([Figure 5\(b,c\)](#)), respectively) in comparison with sample covered with calcium chloride salt ([Figure 5a](#)). This behaviour was

Figure 5. Optical images of cross-sections through alloy IN713LC covered with (a) calcium chloride, (b) sodium chloride and (c) sodium sulphate deposits exposed to air + 300 vppm SO_x gaseous atmosphere gas for 240 h and C1023 covered with (d) calcium chloride and (e) sodium chloride deposits exposed to air + 300 vppm SO_x gaseous atmosphere gas for 160 h at 900°C.

also observed on C1023 samples, a significant metal loss on the edges for sample covered with sodium chloride (Figure 5e) versus the sample covered with calcium chloride salt (Figure 5d). An interesting feature noticed is the internal damage on both alloys covered with calcium chloride salt has a different morphology.

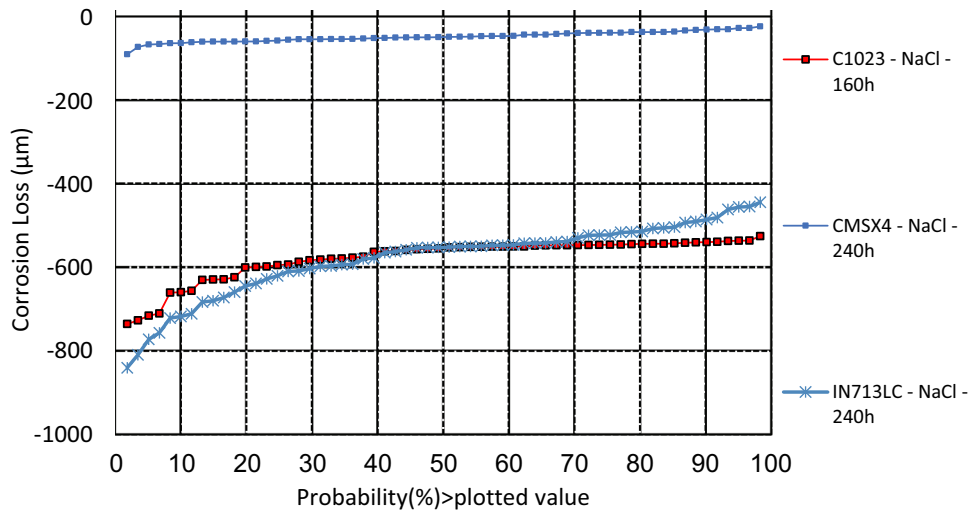
Figure 6 illustrates the damage distributions for alloys CMSX-4, IN713LC, and C1023 covered with sodium chloride deposits exposed to simulated hot corrosion type I combustion gases (air+300 vppm SO_x) at 900°C. It is clearly seen that CMSX-4 showed

The median (50%) corrosion loss value for sample CMSX-4 covered with sodium chloride salt is approximately 45 μm , whereas median corrosion loss values for Inconel 713LC and alloy C1023 are almost 10 times higher (~550 μm). However, this is to be noticed that C1023 had a shorter exposure (160 h) compared to other alloys (CMSX-4 and INC713) exposed for 240 h.

Figure 6. Plot of the probability of sound metal loss of alloys CMSX-4 and IN713LC covered with sodium chloride salts exposed for 240 h and C1023, covered with sodium chloride salts exposed for 160 h to air + 300 vppm SO_x gaseous atmosphere gas at 900°C.

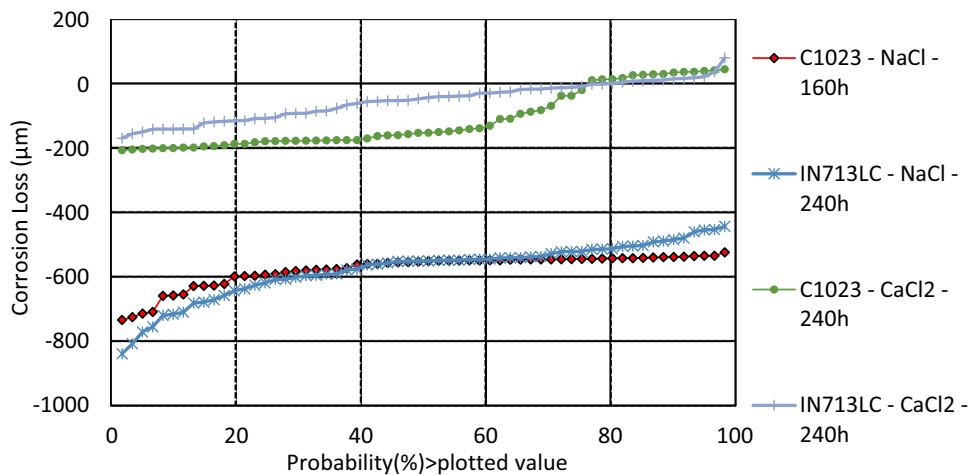
Figure 7 shows that samples covered with sodium chloride deposit exhibited significantly higher metal loss values. The median metal loss values for both alloys (C1023 and IN713LC) was observed as high as ~550 μm . However, when same alloys (INC713 and C1023) were covered with calcium chloride deposits, the median metal loss values were found to be much lower (~160 and ~40 μm , respectively). The mass

Figure 7. Plot of the probability of sound metal loss of alloys C1023, and IN713LC covered with sodium chloride and calcium chloride salt deposits exposed for 160 and 240 h to air + 300 vppm SO_x gaseous atmosphere gas at 900°C.

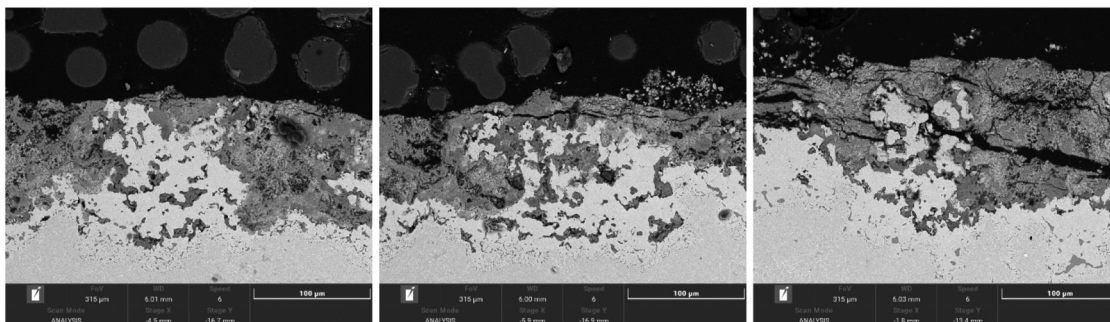
Figure 8. BSE images of alloy C1023 covered with sodium chloride salt deposits exposed to air + 300 vppm SO_x gaseous atmosphere gas for 160 h.

[Figures 8 and 9](#) illustrate the cross-sections through the scales formed on chromia former alloy C1023 and single-crystal alloy CMSX-4 covered with sodium sulphate salt deposits after exposure for 160 and 240 h respectively at 900°C. The cross-section images for C1023 show no external scales are present and suggested the scales are likely to be spalled off the surface. An interesting feature noticed is the significant internal patchy appearance within each image in [Figure 8](#) suggests the propagation of internal attack within the polycrystal alloy is irregular probably initiating a local scale breakdown and then propagating. [Figure 9](#) shows the cross-section images for alloy CMSX-4 is thinner and more uniform scale forms compared to alloy C1023, which is also in agreement with mass change data. The internal damage is also noticeable underneath the thin scales within the alloys, suggesting an internal sulphidation with broad front attack (typical type I hot corrosion mechanism).

It can be seen in [Figure 8](#) that C1023 exhibits deep internal attack after a short exposure of 160 h in comparison to longer exposure for CMSX-4 and INC713 in [Figures 9–11](#). Chromium level in alloy C1023 (15 wt %) is higher compared to chromium level (10%) in IN713LC. Chromium addition into alloys is known for its property as a corrosion resistance, element. However, results suggested that chromium content is not the deciding factor for corrosion rate here. Molybdenum is the (refractory) element with highest concentration of 8.5% in C1023 compared to 4.3 and 0.6% in INC713 and CMSX-4 alloys

The key difference between the alloys is that CMSX-4 is a single-crystal alloy while IN713LC and C1023 are equiaxed grains alloys. The mode of attack is different between these two classes of alloys. Comparison between Figures 8, with 9 and Figure 10 (d–f)

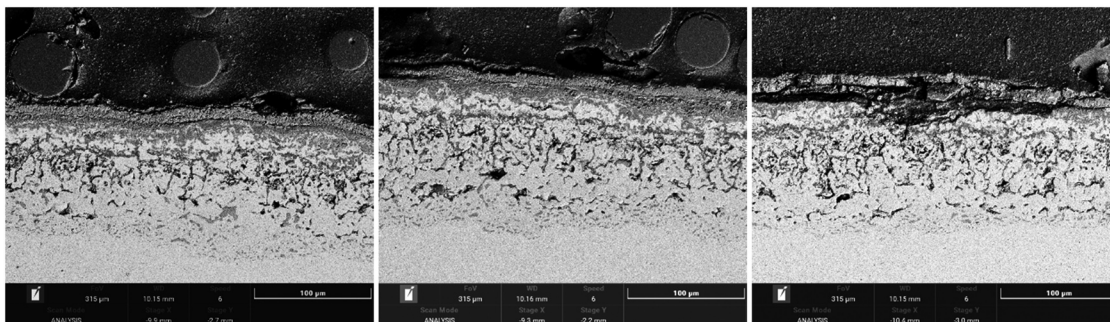
Figure 9. BSE images of alloy CMSX-4 covered with sodium sulphate salt deposits exposed to air + 300 vppm SO_x gaseous atmosphere gas for 240 h.

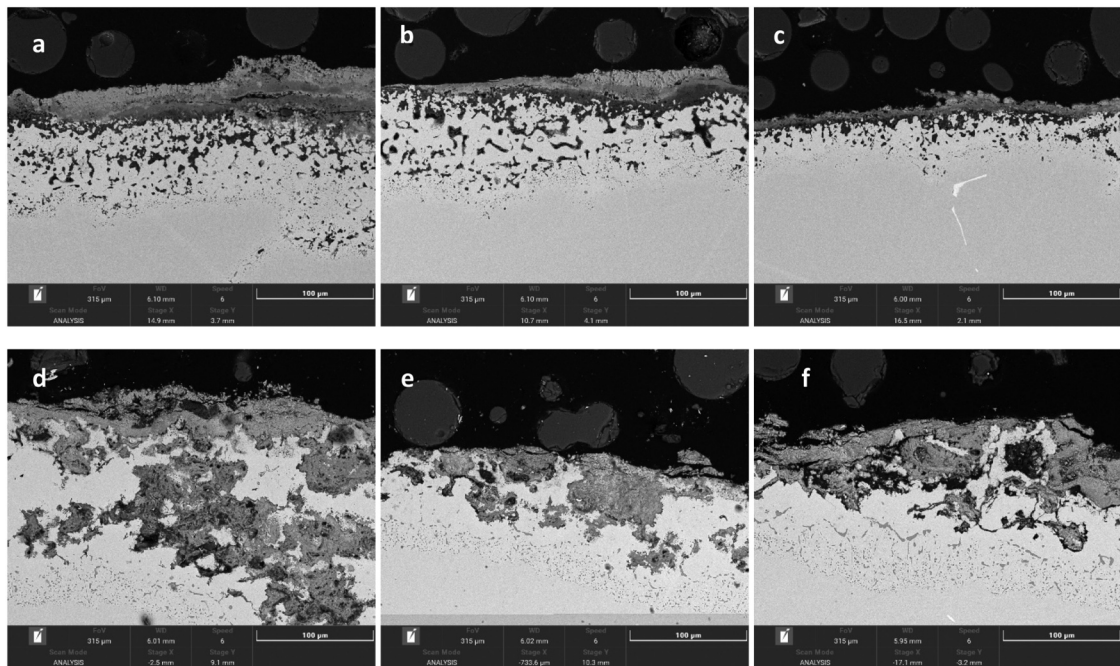
[Figure 10](#) (a–c; cross-sectional images of IN713LC) shows the presence of an outer scales and internal corrosion within the alloy at the scale alloy interface. Clearly, the calcium chloride deposits have entered propagation after 240 h with a mix mode of internal attack showing both internal oxidation and sulphidation. The attack is, however, much less advanced than with sodium chloride salt. [Figure 10](#) (d–f) shows the attack under an initial sodium chloride deposits is much severe. It is evident that the outer oxide has spalled (it is absent) and alloy had an internal irregular patchy internal oxidation degradation. It is also to be noticed that morphology of internal degradation of alloy IN713LC in [Figure 10](#) (a–c) is similar to internal degradation morphologies shown in [Figure 8](#) for alloy C1023. However, the exposure period of C1023 alloy sample was only 160 h compared to 240 h exposure of IN713LC alloy.

Figure 10. BSE images of IN713LC covered with (a–c) calcium chloride and (d–f) sodium chloride salt deposits exposed to air + 300 vppm SO_x gaseous atmosphere gas for 240 h.

The results show that calcium chlorides corrode nickel-based alloys under the conditions of this study. It can be concluded that calcium chloride has a longer incubation period. This incubation period must be at least more than 240 h (the maximal time of exposure of the samples observed in Figure 10 [a–c]).

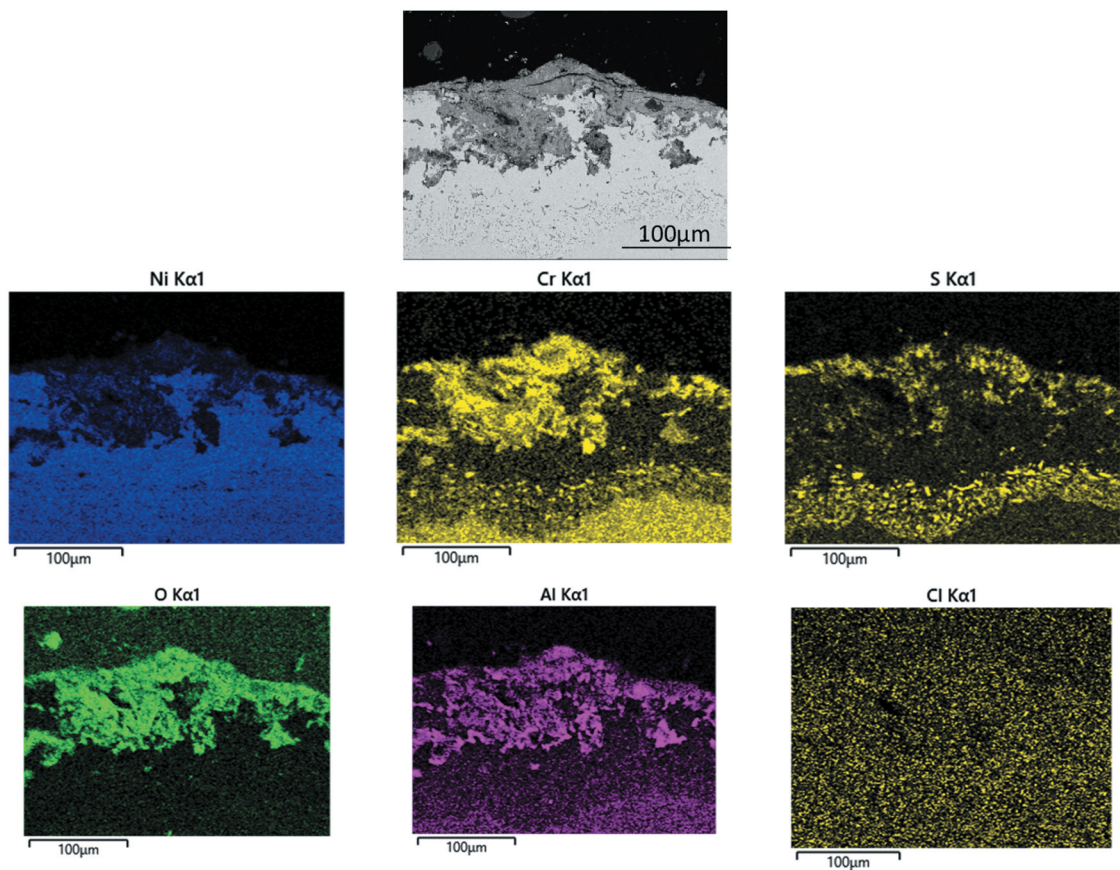
Figure 11. EDX mapping of IN713LC covered with sodium chloride salt deposits exposed to air + 300 vppm SO_x gaseous atmosphere gas for 240 h.

The EDX mapping in Figure 11 demonstrates the elemental distribution around the alloy/scale interface. The BES image shows obvious internal alloy degradation. The role of sulphur in the corrosion attack mechanism is confirmed by the detection of an S-rich layer concentrated underneath the inner scale, showing that it is penetrating through the outer scale layers. In the outer region oxygen, aluminium and chromium are detected. It is interesting to notice that chlorine is not present at the alloy surface. The enrichment of aluminium and chromium and oxygen suggested the well-known corrosion resistance oxide formations.

Figure 13 illustrates EDX mapping of a cross section through alloy C1023 after 160 h exposure under type I hot corrosion test. It is also interesting to notice that the EDX maps of Figures 11 and 13 are very similar. These maps show the distribution of oxygen throughout the scale. Significant presence of aluminium and chromium was found within the inner oxidation and sulphidation zone. EDX maps also show presence of cobalt which is comparatively localised. Pits in Figure 13 suggesting chromium sulphides attack could preferentially occur. Moreover, during this detailed investigation, chlorine was not detected. The morphology suggested the formation of pits within the alloy which propagated later into irregular patches sideways along the grain boundaries then laterally to form broad front attack.

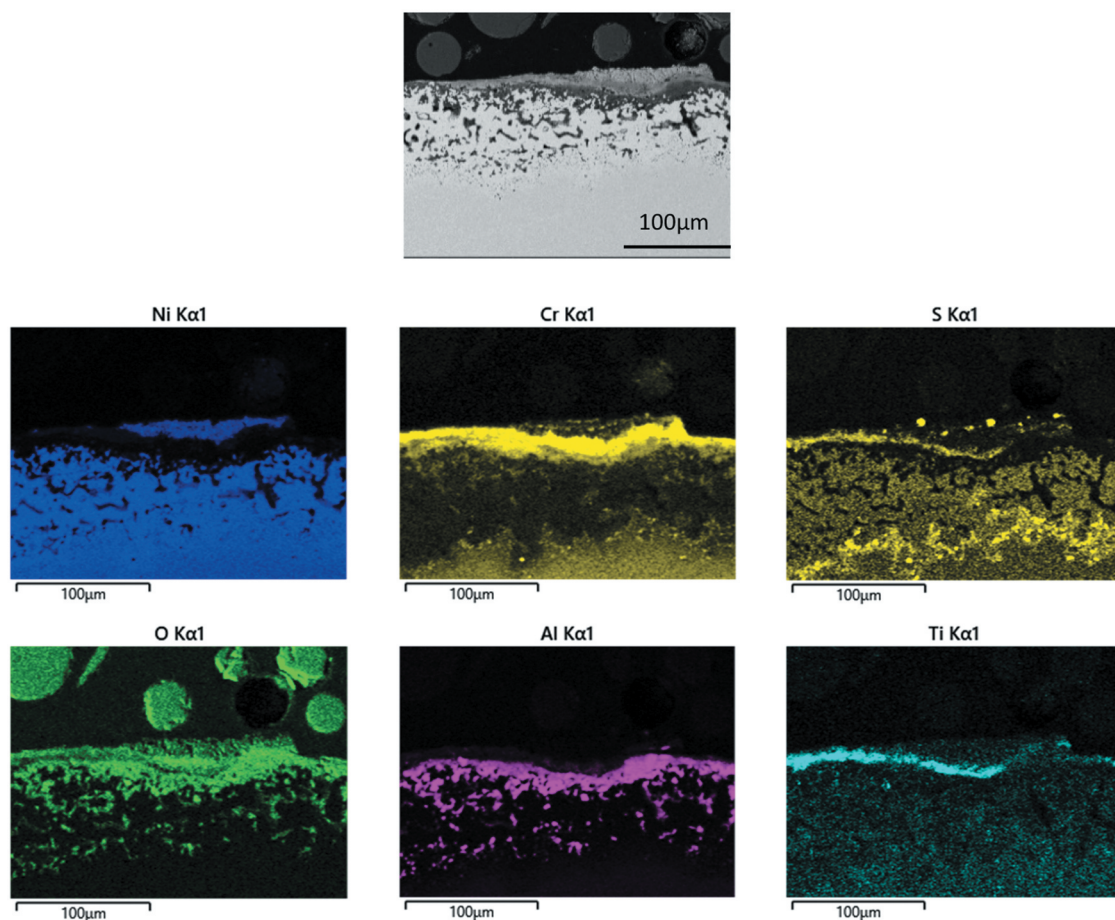
Figure 12 shows EDX mapping of INC 713 exposed to hot corrosion type I conditions for 240 h. It is clearly shown that oxygen is distributed throughout the scale. Chromium enrichment as a thick layer is clearly identified under the corrosive deposits. High level of sulphur was detected underneath the internal damage most probably as chromium sulphide. Significant patches rich in aluminium are also present within the same region most probably alumina. Titanium is also evident at the top region of the oxide/sulphide scale. The backscattered electrons (BSE) image shows the internal degradation has significant porosity.

Figure 12. EDX mapping of IN713LC covered with calcium chloride salt deposits exposed to air + 300 vppm SO_x gaseous atmosphere gas for 240 h.

However, chlorine is very volatile element, especially at 900°C [26,27]. Chlorine is not part of the chemical process of degradation of the alloy, as seen in Figure 12, because it has evaporated before attacking the alloy.

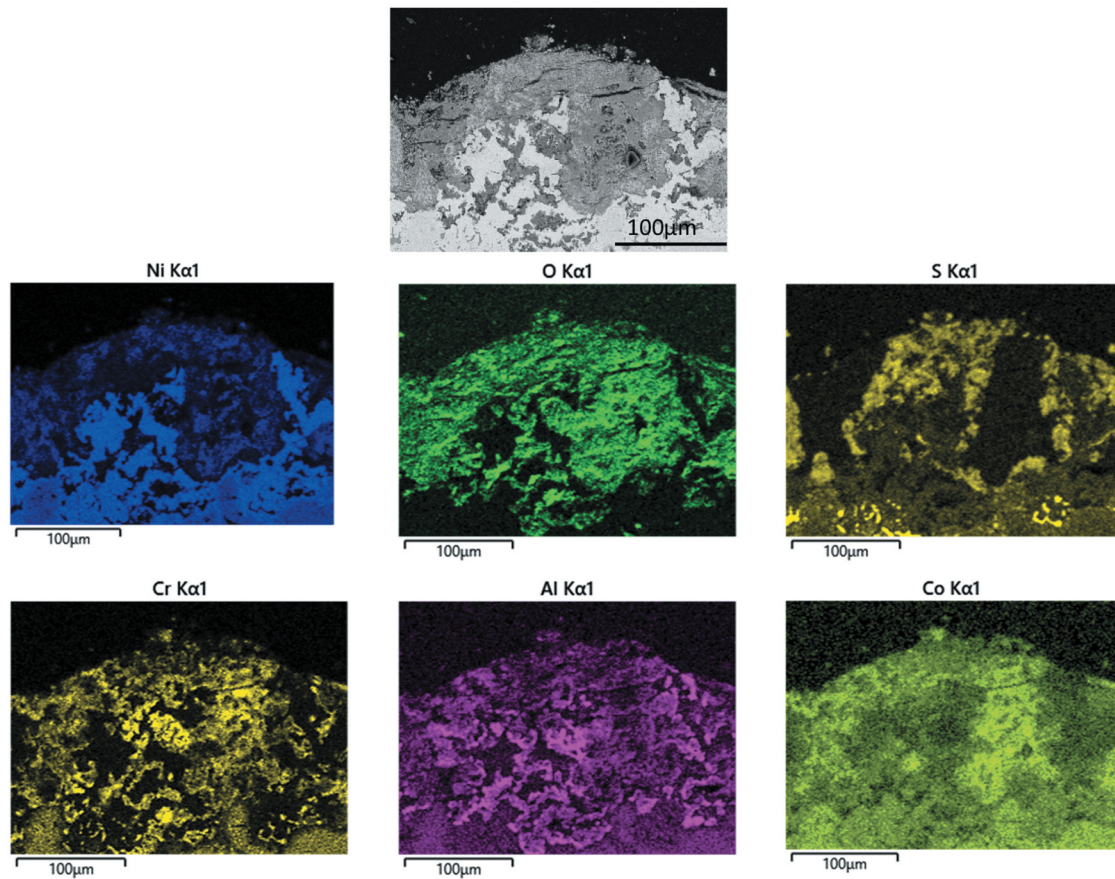
Figure 13. EDX mapping of C1023 salted covered with sodium chloride salt deposits exposed to air + 300 vppm SO_x gaseous atmosphere gas for 160 h.
