Fire behaviour of hybrid filament-wound single and adhesively bonded composites tubes under static pressure

Sonia Braiek, Ated Ben Khalifa, Redouane Zitoune, Mondher Zidi, Mehdi Salem

Sonia Braiek, Ated Ben Khalifa, Redouane Zitoune, Mondher Zidi, Mehdi Salem. Fire behaviour of hybrid filament-wound single and adhesively bonded composites tubes under static pressure. *Polymer Testing*, 2020, 91, pp.106815. 10.1016/j.polymertesting.2020.106815 . hal-02928011

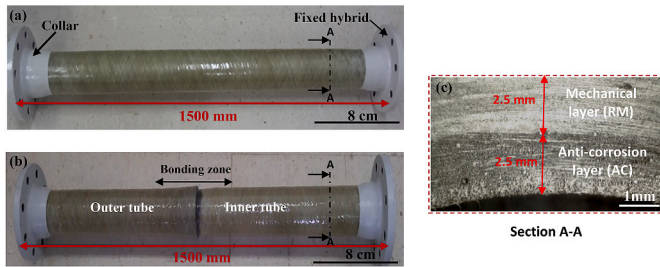
Fig. 1. The filament-wound tube made of E glass/Vinylster 411 resin used for fire endurance tests. With (a) Single tube, (b) Adhesively bonded tube, and (c) The different layers of the tube (cross section).

collars with fixed hybrids (cf. figure1-a).

For the adhesively bonded tube (cf. figure 1-b), composed of an inner and outer tube, it should be mentioned that they were manufactured using the filament-winding technique as described above. For tube bonding, an Araldite 2014-1 adhesive was used. This adhesive, supplied by Huntsman Corporation America, is composed of Epoxy resin and a hardener. The Araldite was applied on the inner surface of the outer tube and bonded with the inner tube. The joined specimens were cured at room temperature for 24 h. It is to be noted that both single and adhesively bonded tubes have an inner diameter of 80 mm and a length of 1500 mm.

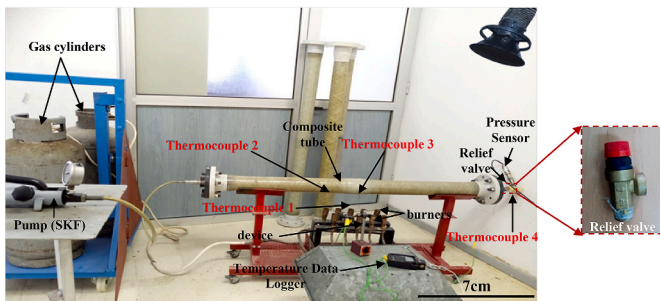
Fig. 2. The experimental device of the fire endurance test.

In order to investigate the fire resistance of hybrid filament-wound composite tubes, a series of fire endurance tests were performed on E glass-reinforced Vinylester 411 tubes. Thus, the experimental test was repeated five times in order to evaluate the variability of the experiments. These tests were done following the International Maritime Organization (IMO) resolution A 753 [42]. For this, a device was designed and manufactured especially for this study as witnessed in Fig. 2. The heat source was provided by two rows of five burners. These burners, referenced under Sievert No.2942, have an inner diameter of 29 mm and are connected to two gas cylinders. A pressure sensor of type Swagelock was used in order to record the tube internal pressure during the test. The temperatures of the flame (Thermocouple 1), tube (Thermocouple 2 and 3) and water (Thermocouple 4) were measured continuously along the fire test using four K-type thermocouples (cf. figure 3). These thermocouples were held in place using a device as illustrated in Fig. 2. These thermocouples were connected to a temperature data logger referenced as Testo 177-T4.

The E glass/VE 411 composite tube was completely filled with water. Afterwards, it was placed horizontally on the two V-shaped supports to be exposed to heat flux for 30 min. It is worth noting that the test duration corresponds to the time required for the evacuation of the people when a fire starts. The specimen was maintained at a distance of 125 mm above the burners. The ends of the tube were closed. One of the

ends was connected to a manual pump (SKF). A relief valve was placed on the other end closure to maintain the pressure of the specimen at 3 ± 0.5 bars during the test following IMO resolution instructions.

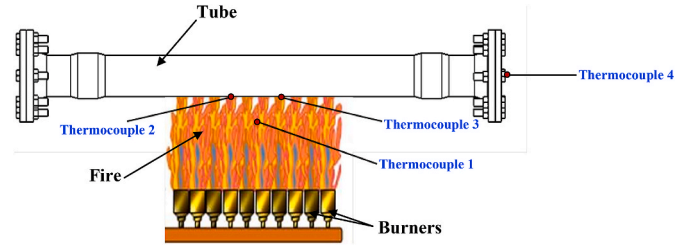
Fig. 3. Schematic view of the tube instrumentation by thermocouples during the fire endurance tests.

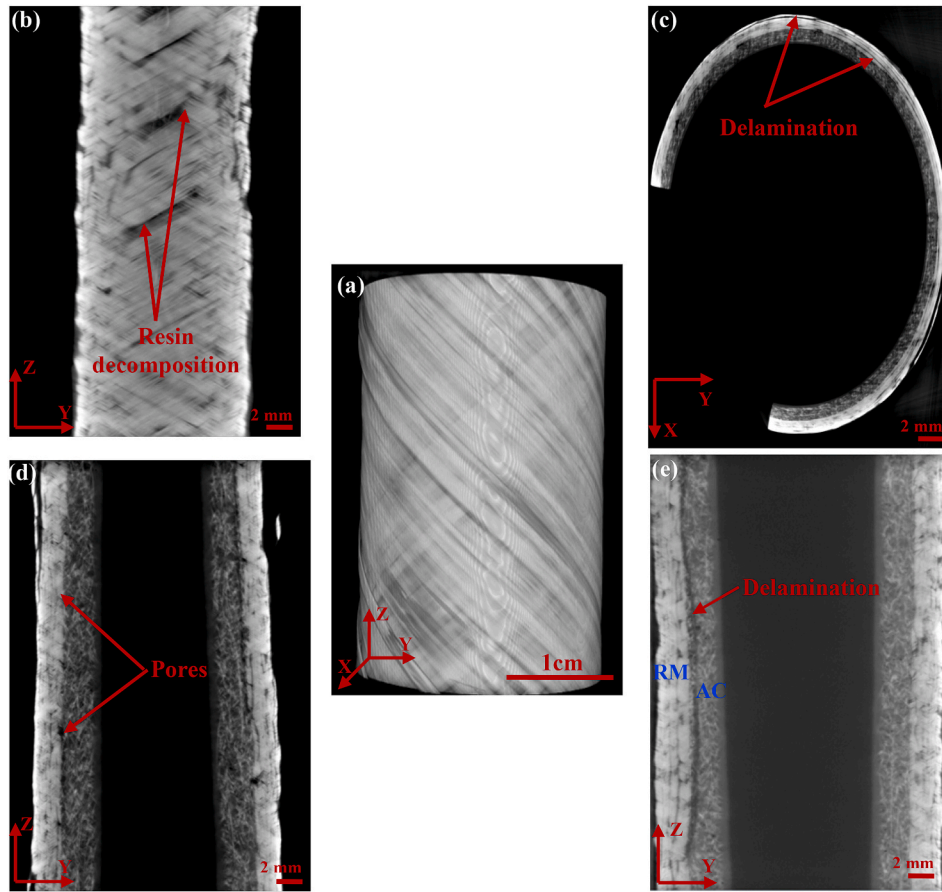
Fig. 8. X-ray tomographic images of burnt E glass/Vinylester 411 composite tube showing the fire induced damage. With (a) 3D image, (b) Resin decomposition, (c) Delamination between the tube plies, (d) Pores, and (e) Delamination between AC and RC plies.

To further understand the fire-induced damage through the composite tube thickness, a non-destructive x-ray tomography technique was carried-out. Fig. 8 illustrates the X-ray tomographic images of the E glass/VE411 composite tube subsequent to the fire test. These post-mortem observations clearly show the resin amount variation through the thickness direction. From Fig. 8-b, it can be observed that the tube surface exposed directly to fire is the first zone to decompose to char at a temperature of 375 °C as illustrated in Fig. 4-d. Albeit, it was found that below this zone, the matrix is partially degraded. Moreover, the delamination phenomenon either between the tube plies (Fig. 8-c) or the anti-corrosion and the mechanical layer (Fig. 8-e) was detected. It is important to mention that compared to other failure mechanisms such as char formation and matrix cracking, the delamination phenomenon is dominating. Referring to Fig. 8-d, the presence of the pores in the resin layer was noticed. This can be explained by the loss of mass of the thermoset resin resulting from the pyrolysis phenomenon taking place after 44s as it was differed from visual observations (Fig. 5-b). This result is in accordance with TGA outcomes.

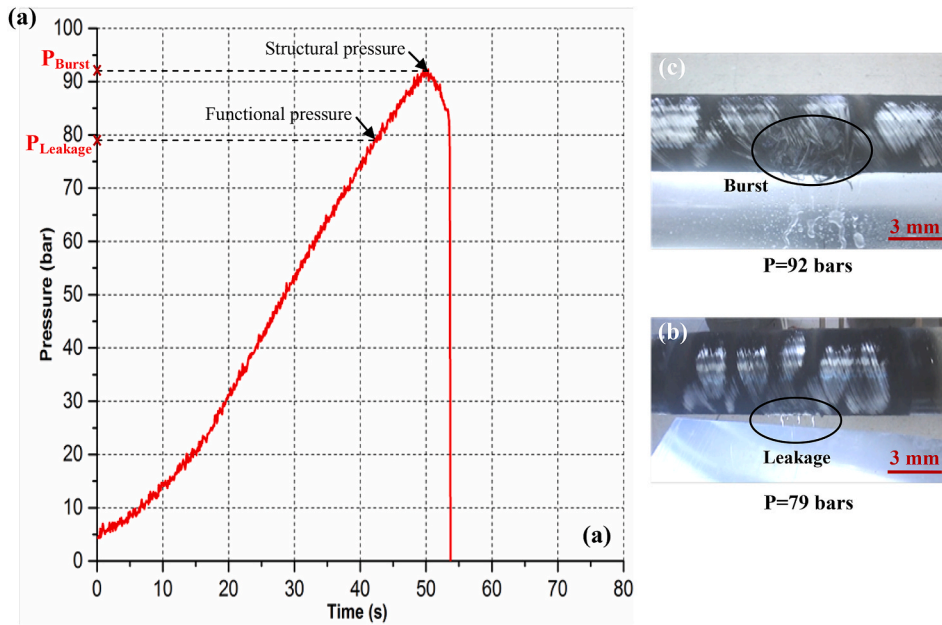
Fig. 9. Internal pressure test until failure. With (a) Pressure-time response of the burnt composite tube under pressure loading, (b) Tube leakage and (c) Tube burst.

Fig. 9-a illustrates the pressure evolution of the E glass/VE411 composite tube during the internal pressure test until failure. From this figure, it can be witnessed that the pressure increases gradually until reaching a value of 79 bars. At this level, water leakage on the burnt tube outer wall was observed (cf. figure 9-b). It can be inferred that the leakage occurrence is mainly related to the growth of cracks caused by fire. These cracks appear mainly due to the delamination taking place between the different layers of the tube. These cracks propagate as the internal pressure rises inside the tube. Consequently, the leakage takes

place on the tube surface exposed directly to fire. The continuous increase of the pressure leads to the tube burst. The burnt tube lost its strength for an applied pressure of about 92 bars as witnessed in Fig. 9-c. This burst results from the matrix and fiber failure (cf. figure 9-c). Beyond the maximum reached pressure (92 bars), it can be clearly seen that the tube pressure decay.

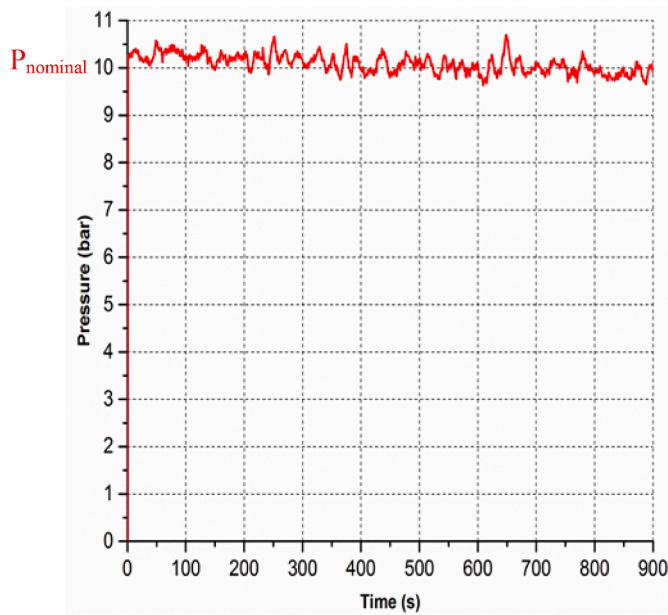
Fig. 10. Hydrostatic test conducted on E glass/Vinylester composite tube after the fire endurance test.

Regarding the hydrostatic test, the burnt composite tube was subjected to its nominal pressure of about 10 bars. Following the IMO resolution and NF EN ISO 14692-2 standard instructions, this pressure should be held for 15 min as illustrated in Fig. 10. During these 15 min, no leakage was detected on the burnt tube outer surface even with the various types of localized fire damage. This result is in accordance with the internal pressure tests until leakage results presented above ($P_{leakage} = 79$ bars). From this experimental inspection, it can be inferred that the E glass/Vinylester 411 composites' tubes are able to contain the liquid in the fire situation for 30 min. Moreover, they are classified under the EA category for the NF EN ISO 14692-2 standard. The EA category confirms that the tubes are working in the safe zone ensuring protection for the offshore staff in extreme accident such as fire, and allowing enough time for their evacuation (referring to IMO standard).

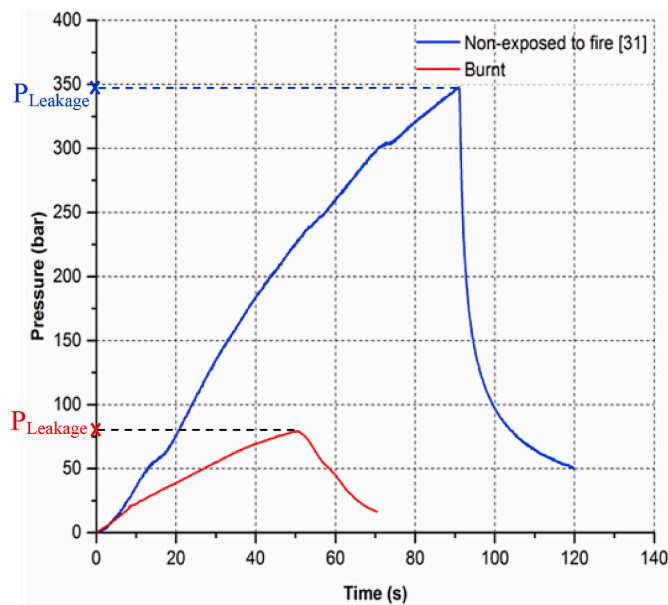
Fig. 11. Comparison between the pressure evolution of the non-exposed to fire and the burnt single composite tube made of E glass fiber reinforced VE411 resin.

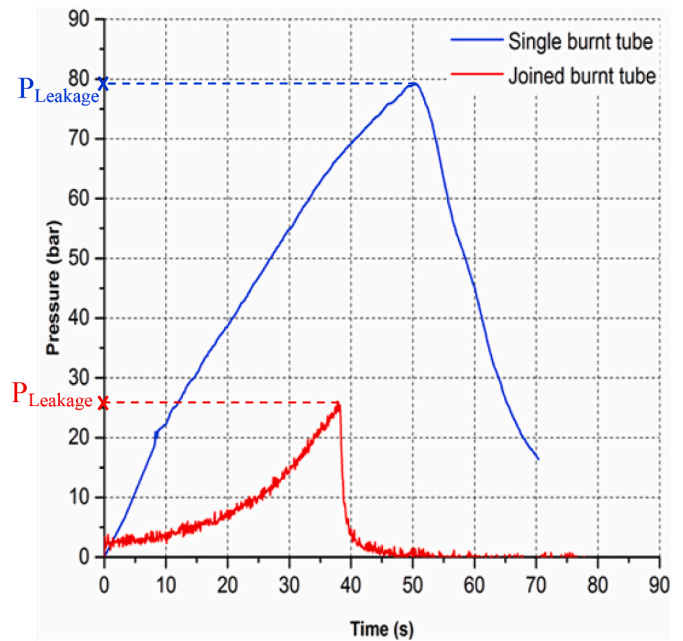
Fig. 13. Comparison between the pressure evolution of the single burnt tube and the joined burnt tube made of E glass/VE411 resin.

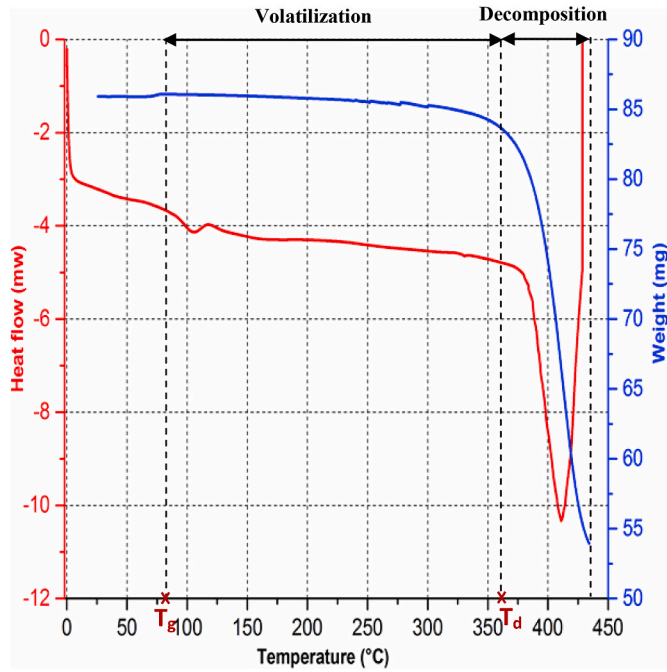
Fig. 15. DSC and TGA test results of E glass reinforced Vinylester 411 composite.

generation rate as well as the weight losses. The results of DSC (heat flow) and TGA (weight losses) are depicted in Fig. 15.

It has been proved through experimental outcomes that the chemical changes of GFRP are present in two zones namely volatilization

[78°C–367 °C] and decomposition [367°C–430 °C] as illustrated in Fig. 15. It has been found that the VE 411 glass transition temperature is equal to 78 °C. Beyond this value, it is worth noting a small weight loss of the specimen. This mass decrease can mainly be attributed to the

A pronounced endothermic peak was recorded at 410°C . In fact, additional heat is needed in order to break the bonds within molecular chains [48].

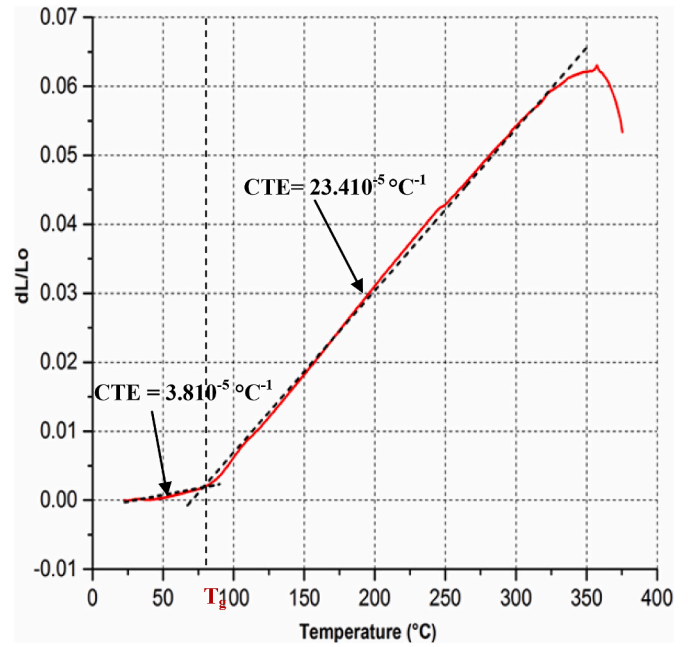
Fig. 16. TMA test result of E glass/Vinylester 411 composite.

Fig. 16 illustrates the TMA result of the E glass/VE411 composite. This figure reveals that the curve slope increases as the temperature varies from 22°C to 430°C . It is indeed essential to mention that the curve slope presents the thermal expansion coefficient (CTE) of the composite. The $\frac{dl}{l_0}$ versus temperature curve denotes an abrupt change in the curve slope around the glass transition temperature (T_g). It was found that the CTE was $3.810^{-5}^\circ\text{C}^{-1}$ below the T_g and increases to reach $23.410^{-5}^\circ\text{C}^{-1}$ above this temperature.

The increase in the curve slope can be explained by the thermal expansion of the specimen. When the composites are exposed to fire, the pyrolysis phenomenon takes place. It follows that gases are released from the VE411 resin decomposition. As the temperature rises, the generation rate of the gases increase. These gases are mainly absorbed by the composite. Consequently, the internal pressure build-up in the sample is witnessed. Afterwards, the specimen begins to contract at $T = 357^\circ\text{C}$. This phenomenon is attributed to char formation which reacts as

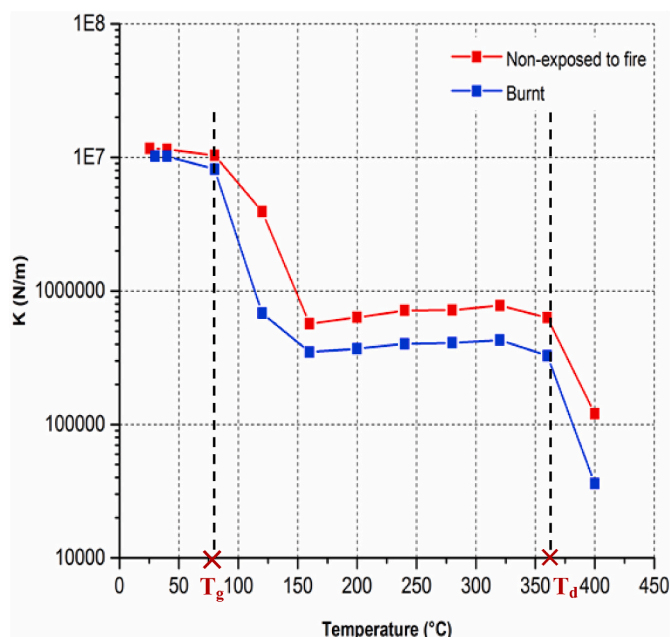
Fig. 17. DMA result of E glass/Vinylester 411 resin composite.

The degradation of the mechanical properties of both non-exposed to fire and burnt composite tube has also been studied by means of DMA tests. Fig. 17 shows the comparison of stiffness evolution with respect to temperature in both non-exposed to fire and the burnt specimens when the temperature increases from 25°C to 400°C. The comparison between the two curves reveals that the stiffness of the non-exposed to fire specimen presents a higher value compared to the burnt tube. The analysis of this curve shows a steep decrease in the stiffness values of both non-exposed to fire and burnt composite samples above the glass

transition temperature (T_g). Subsequently, it was noticed that the stiffness is almost constant in the temperature range of 150°C–367°C. Above the degradation temperature ($T = 367^\circ\text{C}$), a rapid decrease in stiffness was observed. The degradation of the mechanical properties with respect to increase in temperature was mainly related to the resin degradation. This result is in accordance with the internal pressure tests until failure, presented in section 3.1.1, which proved that the non-exposed to fire tube can withstand higher pressure than the burnt one.

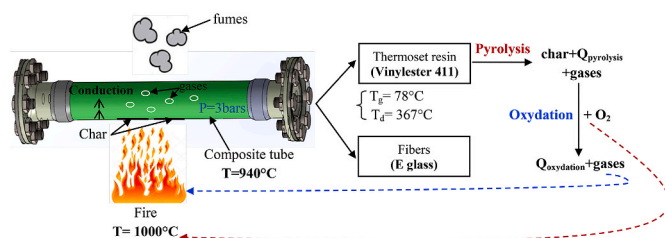
Fig. 18. Chemical processes of E glass/Vinylester 411 tube under fire.

In summary, it can be inferred, through thermal analyses, that tremendous chemical and physical processes are involved during the fire endurance test of the E glass/VE 411 composite tube as witnessed in Fig. 18. Indeed, when the tube is exposed to fire its temperature rises by conduction until reaching the glass transition temperature ($T_g = 78^\circ\text{C}$). At this stage, moisture volatilization is also noticed. As the temperature

increases, the Vinylester 411 resin begins to decompose at $T_d = 367^\circ\text{C}$ with char formation as well as gases and fumes are released. Consequently, a resin mass loss was recorded. A part of the released gas was absorbed by the material leading to the tube expansion. Moreover, it was proved through DMA tests that the mechanical properties of the tube are degraded.
