**Multi-scale analysis of the generated damage when machining pockets of 3D woven composite for repair applications using abrasive water jet process: Contamination analysis**

# Multi-scale analysis of the generated damage when machining pockets of 3D woven composite for repair applications using abrasive water jet process: Contamination analysis

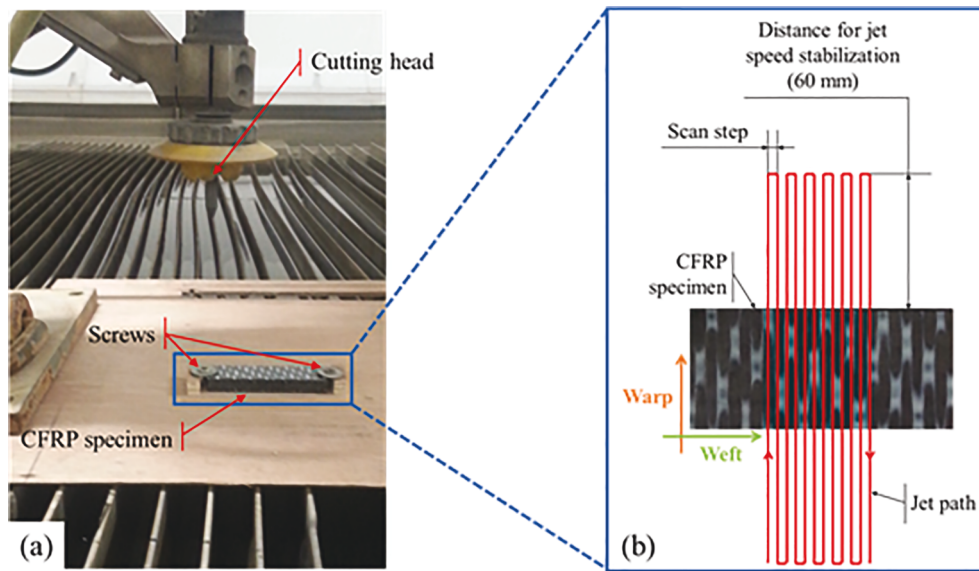
Fig. 2. (a) Set up of the machining operations and (b) Schematic top view of the milling path strategy. (For interpretation of the references to colour in this figure legend, the reader is referred to the web version of this article.)

Because of the lightness of the specimens, they needed to be clamped on the machining table so the water swirl did not make them move (cf. Fig. 2a). A raster scan pattern was considered as the pocket milling path with a machining direction parallel to the specimen's width. To avoid the disparity of erosion due to the speed variations, the changes of milling direction occurred outside the specimens (cf. Fig. 2b). With this safety distance of 60 mm, the traverse speed is stabilized throughout the milling process.

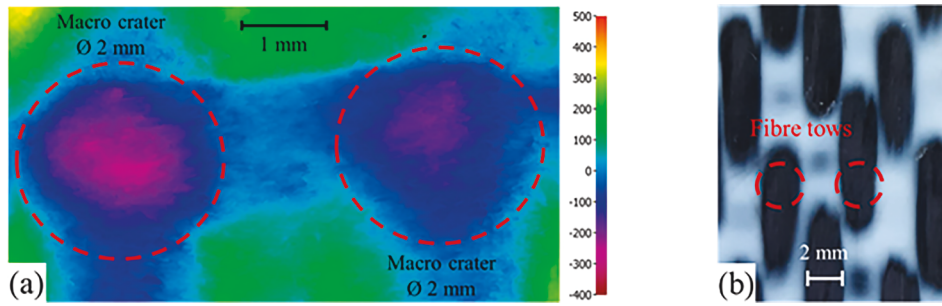
Fig. 6. (a) Topography image showing macro crater on the AWJ milled surface [ $P = 98 \text{ MPa}/SS = 0.5 \text{ mm}/V = 2 \text{ m}/\text{min}$ ] and (b) dimension of a single fibre tow in the 3D woven architecture. (For interpretation of the references to colour in this figure legend, the reader is referred to the web version of this article.)

work conducted by Hejjaji et al. [22], the milling zone concerns all the top surface of the specimens. In this case, the removal of some plies can modify the balance in the composite lay-up and then favour the distortion of the specimens. In addition, in the present study, the 3D weaving architecture leads to avoid this imbalance leading to flat surfaces. The material removal during AWJ milling is mainly by means of micro erosion caused by solid particle impact. This physical interaction between abrasive particles and the composite workpiece gives rise to a modified surface with several kinds of localised surface flaws. Therefore, Scanning Electron Microscope (SEM) was used to observe and identify various machining induced defects on the surface. However, the most prominent defect that was observed was large craters on the machined surface, which was visible to the naked eye and having an average diameter of 2 mm (cf. Fig. 6a). It is to be noted that these macro craters (red dotted circles in Fig. 6a) are created due to the fibre weaving architecture of the 3D composite. Contrarily to what is expected, the fibre tows (red dotted circles in Fig. 6b) on the 3D composite are more easily eroded by the AWJ than the white resin rich areas, hence giving rise to a crater of the similar size. This is due to the fact that the fibre tows are constitutive of discrete entities (fibres) which are easily broken by the abrasive particles. In this case, the material is removed by steps which depth is equal to the fibres diameter. On the opposite, the resin rich regions of the specimens (white zones in Fig. 6b) act like an homogeneous material which has to be eroded and/or cut.

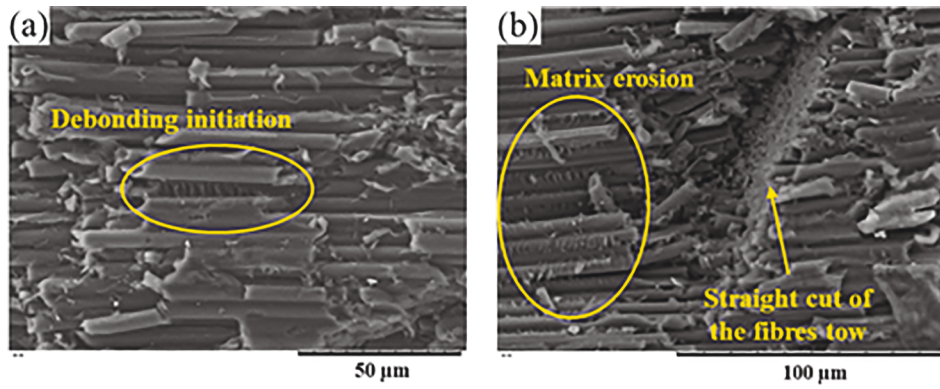
Fig. 9. SEM images showing (a) fibre-matrix debonding and (b) matrix erosion on the AWJ milled surface. (For interpretation of the references to colour in this figure legend, the reader is referred to the web version of this article.)

Apart from these major defects matrix erosion and fibre matrix debonding was observed in some specimens (cf. Fig. 9). The occurrence of these defects was related to the jet traverse speed. As the jet traverse speed increased, the presence of debonding and matrix erosion was predominant. Similar results were reported by Hejjaji et al. [22] and it was attributed to the fact that the jet-workpiece interaction time is greatly reduced at higher traverse speeds. Hence the energy transfer time available to the abrasive particles is less, which means the jet stream is unable to remove the fibres effectively. However, the matrix being softer than the carbon fibres, comparatively lesser energy (only water) is enough to erode it. Therefore, at higher jet traverse speeds greater presence of debonding and matrix erosion is observed.

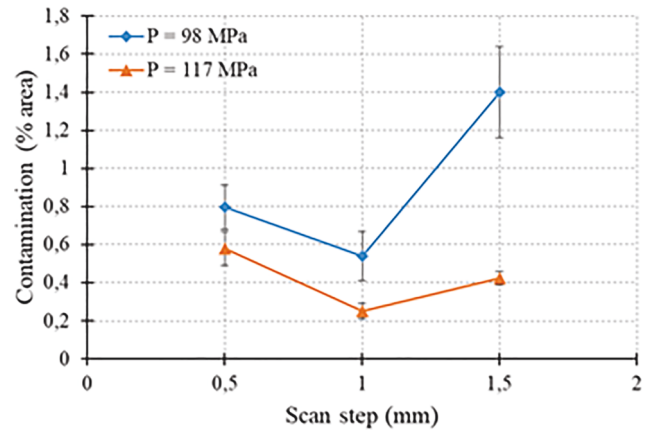
**Fig. 13.** Effect of the scan step on the percentage of contaminated area when machining is done with jet pressure of 98 MPa and 117 MPa and at traverse speed of 4 m/min. (For interpretation of the references to colour in this figure legend, the reader is referred to the web version of this article.)

The Fig. 12 suggests that contamination increases with increasing scan step. However, a closer investigation by plotting the complete range of scan steps used for the studies reveals a different outcome. From the Fig. 13, it is clearly seen that the least contamination is obtained

when using a scan step of 1 mm irrespective of the pressure. As explained in Section 2.2, the effective jet diameter is considered to be close to the nozzle diameter used for the machining, which is 1.016 mm. Therefore, when the scan step is 1 mm, the adjacent jet traverse paths just brush each other and there is no overlapping or exclusion of the workpiece surface. Consequently, when the primary jet is removing material in its path, the secondary jet will be flushing out loosely embedded particles in the previous adjacent jet path leading to a lower contamination levels. However, when a scan step of 0.5 mm or 1.5 mm is considered, the adjacent jet paths overlap and isolate respectively. When the jet paths overlap ( $SS = 0.5$  mm), milling occurs on already machined surface, leading to aggravate the formation of cracks and micro-craters where abrasive particle embedment occurs. Whereas, when the jet paths isolate each other ( $SS = 1.5$  mm), the excluded region is mainly machined by the secondary jet which mostly erodes the matrix and creates crevices leading to abrasive particle embedment. In addition, due to the increased distance between adjacent traverse paths, the secondary jet would be weaker at that distance and the flushing action is ineffective. Hence, a higher jet pressure and scan step equal to the primary jet diameter is recommend for reducing abrasive particle contamination.
