Multi-scale analysis of the generated damage when machining pockets of 3D woven composite for repair applications using abrasive water jet process: Contamination analysis

Xavier Sourd, Redouane Zitoune, Akshay Hejjaji, Mehdi Salem, Laurent Crouzeix, D. Lamouche

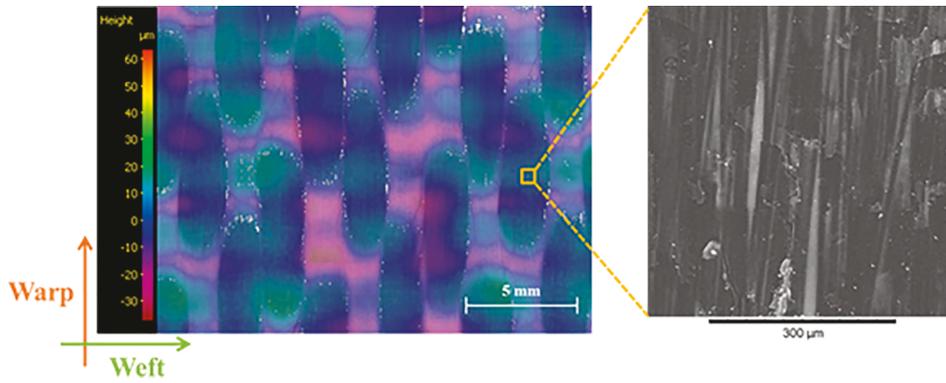
Fig. 1. Mixed view (optical and 3D topography) of the 3D woven CFRP composite plate. (For interpretation of the references to colour in this figure legend, the reader is referred to the web version of this article.)

work conducted by Hejjaji et al. [22], the milling zone concerns all the top surface of the specimens. In this case, the removal of some plies can modify the balance in the composite lay-up and then favour the distortion of the specimens. In addition, in the present study, the 3D weaving architecture leads to avoid this imbalance leading to flat surfaces. The material removal during AWJ milling is mainly by means of micro erosion caused by solid particle impact. This physical interaction between abrasive particles and the composite workpiece gives rise to a modified surface with several kinds of localised surface flaws. Therefore, Scanning Electron Microscope (SEM) was used to observe and identify various machining induced defects on the surface. However, the most prominent defect that was observed was large craters on the machined surface, which was visible to the naked eye and having an average diameter of 2 mm (cf. Fig. 6a). It is to be noted that these macro craters (red dotted circles in Fig. 6a) are created due to the fibre weaving architecture of the 3D composite. Contrarily to what is expected, the fibre tows (red dotted circles in Fig. 6b) on the 3D composite are more easily eroded by the AWJ than the white resin rich areas, hence giving rise to a crater of the similar size. This is due to the fact that the fibre tows are constitutive of discrete entities (fibres) which are easily broken by the abrasive particles. In this case, the material is removed by steps which depth is equal to the fibres diameter. On the opposite, the resin rich regions of the specimens (white zones in Fig. 6b) act like an homogeneous material which has to be eroded and/or cut.

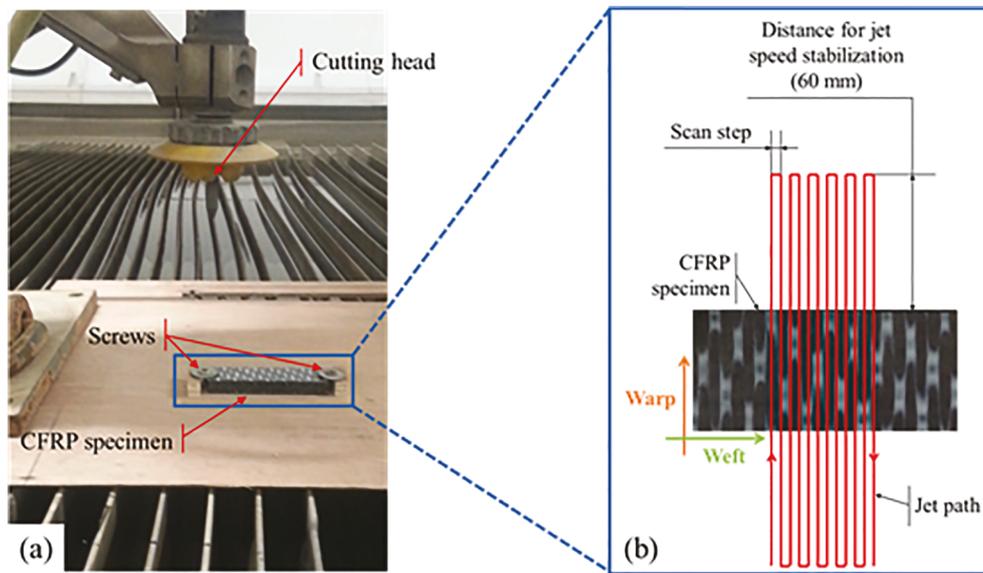
Fig. 2. (a) Set up of the machining operations and (b) Schematic top view of the milling path strategy. (For interpretation of the references to colour in this figure legend, the reader is referred to the web version of this article.)

Because of the lightness of the specimens, they needed to be clamped on the machining table so the water swirl did not make them move (cf. Fig. 2a). A raster scan pattern was considered as the pocket milling path with a machining direction parallel to the specimen's width. To avoid the disparity of erosion due to the speed variations, the changes of milling direction occurred outside the specimens (cf. Fig. 2b). With this safety distance of 60 mm, the traverse speed is stabilized throughout the milling process.

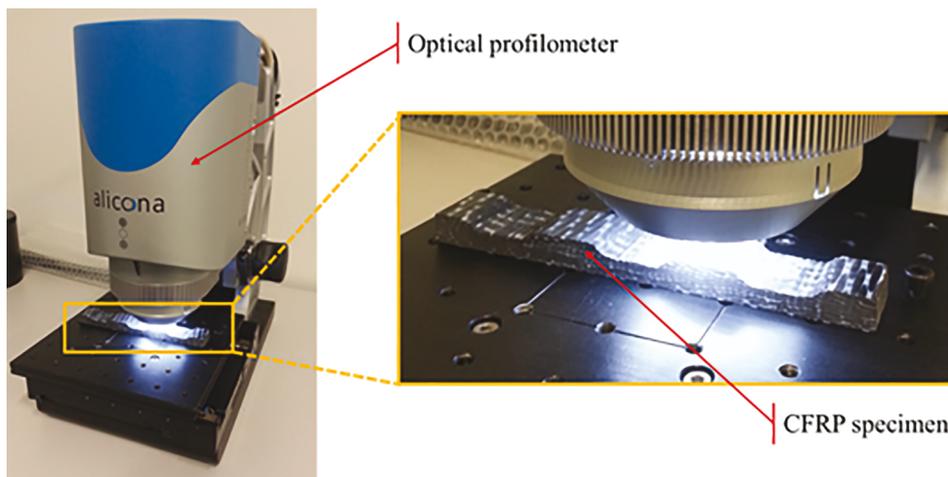
Fig. 3. Optical profilometer used for the topographies acquisition. (For interpretation of the references to colour in this figure legend, the reader is referred to the web version of this article.)

The topography of all the pockets were made thanks to optical profilometer Infinite Focus SL from Alicona (cf. Fig. 3) The measurements are performed with a technique called focus variation, acquiring the coordinates of each pixel centre of the scanned area by autofocus along the device's optical axis. Table 2 gathers the parameters used for the different measurements. The selected parameters allow a good compromise between acquisition precision (0.1 µm) and time (around 15 min for each scan).

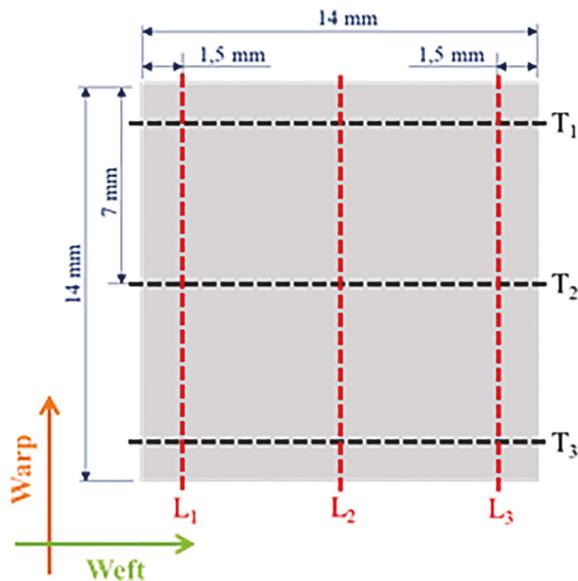
Fig. 4. Schematic view to illustrate the location of 2D profiles extraction for the Ra and Wa measurement from the topologies of machined surfaces (14×14 mm) for both directions “warp” (L_1 to L_3) and “weft” (T_1 to T_3). (For interpretation of the references to colour in this figure legend, the reader is referred to the web version of this article.)

correlated with SEM images for identification and quantification of the surface damage. Moreover, some measurements with classical surface quality (surface roughness R_a and waviness W_a) have also been made from the topologies using the software provided by Alicona. Each line detailed on Fig. 4 corresponds to 10 profiles separated by $4 \mu\text{m}$. Two sets of three measurements have been performed, respectively in the warp direction along the jet path (L_1 to L_3) and in the weft direction perpendicularly to the jet path (T_1 to T_3). A Gaussian filter, with a cut-off length of 2.5 mm , has been used to separate the roughness from the waviness. The surface roughness and waviness in the warp (R_{aL} and

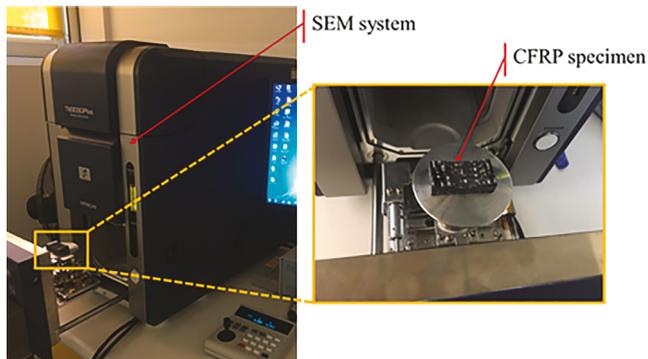
Fig. 5. Scanning Electron Microscope used for the observations of the milled surfaces. (For interpretation of the references to colour in this figure legend, the reader is referred to the web version of this article.)

Scanning electron microscope (SEM) was used to find and identify various machining induced defects on the machined surface (cf. Fig. 5). SEM images obtained from secondary electron (SE) sensor at different magnification levels was used to identify the nature and form of various defects, in addition, back scattered electron (BSE) images were used to highlight the presence of abrasive particles stuck on the machined surface. Indeed, the BSE sensor differentiates various elements present on the studied surface based on their atomic number and hence produces a grey scale image of the surface where elements with lower atomic numbers are darker and vice versa. Based on the processing of these BSE images (ImageJ software), the contaminated area by the abrasive particles has been quantified which represents the ratio between the area taken up by the particles over the total area analysed by SEM viz. $5 \text{ mm} \times 5 \text{ mm}$ which is considered as wide enough to capture the tow and resin rich regions.

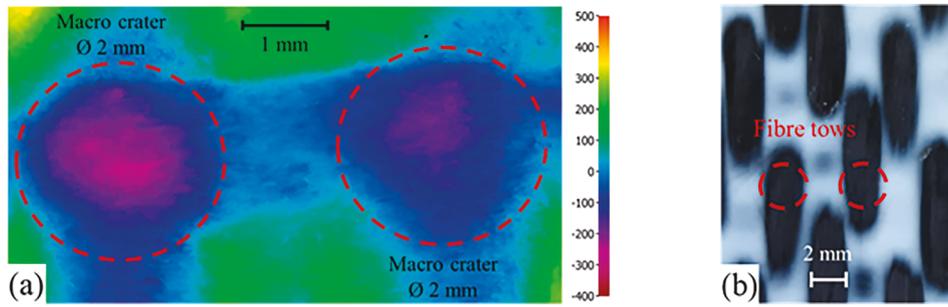
Fig. 6. (a) Topography image showing macro crater on the AWJ milled surface [$P = 98 \text{ MPa}/SS = 0.5 \text{ mm}/V = 2 \text{ m/min}$] and (b) dimension of a single fibre tow in the 3D woven architecture. (For interpretation of the references to colour in this figure legend, the reader is referred to the web version of this article.)

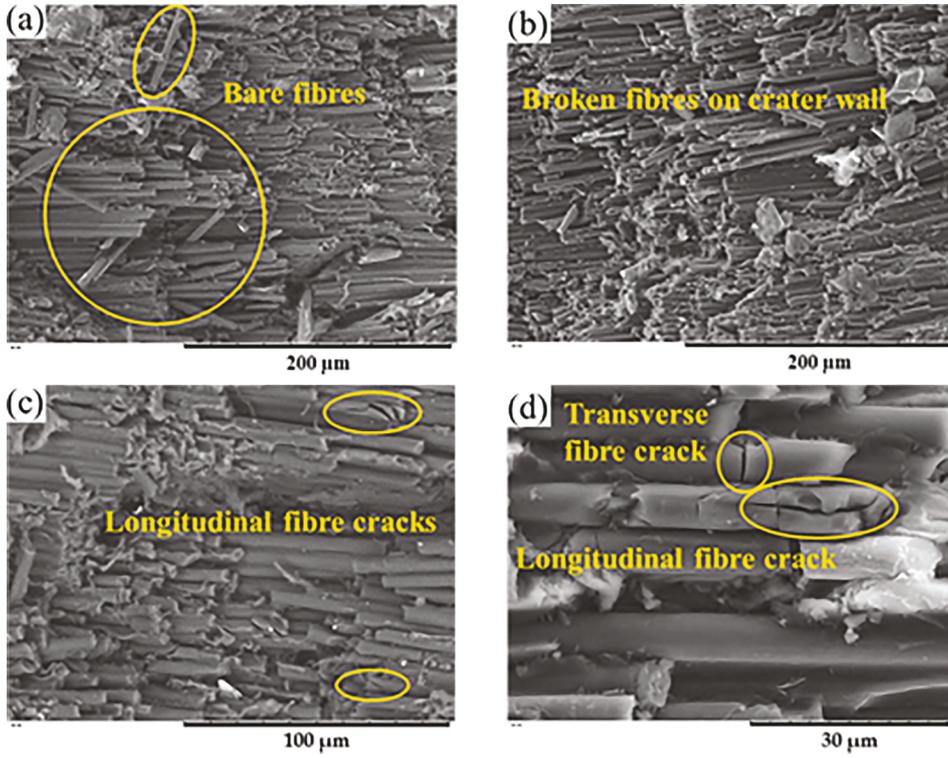
Fig. 7. Different kinds of microscopic defects on the AWJ milled surface, (a) Bare/exposed fibres, (b) broken fibres along the macro crater wall, (c) & (d) longitudinal and transverse fibre cracks. (For interpretation of the references to colour in this figure legend, the reader is referred to the web version of this article.)

Further, high magnification SEM analysis of the machined surface reveals several other micro size defects. The most prominent micro defect was bare and broken fibres. This defect was found across all specimens irrespective of the machining parameters. The bare fibres are the exposed fibre filaments due to removal of the matrix (cf. Fig. 7a). In addition, broken fibres were found all across the surface, especially near the walls of the macro craters (cf. Fig. 7b). Some fibres were broken due to longitudinal and transverse cracks (cf. Fig. 7c & d). By having a closer look on Fig. 7d, it can be noticed that some fibres are chipped, probably indicating the origin of particles impact. Cracks being located at the vicinity of these impact zones, it may be considered that they are the results of several smaller cracks, originating from these impact zones, which have merged. It has to be noted that Pahuja & Ramulu [46] also noticed exposed fibres as well fibre breaking in case of machining randomly chopped discontinuous fibre composites by abrasive water jet. This material is characterised, as it is the case in the present study, by resin rich regions.

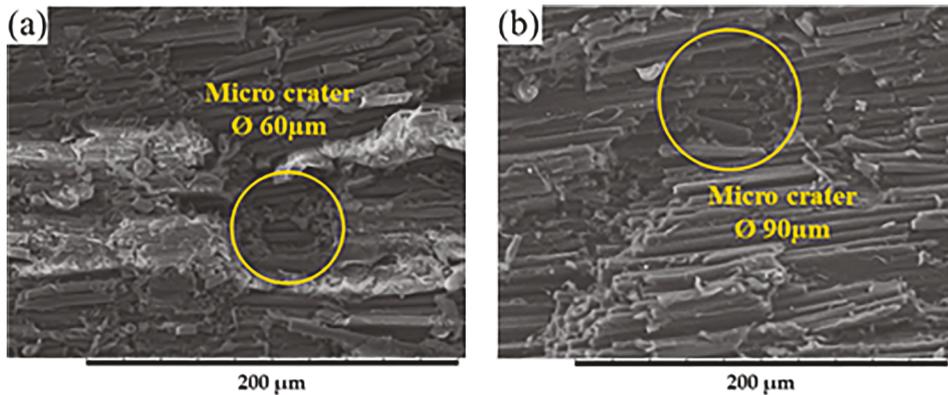
Fig. 8. SEM images showing craters of several sizes on the AWJ milled surface. (For interpretation of the references to colour in this figure legend, the reader is referred to the web version of this article.)

Another major defect observed was microscopic craters, which can be termed as micro craters in order to differentiate from large craters (cf. Fig. 8). SEM analysis revealed that diameter of these microscopic craters ranged between of 80 μm and 200 μm and were randomly distributed across the machined surface irrespective of the machining parameters. They were also found on the bottom surface of the macro craters. These micro craters can form stress concentration zones and can be detrimental to the material integrity of the machined component.

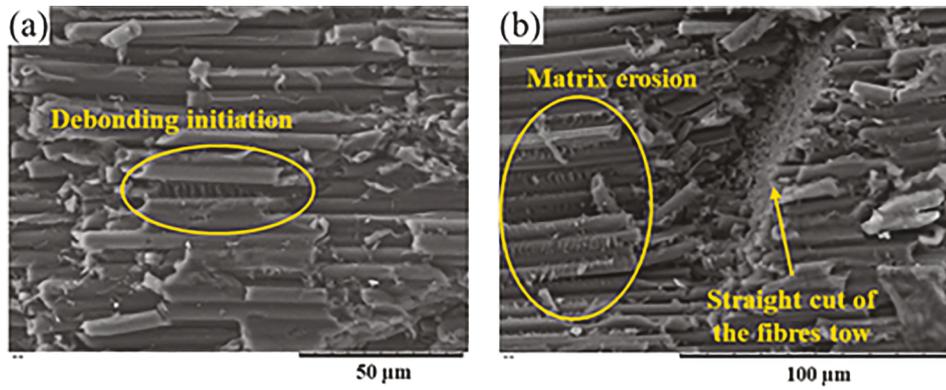
Fig. 9. SEM images showing (a) fibre-matrix debonding and (b) matrix erosion on the AWJ milled surface. (For interpretation of the references to colour in this figure legend, the reader is referred to the web version of this article.)

Apart from these major defects matrix erosion and fibre matrix debonding was observed in some specimens (cf. Fig. 9). The occurrence of these defects was related to the jet traverse speed. As the jet traverse speed increased, the presence of debonding and matrix erosion was predominant. Similar results were reported by Hejjaji et al. [22] and it was attributed to the fact that the jet-workpiece interaction time is greatly reduced at higher traverse speeds. Hence the energy transfer time available to the abrasive particles is less, which means the jet stream is unable to remove the fibres effectively. However, the matrix being softer than the carbon fibres, comparatively lesser energy (only water) is enough to erode it. Therefore, at higher jet traverse speeds greater presence of debonding and matrix erosion is observed.

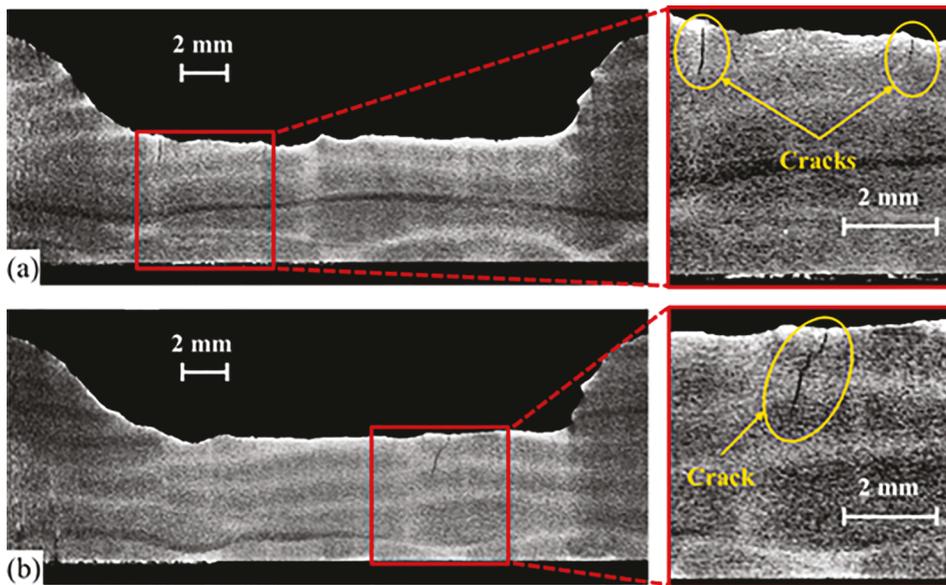
Fig. 10. X-ray tomography images showing cracks perpendicular to the surface throughout the milled zone close to both the free edges (a) and (b) of the specimens [$P = 156 \text{ MPa}/SS = 0.5 \text{ mm}/V = 4 \text{ m/min}$]. (For interpretation of the references to colour in this figure legend, the reader is referred to the web version of this article.)

In addition, the X-ray tomography images have highlighted the presence of cracks up to 2 mm long which are perpendicular to the machined surface (cf. Fig. 10). It has to be noticed that these cracks are located close to the free edges of the specimens, were the jet enters the material. The analysis of the X-Ray images also reveals that the

propagation depth of the cracks within the specimens is around 3 mm. As the cracks have been found along the pocket's free edge, it can be concluded that these defects originate from the entrance and exit of the water jet within the material during milling. No such defects have been found neither on the machined surface, nor along the free edges far from the pockets, which supports this conclusion.

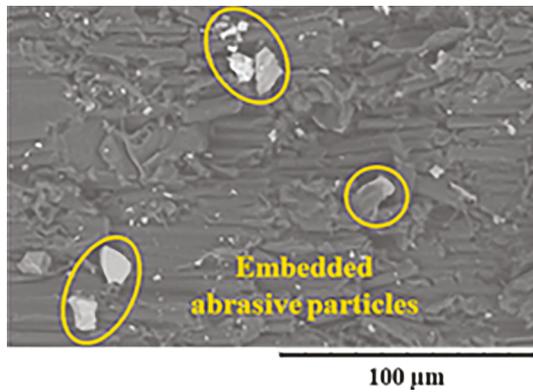
Fig. 11. Contamination of the milled surface by abrasive particles embedment [$P = 98$ MPa/ $SS = 1.5$ mm/ $V = 4$ m/min]. (For interpretation of the references to colour in this figure legend, the reader is referred to the web version of this article.)

regions and the crevices formed between carbon fibres [46,47]. To investigate this phenomenon, scanning electron microscopy (SEM) was used in the back scattered electron (BSE) mode, where the obtained images show various levels of brightness depending on the atomic number of the element present. Hence, the heavier abrasive particles (containing Si and Al) appear lighter/brighter than the surrounding carbon fibres or matrix (cf. Fig. 11). Also, it can be noticed that the embedded abrasive particles (light areas in the Fig. 11) are smaller than the initial diameter of $125 \mu\text{m}$ (#120) and has sharp edges indicating that these are the fragments formed due to interactions inside the mixing chamber or after impacting the workpiece. Similar observations have been performed by Fowler et al. [33] in case of machining titanium alloy. The SEM-BSE images indicated that the smaller particles are embedded in between the fibres and cracks whereas larger ones are inside the micro craters. In the context of composite repair, the milled surface will be the parent surface on with the repair plies will be bonded using a suitable adhesive and when such contamination is present on the bonding surface it can lead to poor bonding and hence an inferior quality repair. Contrarily to metallic materials, a post-machining plain waterjet cleaning process cannot be performed on composite materials because of the great sensibility of the matrix to the water erosion [21,31] and only pressurized air can be used in order to remove the loose and lightly

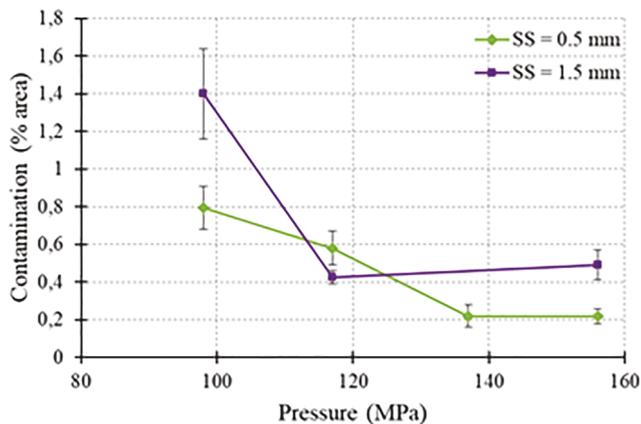
Fig. 12. Effect of the jet pressure and scan step on the percentage of contaminated area when machining is done with traverse speed of 4 m/min. (For interpretation of the references to colour in this figure legend, the reader is referred to the web version of this article.)

The effect of jet pressure and scan step on the abrasive particle contamination when machining at a traverse speed of 4 m/min is presented in the Fig. 12. It is clearly noticed that an increase in jet pressure induces lower levels of surface contamination. Indeed, at a scan step of 0.5 mm, the percentage of contaminated area drops from 0.8% to 0.2% for jet pressures of respectively 98 MPa and 137 MPa. From the flow mechanics studies, it is known that the abrasive water jet has two components: a primary jet which is the effective jet that carries abrasive particles and a secondary jet which is mostly water. This secondary jet does not contain abrasive particles and does not contribute to any cutting action. However, it aids in water erosion of the softer matrix material, meanwhile it also flushes the loose abrasive particles embedded in the matrix. Hence, with increasing pressure the flushing action of secondary jet increases too, reducing the contamination.

The Fig. 12 suggests that contamination increases with increasing scan step. However, a closer investigation by plotting the complete range of scan steps used for the studies reveals a different outcome. From the Fig. 13, it is clearly seen that the least contamination is obtained

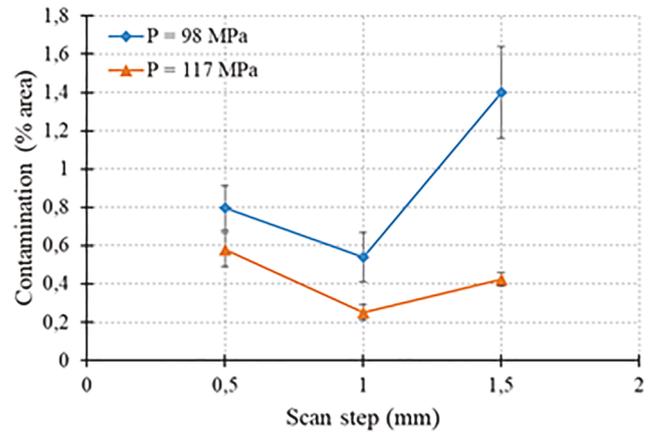
Fig. 13. Effect of the scan step on the percentage of contaminated area when machining is done with jet pressure of 98 MPa and 117 MPa and at traverse speed of 4 m/min. (For interpretation of the references to colour in this figure legend, the reader is referred to the web version of this article.)

when using a scan step of 1 mm irrespective of the pressure. As explained in Section 2.2, the effective jet diameter is considered to be close to the nozzle diameter used for the machining, which is 1.016 mm. Therefore, when the scan step is 1 mm, the adjacent jet traverse paths just brush each other and there is no overlapping or exclusion of the workpiece surface. Consequently, when the primary jet is removing material in its path, the secondary jet will be flushing out loosely embedded particles in the previous adjacent jet path leading to a lower contamination levels. However, when a scan step of 0.5 mm or 1.5 mm is considered, the adjacent jet paths overlap and isolate respectively. When the jet paths overlap ($SS = 0.5$ mm), milling occurs on already machined surface, leading to aggravate the formation of cracks and micro-craters where abrasive particle embedment occurs. Whereas, when the jet paths isolate each other ($SS = 1.5$ mm), the excluded region is mainly machined by the secondary jet which mostly erodes the matrix and creates crevices leading to abrasive particle embedment. In addition, due to the increased distance between adjacent traverse paths, the secondary jet would be weaker at that distance and the flushing action is ineffective. Hence, a higher jet pressure and scan step equal to the primary jet diameter is recommend for reducing abrasive particle contamination.

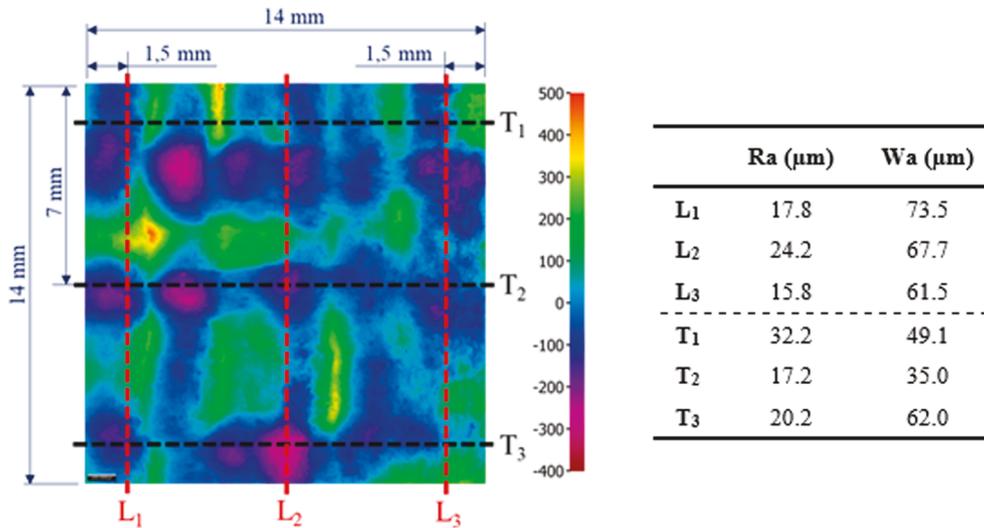
Fig. 14. Topography and surface parameters (Ra, Wa) of a milled specimen [$P = 98 \text{ MPa}/SS = 0.5 \text{ mm}/V = 2 \text{ m/min}$]. (For interpretation of the references to colour in this figure legend, the reader is referred to the web version of this article.)

When dealing with surface quality, surface roughness (R_a) and waviness (W_a) are the most commonly used parameters. In the current study, this approach is not relevant as shown from Fig. 14. Each line detailed on the picture corresponds to 10 profiles separated by 4 μ m and the results are mean values obtained with a cutting length of 2.5 mm. A great disparity within the results, depending on the measured area and the direction of scanning, has been observed. Indeed, surface roughness and waviness of the machined surface vary respectively from 15.8 to 24.2 μ m and 61.5 to 73.5 μ m when measuring along the jet path (L_1 to L_3). Furthermore, in case of measuring perpendicularly to the jet path (T_1 to T_3), surface roughness and waviness vary respectively from 17.2 to 32.2 μ m and from 35.0 to 62.0 μ m. These scattered values can be mainly attributed to the weaving architecture of the specimen.

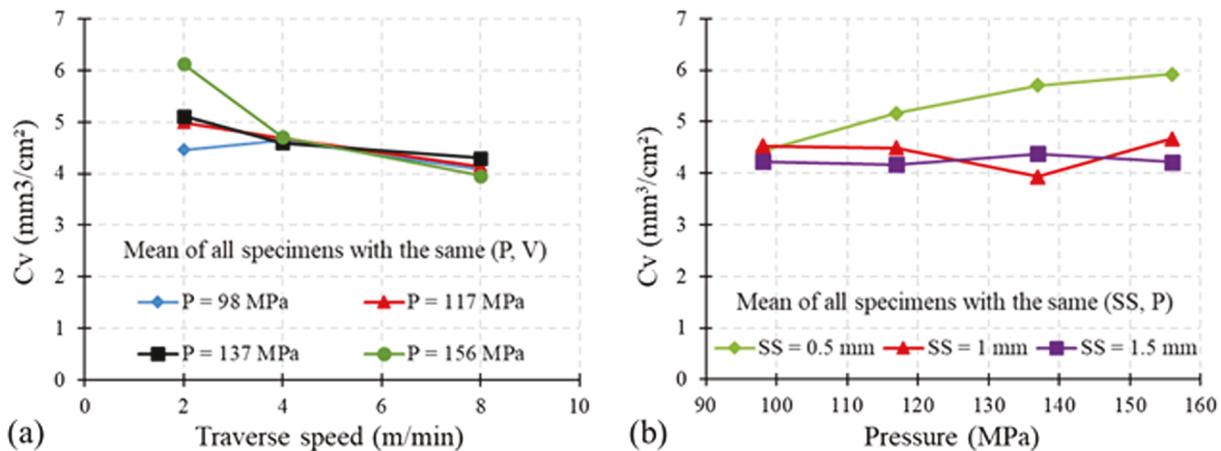
Fig. 15. Mean combined effect of (a) pressure and traverse speed and (b) pressure and scan step on the crater volume by unit area C_v . (For interpretation of the references to colour in this figure legend, the reader is referred to the web version of this article.)

The mean effects of the milling parameters on the crater volume by unit area (C_v) are presented in Fig. 15. Each point of the graphs corresponds to a mean value of all specimens with similar set of parameters. For example, each point from Fig. 15a has the same set of pressure and traverse speed, with different scan steps. This parameter is then “hidden” and the focus is made on the combined influence of pressure and traverses speed.

It can be seen from Fig. 15a that the jet pressure greatly influences C_v

in case of milling with low traverse speed (2 m/min). Indeed, when the pressure varies from 98 MPa to 156 MPa, the crater volume per unit area increases from $4.46 \text{ mm}^3/\text{cm}^2$ to $6.13 \text{ mm}^3/\text{cm}^2$. Milling with a low traverse speed leads to a long jet exposure time on the specimen. Because of the material’s inhomogeneity, the matrix being more easily removed by the abrasive waterjet than the fibres, the disparity of removal is increased. The higher the jet energy (e.g. the higher the pressure), the greater this difference. By increasing the traverse speed, the effect of pressure on C_v is significantly reduced. This seems to prove that the jet exposure time is of crucial importance when considering the surface quality. Moreover, as the traverse speed increases, the crater volume slightly decreases, from around $4.7 \text{ mm}^3/\text{cm}^2$ to $4.0 \text{ mm}^3/\text{cm}^2$ for traverse speeds of respectively 4 m/min and 8 m/min.

The results from Fig. 15b emphasize the effect of scan step on the surface quality. Indeed, milling with a scan step smaller than the jet diameter (e.g. 0.5 mm) leads to an increase of craters as the pressure increases. Indeed, when the pressure increases from 98 MPa to 156 MPa, C_v rises from $4.43 \text{ mm}^3/\text{cm}^2$ to $5.92 \text{ mm}^3/\text{cm}^2$. This trend can be explained by the important degree of overlapping of two consecutive trenches when milling with a scan step of 0.5 mm. The defects created by a jet pass are worsen by the next one, reducing the surface quality. On the contrary, milling with a scan step around the nozzle diameter (1 mm) leads to an almost constant surface quality, which can be attributed
