## Surface integrity while trimming of composite structures: X-ray tomography analysis

N. Nguyen-Dinh, Redouane Zitoune, Christophe Bouvet, Sabine Le Roux. Surface integrity while trimming of composite structures: X-ray tomography analysis. *Composite Structures*, 2019, 210, pp.735-746. 10.1016/j.compstruct.2018.12.006 . hal-01969389

# Surface integrity while trimming of composite structures: X-ray tomography analysis

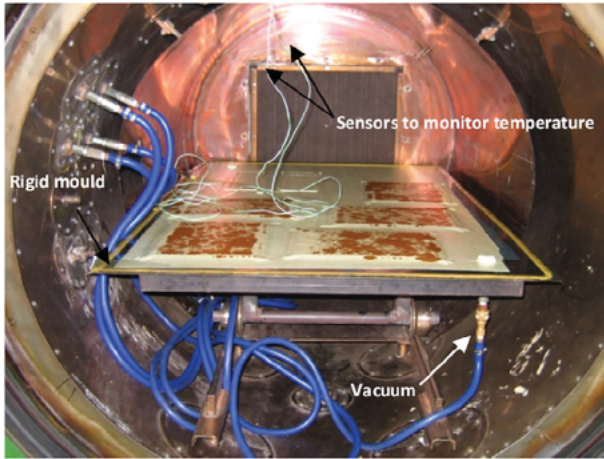
Fig. 1. Composite laminate after the curing process in the autoclave.

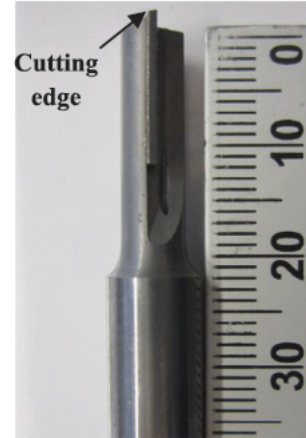
Fig. 2. PCD tool used with two straight flutes.

In order to better analyze the damage generation in function of the machining parameters, a new polycrystalline diamond cutter with two straight flutes (PCD) was used for each cutting condition (Fig. 2). The machining is conducted without lubricant (dry machining). The detail information of experimental parameters is presented in Table 2.

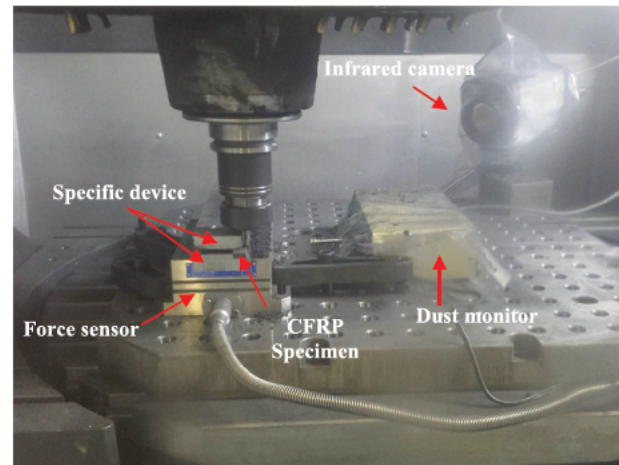
Fig. 3. Experimental devices for trimming tests.

Trimming process was carried out on a “DMU 85 mono BLOCK” 5 axis milling machine with maximum spindle speed of 18,000 rpm. The specimens were fixed firmly by cap screws on a specific device designed and manufactured for this study. The acquisition of cutting forces was recorded using a dynamometer (Kistler 9272). The dynamometer was connected to a Kistler charge amplifier (Model 5019). The force signals were obtained after being converted from the charge signals by the amplifier. Machining temperatures were registered by an infrared camera referenced under ‘Thermo Vision’ A40. The details of experimental devices used trimming test are shown in the Fig. 3.

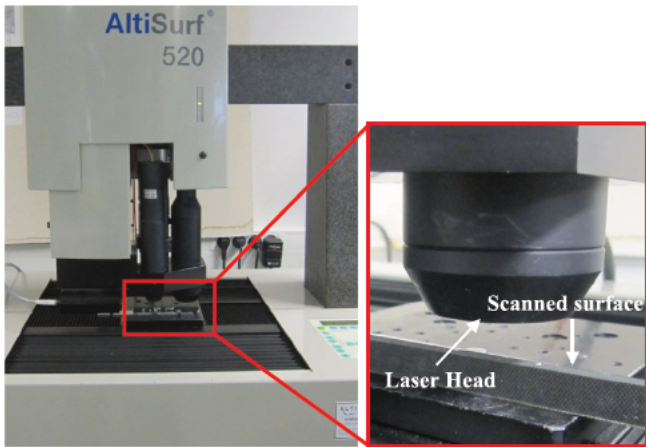
Fig. 4. Confocal Microscope – For 3D topography measurement.

The machining quality has been investigated by three different techniques. The first technique concerns the 3D topographer “Altisurf 520” which works based on the principle non contact stylus (Fig. 4). The evaluation area of 8 mm × 4.5 mm (corresponding to direction of length and thickness respectively) was scanned with a spatial resolution of 4 μm. 3D average surface roughness is extracted from the topography using “Digitalsurf” software using Gaussian filter (cut off = 0.8 mm). Moreover, craters occurring on the machined surface were estimated by their volume by analyzing the topography surface using the software Mountain maps. The volume calculation is performed based on the polynomial (with degree 3) approximation technique [37]. The second technique of the surface characterization is based on the use of the Scanning Electron Microscope (SEM). For this, the SEM used is referenced under “JEOL JSM 5310”. Finally, to quantify the damage

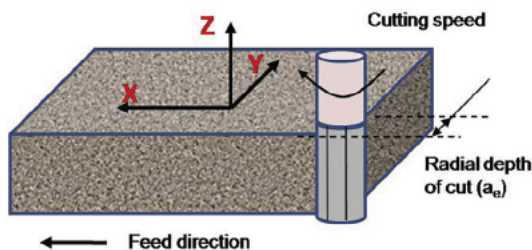
Fig. 6. Schema of the axes and the machining directions.

The schematic diagram of trimming process is described in Fig. 6. Cutting forces are presented by Eq. (1) in which it is noticed that force component in Z direction is approximated zero due straight flute (helix angle ≈ 0°).

where:  $F_x$  and  $F_y$ ,  $F_z$  are the cutting force components in X (feed force), Y (normal force) and Z (thrust force) directions, respectively.

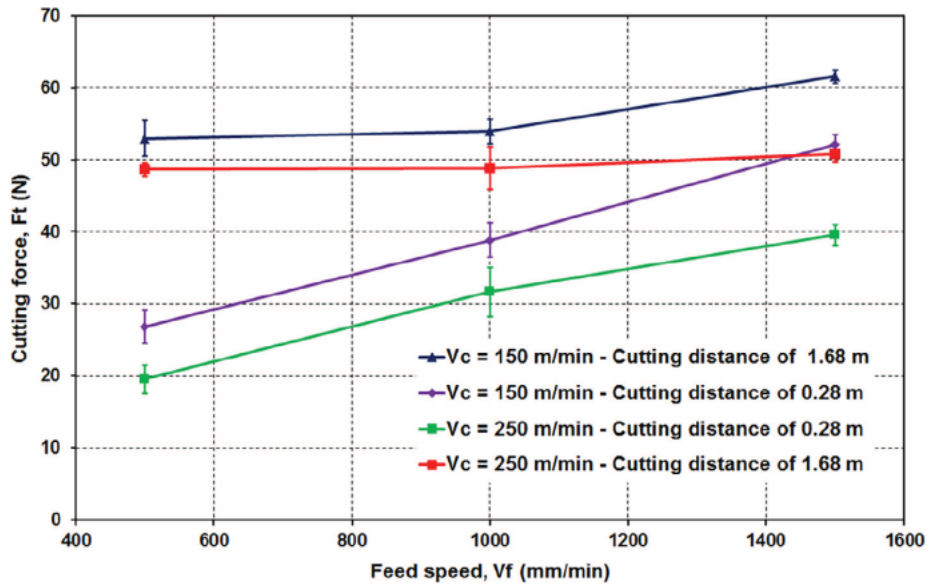
Fig. 7. Influence of cutting parameters and cutting distance on cutting forces.

The evolution of cutting forces as a function of cutting parameters is illustrated in Fig. 7 at two cutting distances (0.28 m and 1.68 m). The choice of these two cutting distances, leads to analyse the results for the case where the tool is considered as new (for a distance of 0.28 m) and for the case where the tool is worn (for a distance of 1.68 m). It is important to mention that each point of the cutting force in Fig. 7 represents an average value of five measurements. From this figure it can be noticed that the amplitude of the cutting forces recorded for any cutting distance as well as cutting speed increases with the increasing of the feed speed, with an exception of the case of machining with 250 m/min and after a distance of 1.68 m. For example, when the tool is considered as new (distance of machining equal to 0.28 m) and when the trimming is conducted with a feed speed of 500 mm/min and a cutting speed of 150 m/min, the generated cutting force is 66% lower compared to the case of machining with a feed speed of 1500 mm/min (with the same cutting speed). This result can be explained by the fact that, with the increasing of the feed speed, the volume of the cut material increases too and this requires more force for the chip formation. If we refer to the literature work of [1,5], the influence of the cutting parameters (feed speed and cutting speed) on the cutting forces is directly related to the theoretical chip thickness. As a matter of fact, an increase in the feed speed or the decrease in the cutting speed favours the augmentation of the chip thickness. This can explain the reduction of the cutting forces with the augmentation of the cutting speed from 150 m/min to 250 m/min. For example, when trimming is conducted with a new cutting tool and with a cutting speed of 250 m/min (for a feed speed of 1500 mm/min), the cutting force is 25% lower compared to the case of trimming with a cutting speed of 150 m/min and for the same feed speed and the state of the tool. This result can be related, on the one side to the reduction of the theoretical chip thickness with the increasing of the cutting speed, and on the other side to the augmentation of the temperature of machining. In fact, with the augmentation of the temperature of machining favours the softening phenomenon of the epoxy matrix and the material can be easily cut. However, for the same conditions of machining (250 m/min) and after a distance of machining of 1.68 m, the variation of the cutting force in function of the feed speed is less evident compared to all other cases. This result can be related, on the one side to the theoretical chip thickness, and on the other side to nose radius of the cutting tool which is impacted by the wear phenomenon. In fact, with mentioned cutting speed and when the feed speed varies from 500 mm/min till 1500 mm/min the theoretical chip thickness varies from 2 μm to 6 μm. These theoretical values of the chip thickness are estimated based on the method proposed in [1]. In this case, the maximum and the minimum values of the chip thickness are inferior to the carbon fibres diameter (7 μm) and also inferior to the nose radius of the cutting tool after a distance of cutting of 1.68 m (Fig. 8). In this situation, it can be supposed that the mechanisms of chip formation, when helical tools or straight flutes tools are used, is more by pushing rather than cutting the matrix and the carbon fibres compared to the other cases. Similar results have been observed by Haddad et al. [5], Prakash et al. [15] and Wang et al. [38]. However, when the burr tools are used, Prakash et al. [15] have observed an augmentation of the cutting forces in function of the feed rates for any value of the cutting speeds.

From the Fig. 7, it can be also noticed that, the augmentation of the distance of machining has a non negligible impact on the augmentation of the cutting forces. This can be related by the fact that, due to the abrasive character of the carbon fibres, the wear of the tool occurs and with the augmentation of the machining distance the friction phenomenon and the cutting forces increase too.

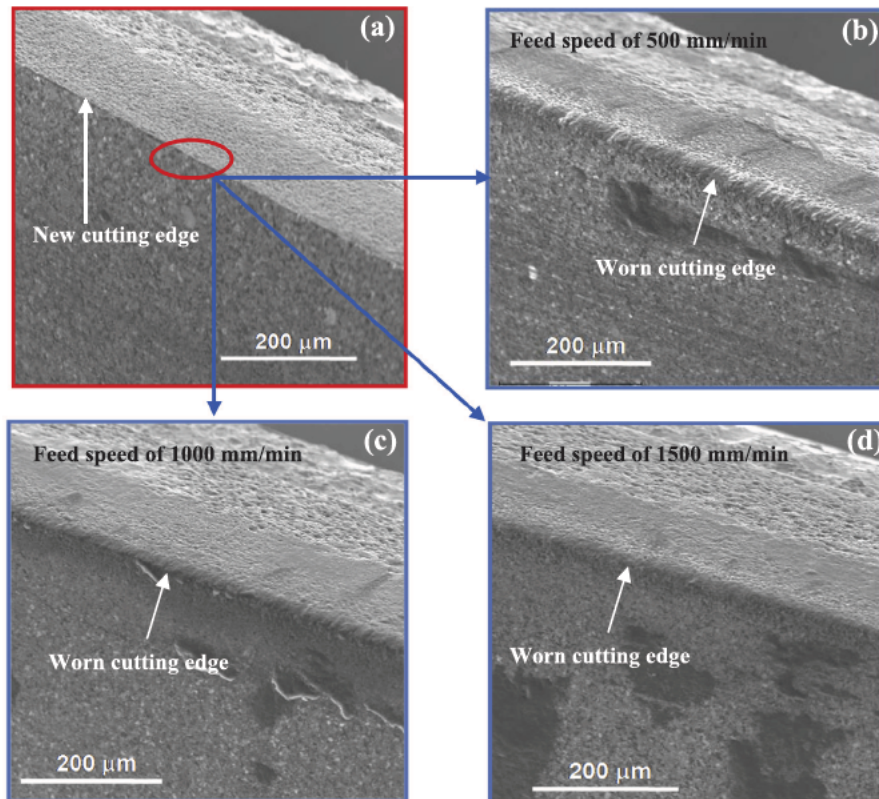
Fig. 8. SEM images of cutting edges of tools: magnified view of cutting edge of (a) unused tool and after cutting distance of 1.68 m for cutting speed of 150 m/min and with feed speed of (b) 500 mm/min, (c) 1000 mm/min and (d) 1500 mm/min.

These informations can be confirmed by the SEM images of cutting edge of tool before and after machining for different cutting condition of the feed speed and for a cutting speed of  $V_c = 150$  m/min (Fig. 8). Form this figure it is clear that the wear of tool in term of nose radius of

the cutting edges is strongly impacted by the choice of the feed speed. From the Fig. 8 a and b, we can observe that, after trimming with a feed speed of 500 mm/min, the radius of the cutting edge has been strongly modified and is higher compared to the initial state (before machining). However, with the increasing of the feed speed, the variation of the local geometry of the radius of the cutting edge of the tool is less impacted (Fig. 8 c and d). This result can be explained by the fact, that when trimming is conducted with small feed speed, the machining time is more compared to the case when the feed speed is higher. Similar results have been observed by Cadorin et al. [4] during

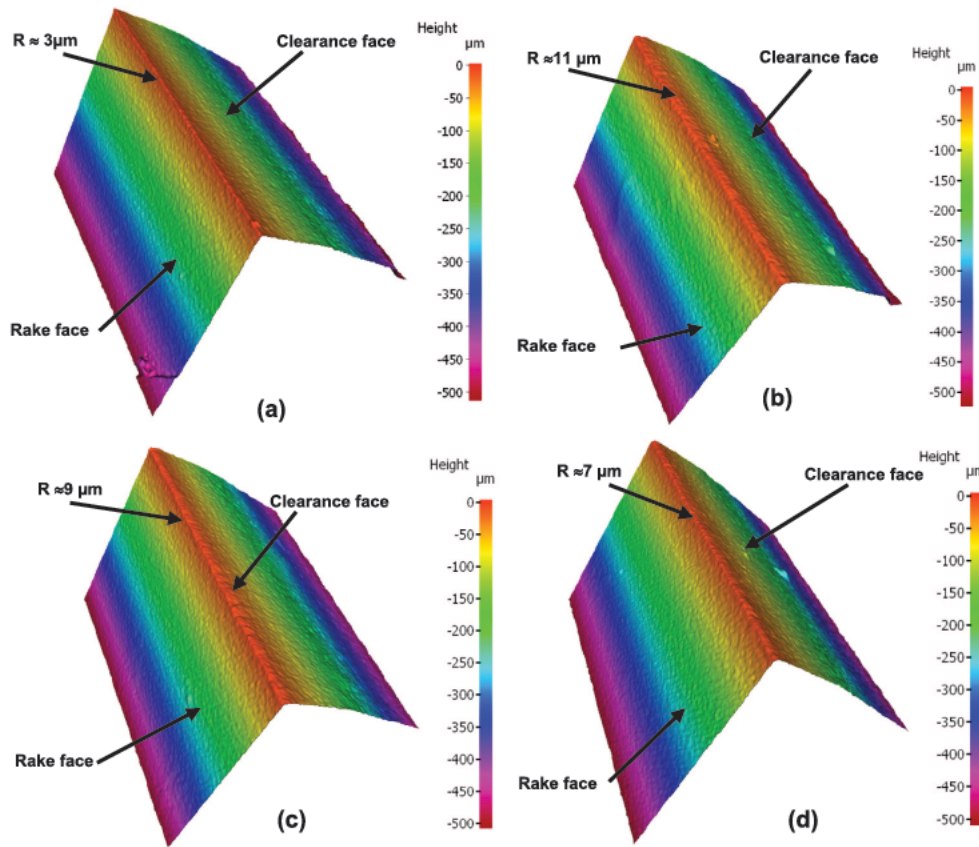
Fig. 9. Cartographies of the cutting edges of the tool in function of the machining parameters for cutting speed of 150 m/min. Before machining (a), and after machining ( $L_c = 1.68$  m) with (b)  $V_f = 500$  mm/min, (c)  $V_f = 1000$  mm/min and (d)  $V_f = 1500$  mm/min.

The cartographies of the cutting edges for the different tools used are obtained thanks to microscopy leads to estimate the impact of the feed speed on the values of the nose radius of the cutting tools (Fig. 9). Based on these images and image processing technique, the value of the

nose radius measured before machining on a new cutting tool is around 3  $\mu\text{m}$ . However, when trimming is conducted with feed speed of 1500 mm/min and a cutting speed of 150 m/min, the value of the nose radius reaches 7  $\mu\text{m}$  (Fig. 9 d). Moreover, with the reduction of the feed speed till 500 mm/min, the value of nose radius reaches 11  $\mu\text{m}$  (Fig. 9 b).

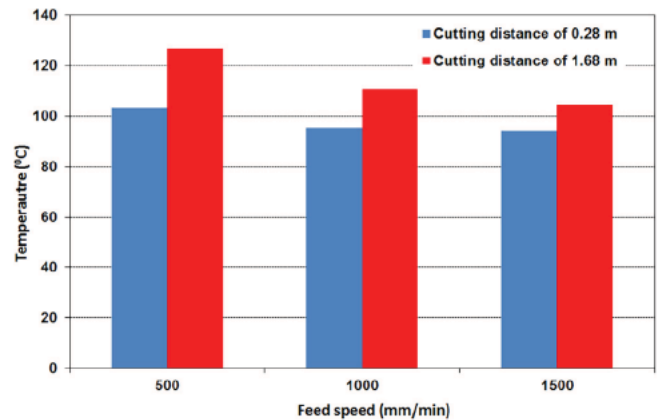
Fig. 10. Evolution of machining temperature versus feed speed and cutting distance for cutting speed of 150 m/min.

In the Fig. 10, the influence of the feed speed and the machining distance on the maximum temperature generated during the trimming process captured on the surface by the Infrared (IR) camera is presented. From this figure it is clear that the levels of the machining temperature generated after a machining distance of 0.28 m is less than or equal to 103  $^{\circ}\text{C}$  for any feed speed tested. However, with the increasing of the machining distance (from 0.28 m to 1.68 m), the generated temperatures recorded by the IR camera are 25% superior to those measured after a machining distance of 0.28 m. In addition, the minimum value of the temperature recorded after a distance of machining of 1.68 m is superior to the maximum value recorded after a distance of machining of 0.28 m. For example, machining with a feed speed of 500 mm/min and with a new tool (distance of machining of 0.28 m), leads to generate a maximum temperature of 105  $^{\circ}\text{C}$ . However, when the tool is considered as worn (distance of machining of 1.68 m)

and with the same condition of trimming the maximum temperature recorded by the IR camera reaches its maximum value which is around 127  $^{\circ}\text{C}$ . In fact, this can be explained by the fact that, with the increase of the contacting distance between the active part of the cutting tool and the composite part, the wear of the tool is more pronounced and the geometry of the cutting edge is subjected to a local modification (Fig. 8). This information can be confirmed by the SEM observations of the cutting edge of the tool before and after machining for different machining distances and for different cutting conditions illustrated in the Fig. 8. From these SEM images, it is clear that the increase of the distance of machining, as well as the reduction of the feed speed, favors the raise of the nose radius of the cutting edge of the tool. It is important to mention that with the local modification of the nose radius of

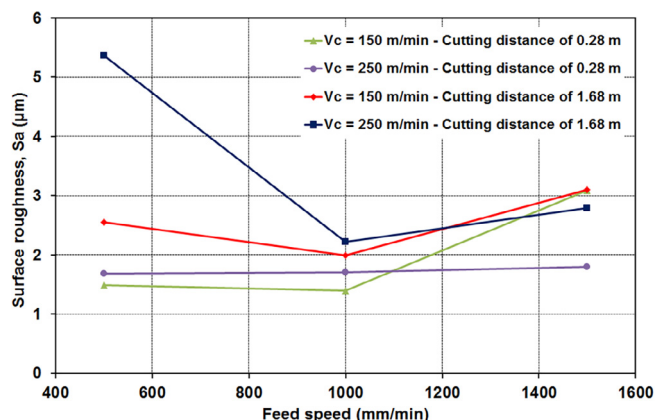
Fig. 11. Evolution of surface roughness, Sa, versus cutting parameters at two cutting distances.

In the Fig. 11 is presented the evolution of the roughness (Sa) as a function of the machining parameters as well as the cutting distance. From this figure it is clear that for a distance of machining of 0.28 m the values of the parameter Sa remain small and inferior to 3 μm. However with the increasing of the distance of machining important values of the parameter are recorded. For example, when trimming is conducted at small feed speed (500 mm/min) and high cutting speed the value of measured Sa after a distance of machining of 0.28 m is around 1.7 μm. However, with the increasing of the distance of machining (till 1.68 m), the recorded value of Sa reaches 5.5 μm. These differences can be related to the high values of the cutting forces recorded as well as the wear mechanisms observed when trimming is carried out at lower feed speed and high cutting speed. In fact, with the apparition of the wear phenomenon on the active part of the tool and in particular the augmentation of the radius cutting edge of the tool the machining quality can be impacted (Fig. 8 b). Trimming at high cutting speeds leads to accelerated tool wear phenomenon and especially when low feed speeds are combined with high cutting speeds. In fact, in this situation, the rate of tool wear and the temperature of machining is much higher compared to the case when the machining is conducted as high feed speeds. This phenomenon is also acknowledged by several authors and for different tool geometries as in Haddad et al. [5] and Prakash et al. [15]. It is important to notice that, when trimming is conducted with cutting speed of 250 m/min and low feed rate of 500 mm/min a high surface roughness is obtained (Fig. 11) after machining 1.68 m. This

combination of feed speed and cutting speed induces rapid tool wear, and after machining 1.68 m the nose radius of the tool is increased. This leads to increase in the cutting forces which favours the generation of the damages. These damages which have the form of crater and fibre pull outs (Fig. 14 and Fig. 15) have a real consequence on the augmentation of the surface roughness. To confirm that SEM images have been conducted for all the trimmed specimens.

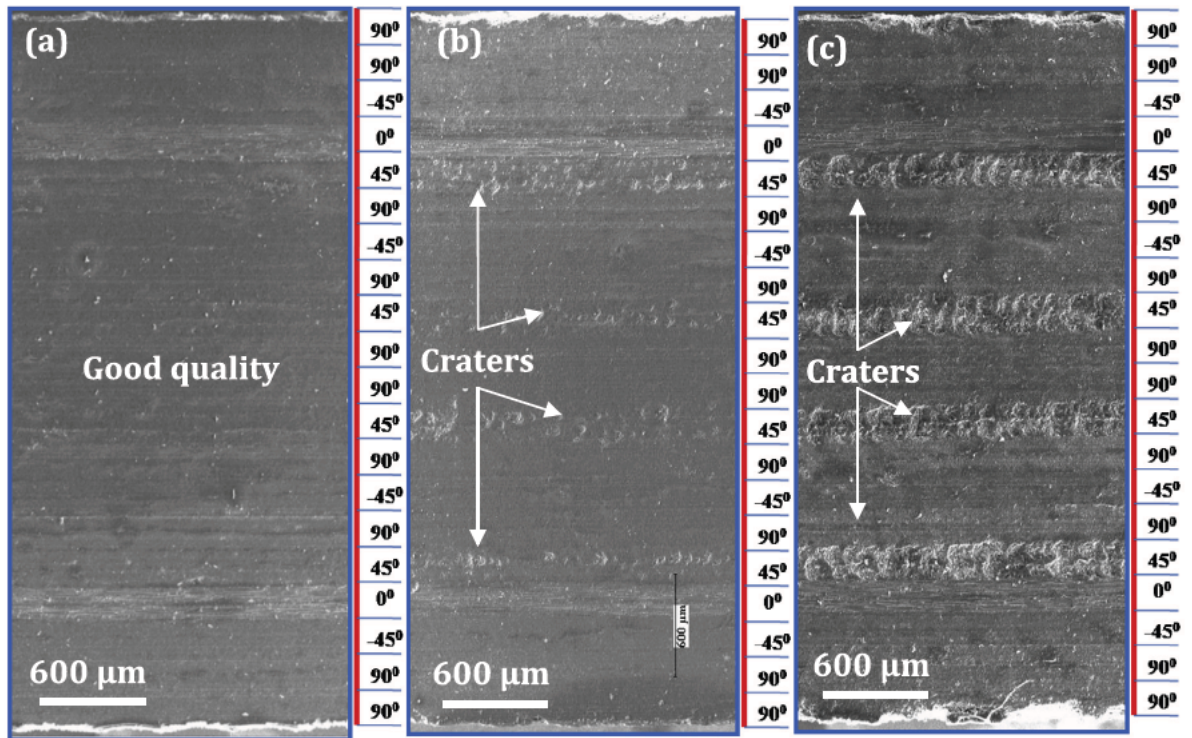
Fig. 12. SEM images conducted on specimens trimmed with a cutting speed of 150 m/min and after a cutting distance of 0.28 m with a feed speed of (a) 500 mm/min, (b) 1000 mm/min and (c) 1500 mm/min.

The SEM images conducted on the different machined specimens after a distance of cutting of 0.28 m are illustrated in the Fig. 12. From these images it can be noticed that, when trimming is carried out with small feed speed (500 mm/min), the machining quality can be considered as good (Fig. 12 a). In fact, with this condition of machining the obtained surface is smooth and it is difficult to distinguish between the different plies of orientations of the laminates. However, with the raise of the feed speed (e.g. 1000 mm/min), it can be observed the evolution of small mechanical damage or mechanical degradation of the matrix on the machined surface. These damages are located mainly on the fibres oriented at +45°. It is important to mention that, with the configuration of trimming selected (down milling) the relative angle between the direction of the cutting speed and the plies oriented at +45°, is equal to 135° or -45°. In fact, in this machining configuration, the experimental tests of the orthogonal cutting conducted on unidirectional specimens by Zitoune et al. [10], reveals that with the raise of the depth of cut, macro cracks are generated on the free edge of the specimen and several zones of damages on the machined surface are observed. However, good machining qualities have been observed for the specimens oriented at 0° and +45°. In fact, these results have been explained by the physic of cutting which is strongly influenced by the relative angle measured between the ply orientation and the cutting speed direction.

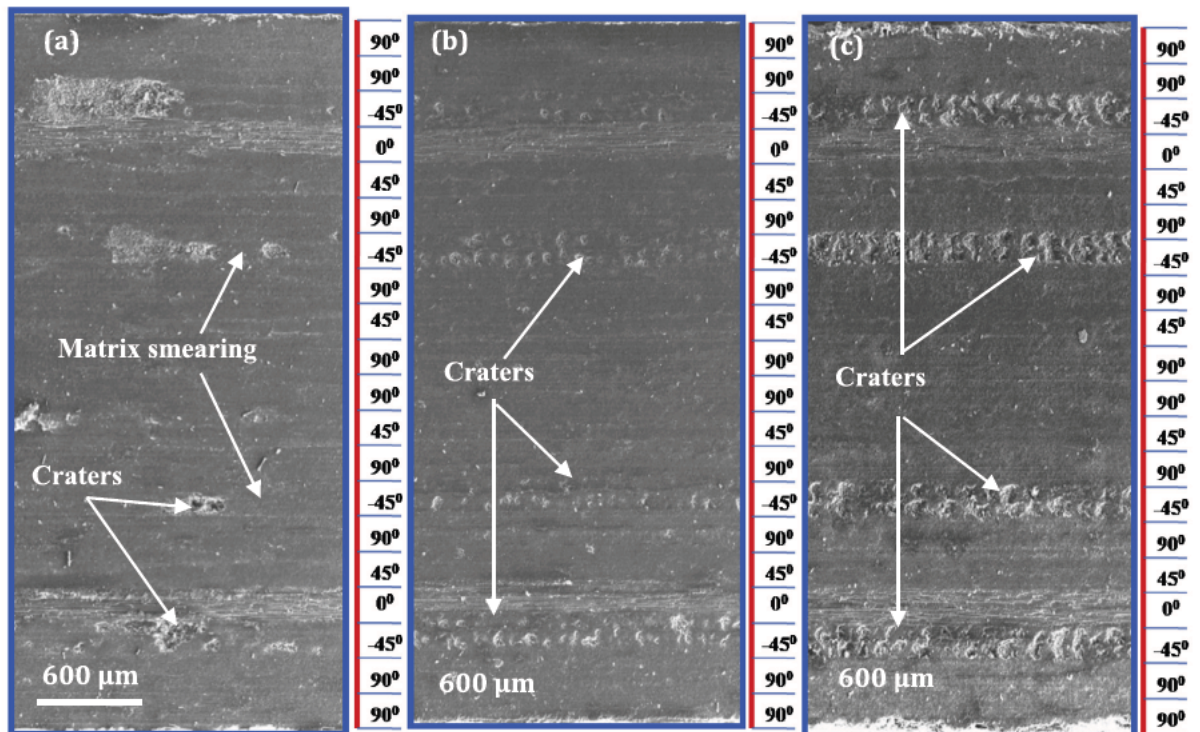
Fig. 13. SEM images conducted on specimens trimmed with a cutting speed of 150 m/min and after a cutting distance of 1.68 m with a feed speed of (a) 500 mm/min, (b) 1000 mm/min and (c) 1500 mm/min.

The SEM images conducted after a distance of cutting of 1.68 m reveal that when the trimming is carried out with a feed speed superior or equal to 1000 mm/min, the augmentation of the cutting distance does not show a real impact on the machining quality (Figs. 12 c and 13 c). However, when the machining is conducted with small feed speed (500 mm/min), the SEM images of the Figs. 12 a and 13 a show the generation of important zones of craters and mechanical degradation of the matrix. This result can be clearly related to the wear phenomenon which impacted the local modification of the radius of the cutting edge of the tool.

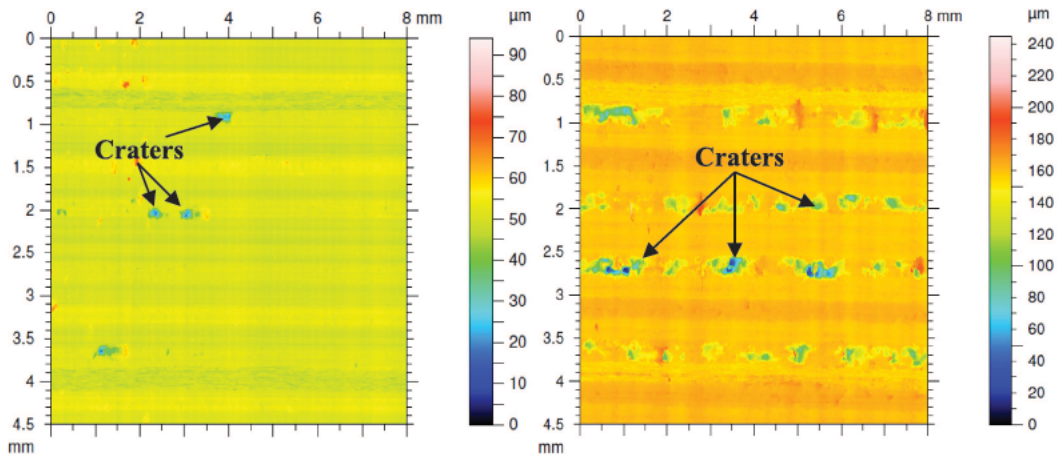
Fig. 14. Topography profiles showing the appearances of craters on the machined surface for the cutting condition of 500 mm/min feed speed and 250 m/min cutting speed for cutting distance of (a) 0.28 m and (b) 1.68 m.

Thanks to the surface characterization by confocal microscope, measurements conducted on the different trimmed specimens reveal that, with the augmentation of the cutting distance the maximum depth of the damaged zone measured after a distance of machining of 1.68 m can be three times superior to the one measured after a distance of machining of 0.28 m. For example, when trimming is conducted with a feed speed of 500 mm/min and cutting speed of 250 m/min, the maximum damage depth measured by the confocal microscope is around 50 μm after a distance of machining of 0.28 m. However, with the same condition of machining and after a distance of machining of 1.68 m, the maximum damage depth recorded is around 160 μm. Based on these images the volume of the craters generated by the process of cutting have been quantified in function of the machining parameters (Fig. 14).

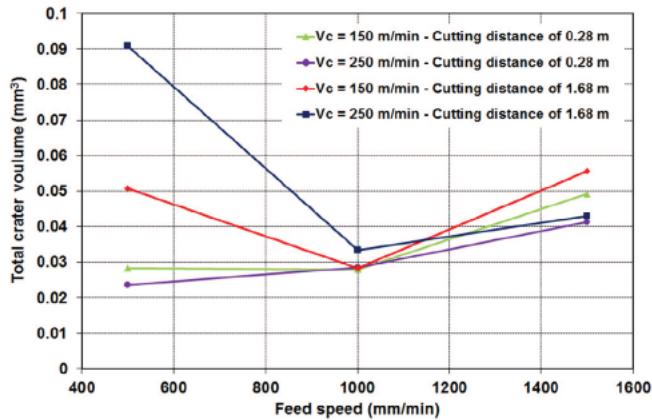
Fig. 15. Evolution of crater volume versus cutting parameters at two cutting distances.

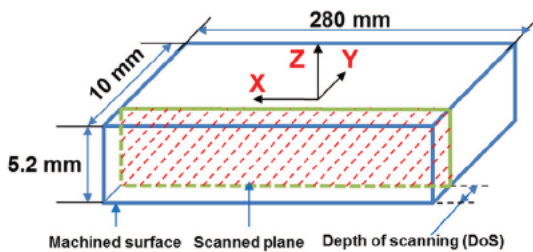
Fig. 16. Schematic view of the depth of machining damage.

“Y = 0” or to the Depth of Scanning (DoS) equal to 0 (Fig. 16). In fact, the damage depth is visualized in the Y direction as described schematically in the Fig. 16 and is measured using the “Volume Viewer” Plugin of ImageJ software.

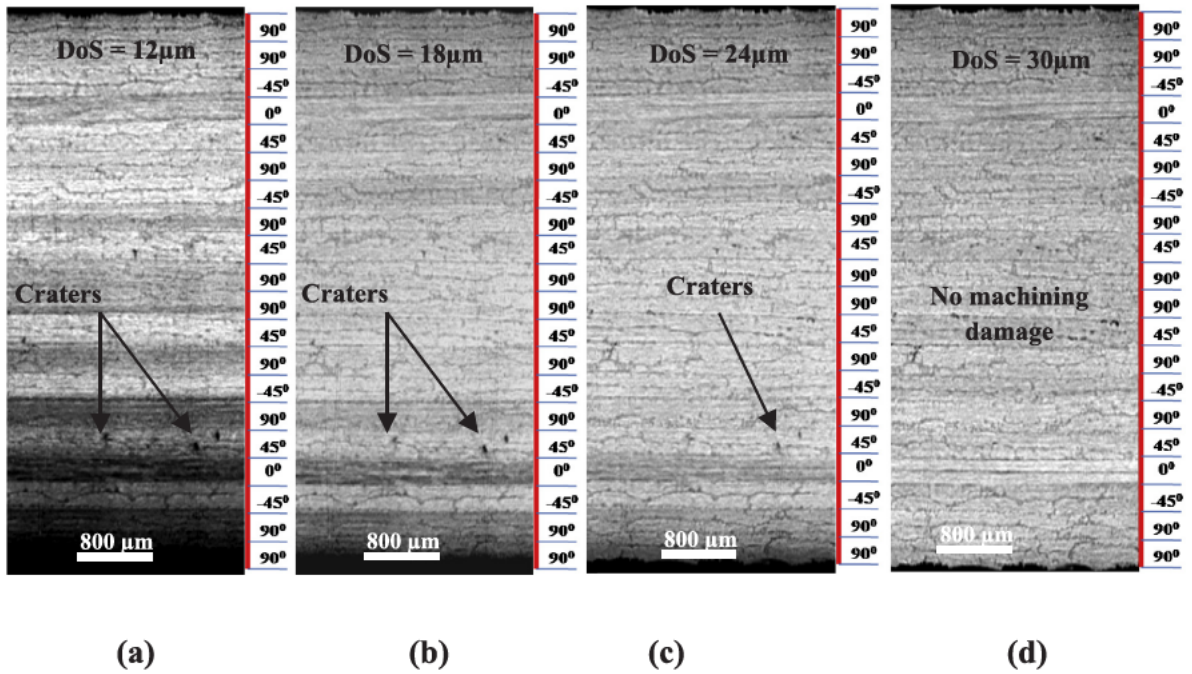
Fig. 17. X-ray tomography images showing machining damage for cutting speed of 150 m/min and feed speed of 500 mm/min at cutting distance of 0.28 m with various depth of scanning of (a) 12  $\mu\text{m}$ , (b) 18  $\mu\text{m}$ , (c) 24  $\mu\text{m}$  and (d) 30  $\mu\text{m}$ .

tomography on specimen after trimming with a cutting speed of 150 m/min, feed speed of 500 mm/min and distance of cutting of 0.28 m. From these images we notice the presence of small craters located in the area where the plies are oriented at  $-45^\circ$  (Fig. 17 a) and the machining quality is considered as good. In fact, with the increasing of the depth of

Fig. 17 represents the different images obtained by the X ray

scanning the images of the Fig. 17 b and c reveal that, the maximum depth of the observed craters is less or equal to 24  $\mu\text{m}$ . However, with the same machining parameters and when the distance of machining reaches 1.68 m, several zones of damage (with form of craters) are observed (Fig. 18 a). Based on the images of the Fig. 18, it can be mentioned that the form and the size of damage are different from those observed when the cutting distance is around 0.28 m. In addition, when the distance of cutting is around 1.68 m, the maximum depth of the damage reaches 140  $\mu\text{m}$ .

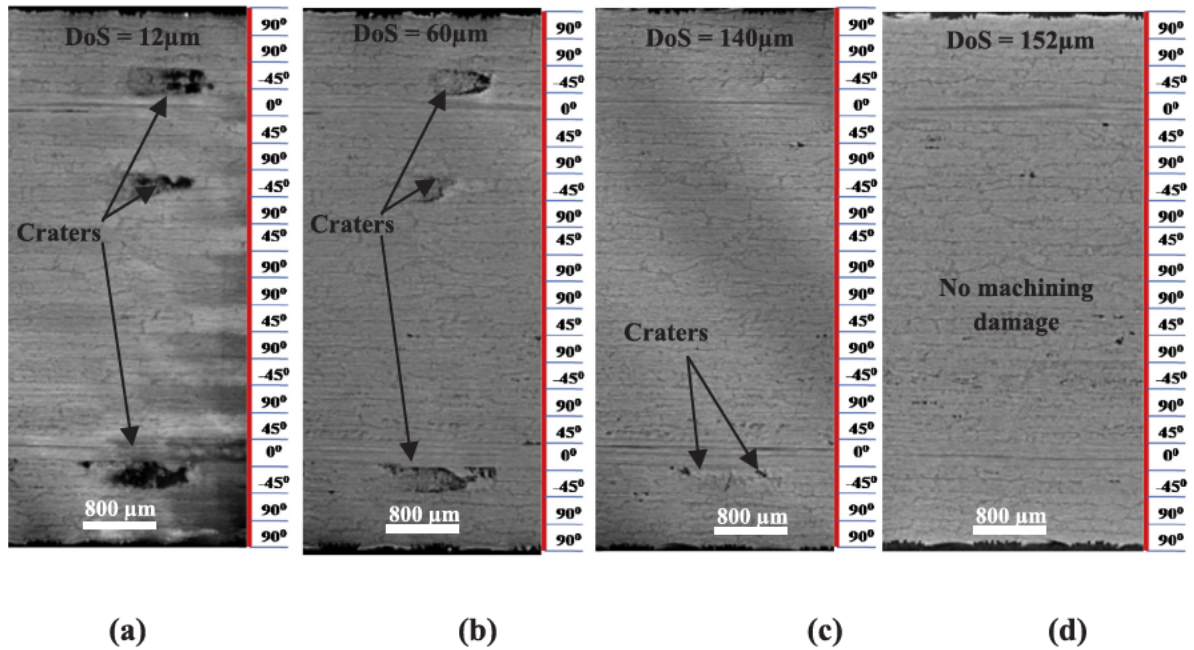
Fig. 18. X-ray tomography images showing machining damage for cutting speed of 150 m/min and feed speed of 500 mm/min at cutting distance of 1.68 m with various depth of scanning of (a) 12  $\mu\text{m}$ , (b) 60  $\mu\text{m}$ , (c) 140  $\mu\text{m}$  and (d) 152  $\mu\text{m}$ .

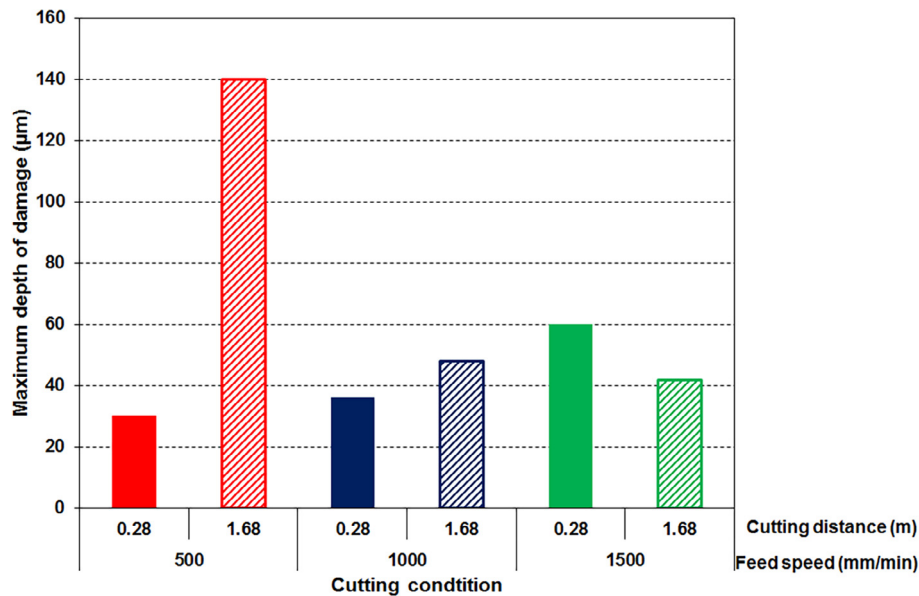
Fig. 19. Influence of the feed speed and the cutting distance on the depth of the machining damage when trimming is conducted with a cutting speed of 150 m/min.

Based on this new technique of measurement and characterization of the damage due the machining process, in the Fig. 19 is represented the influence of the feed speed and the distance of cutting on the maximum depth recorded after trimming with a cutting speed of 150 m/min. From this figure it is clear that the minimum internal depth of damage is observed when trimming is conducted with a feed speeds

less or equal to 1000 mm/min and with a distance of machining of 0.28 m. With this condition of trimming the depth of the internal damage is inferior to 40  $\mu\text{m}$ . However, with the increasing of the distance of machining and due to the mechanisms of wear and the local modification of the cutting edge of the tool, the maximum depth of the internal damage is superior to 40  $\mu\text{m}$  and can reach 140  $\mu\text{m}$  when the feed speed used is 500 mm/min.
